# The Escort Carrier **GAMBIER BAY**

Al Ross

# The Drawings

## A General arrangement

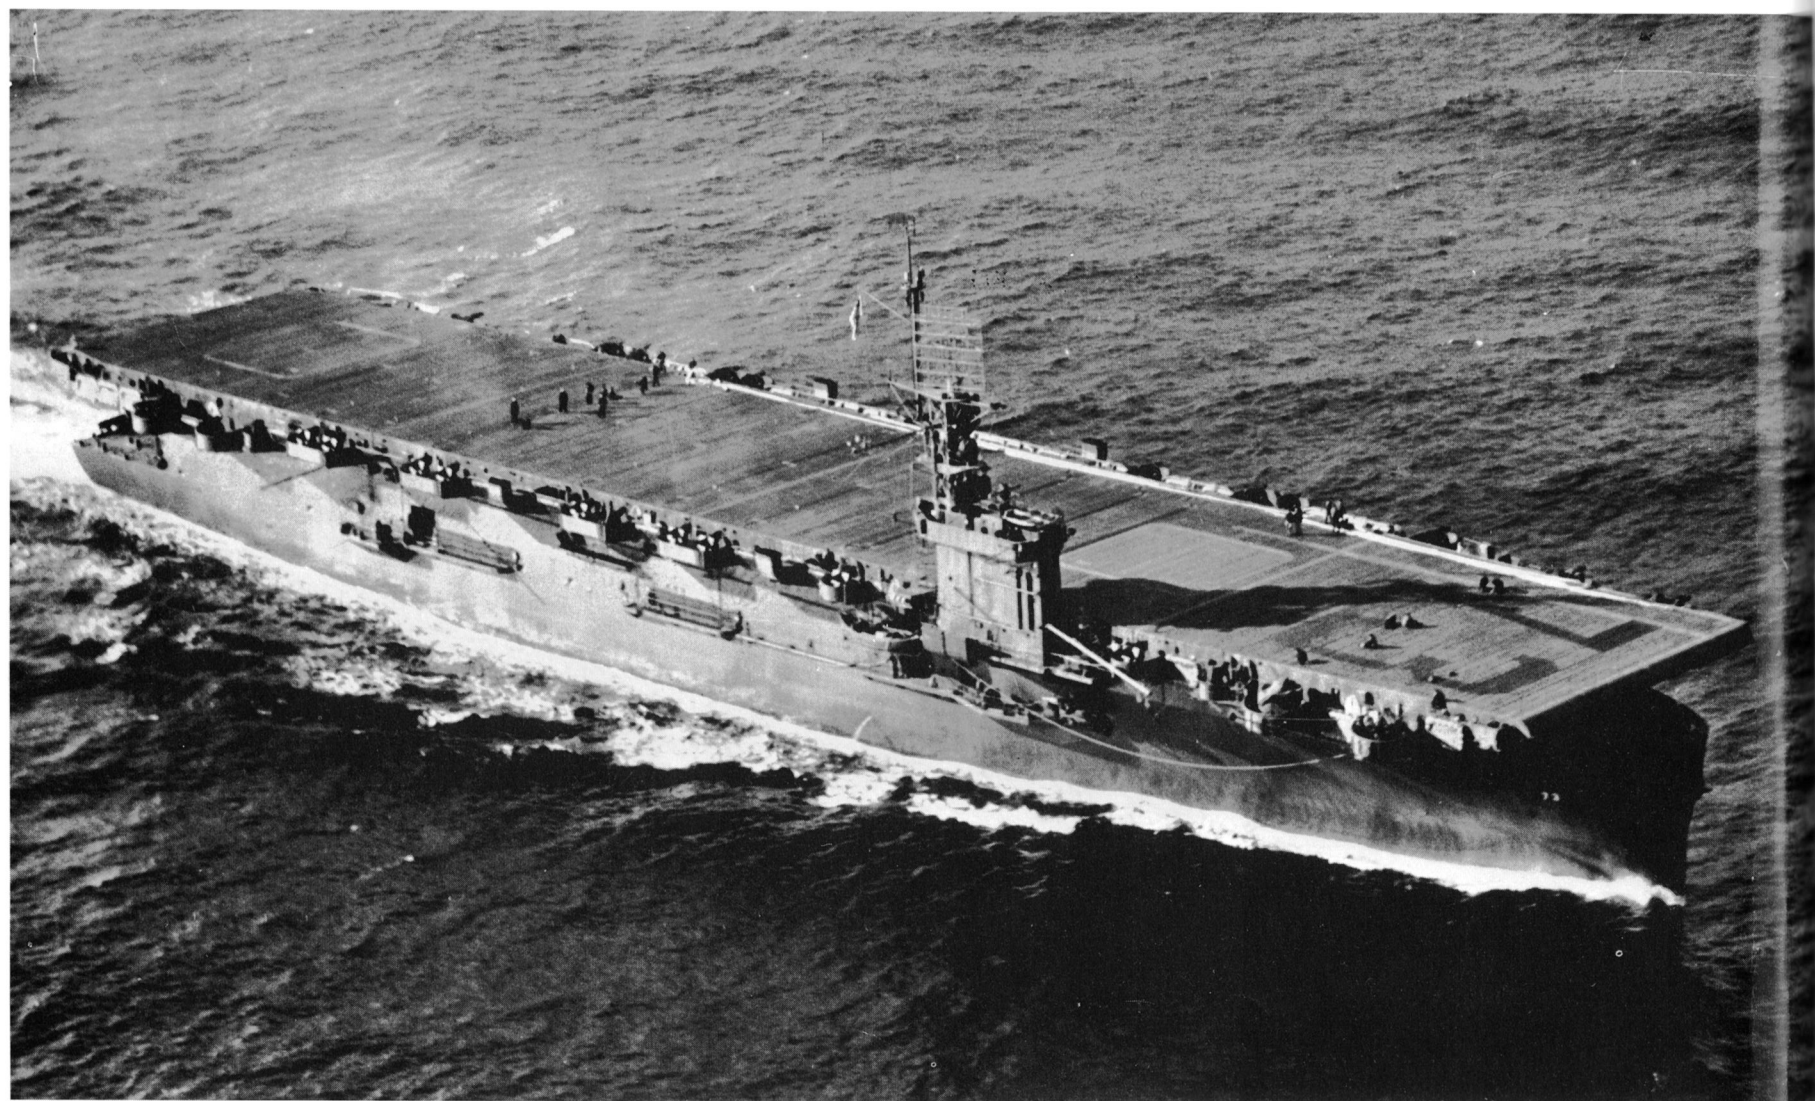
*Frontispiece: Gambier Bay* was painted initially in Measure 14 – overall ocean grey. The single H2-1 catapult is visible as a thin, light line running from about the middle of the forward elevator to the flight deck edge. (National Archives 80-G-222456)

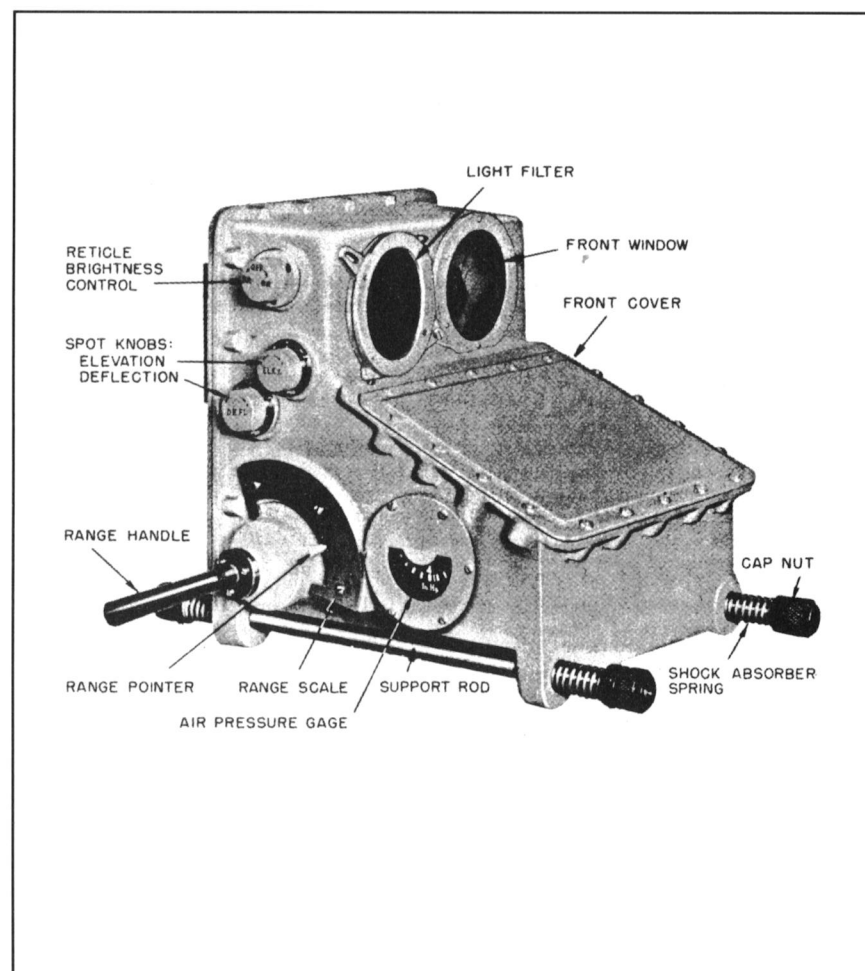
Mk14 gunsight - right side showing controls.

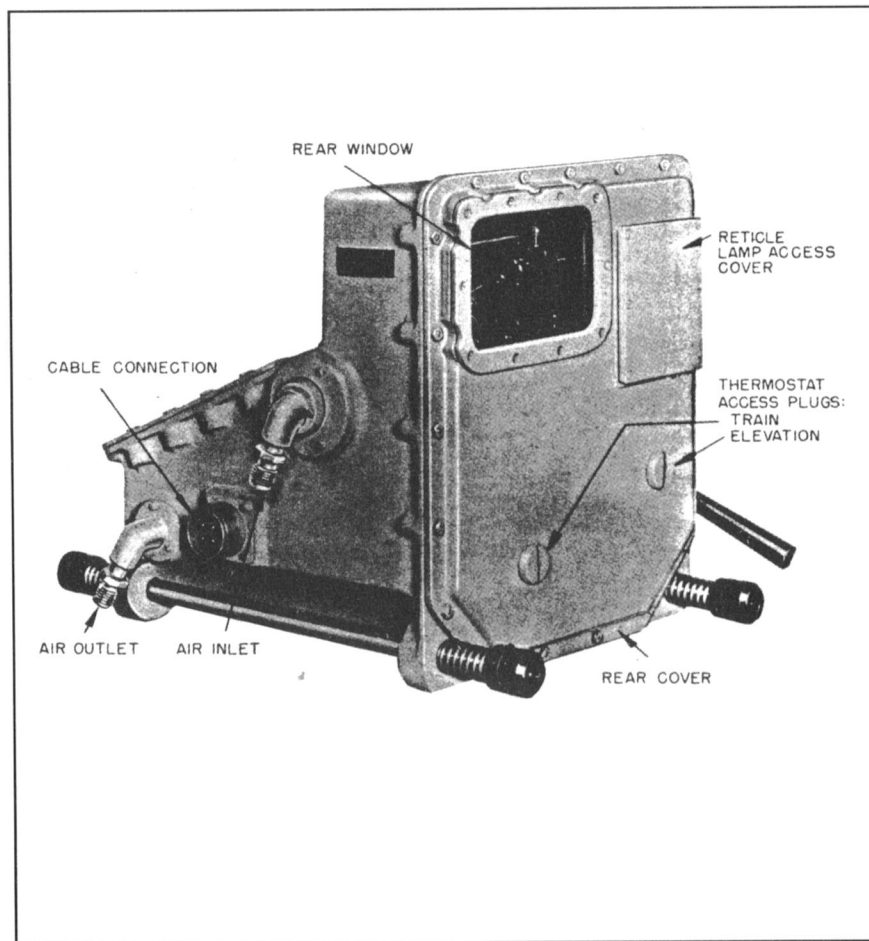
Mk14 gunsight – left side and rear.

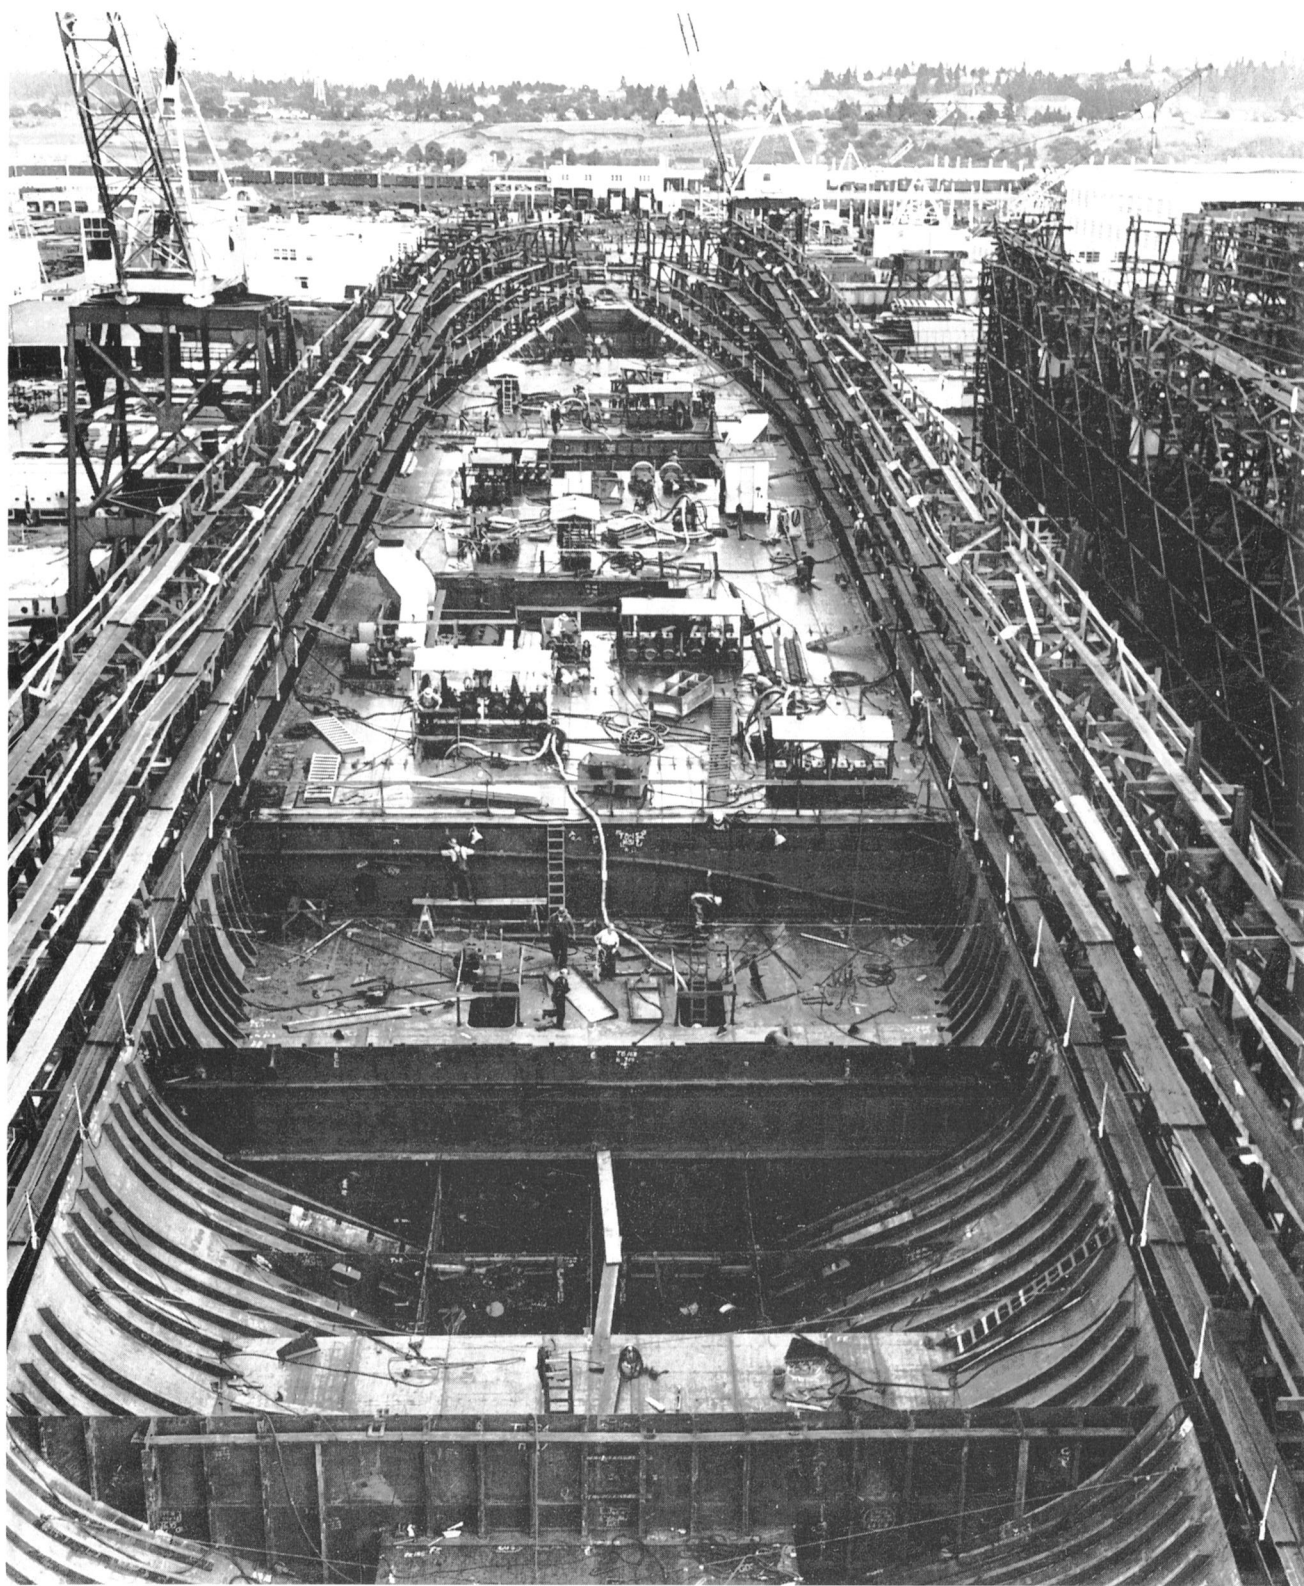
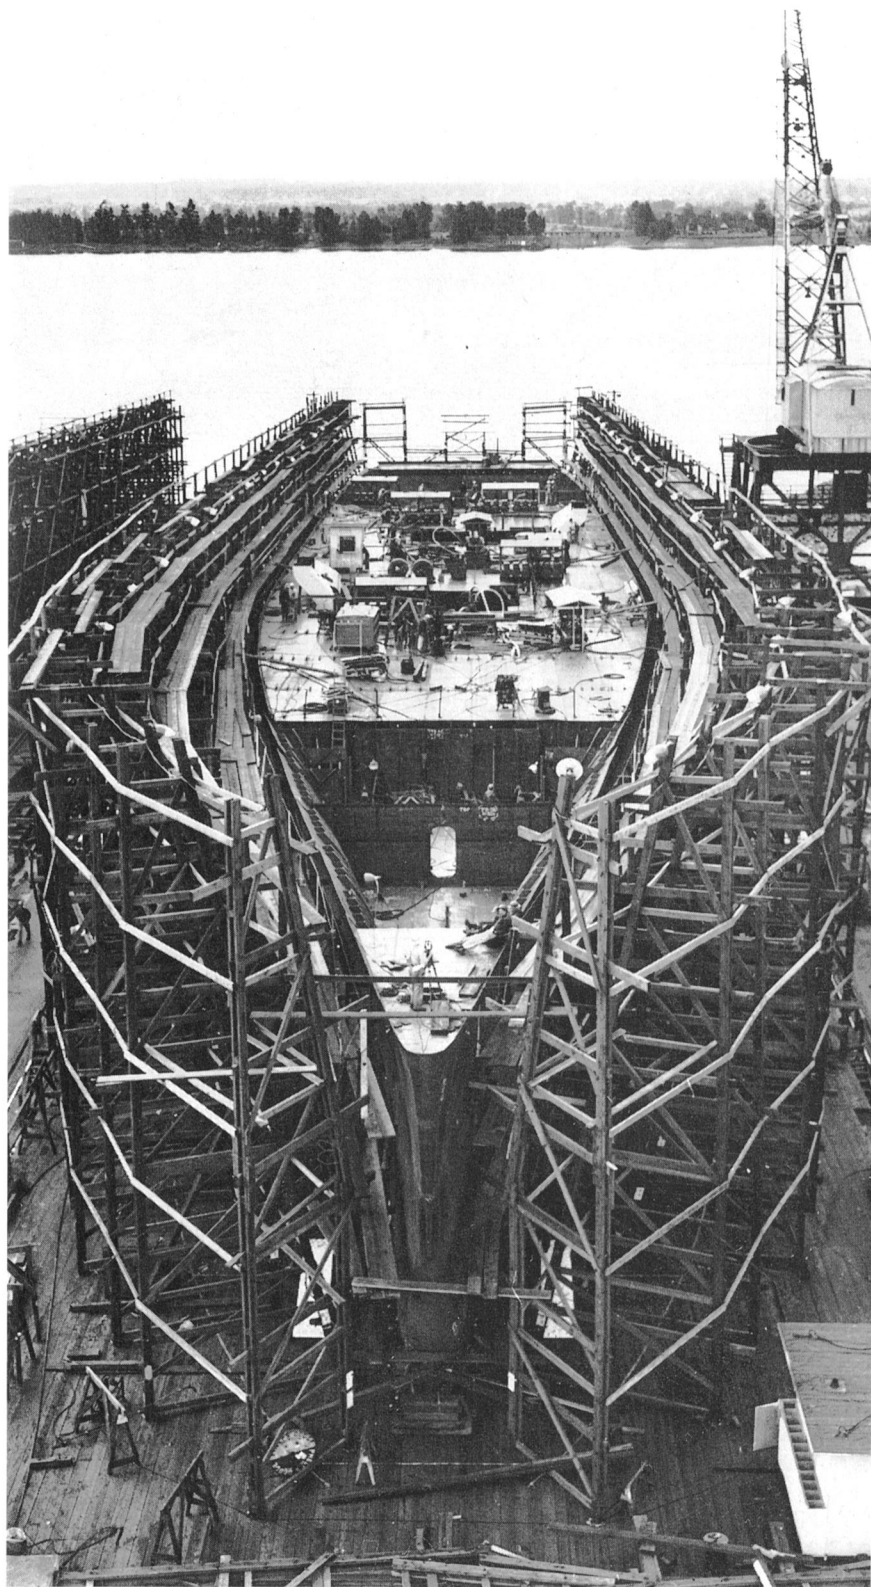
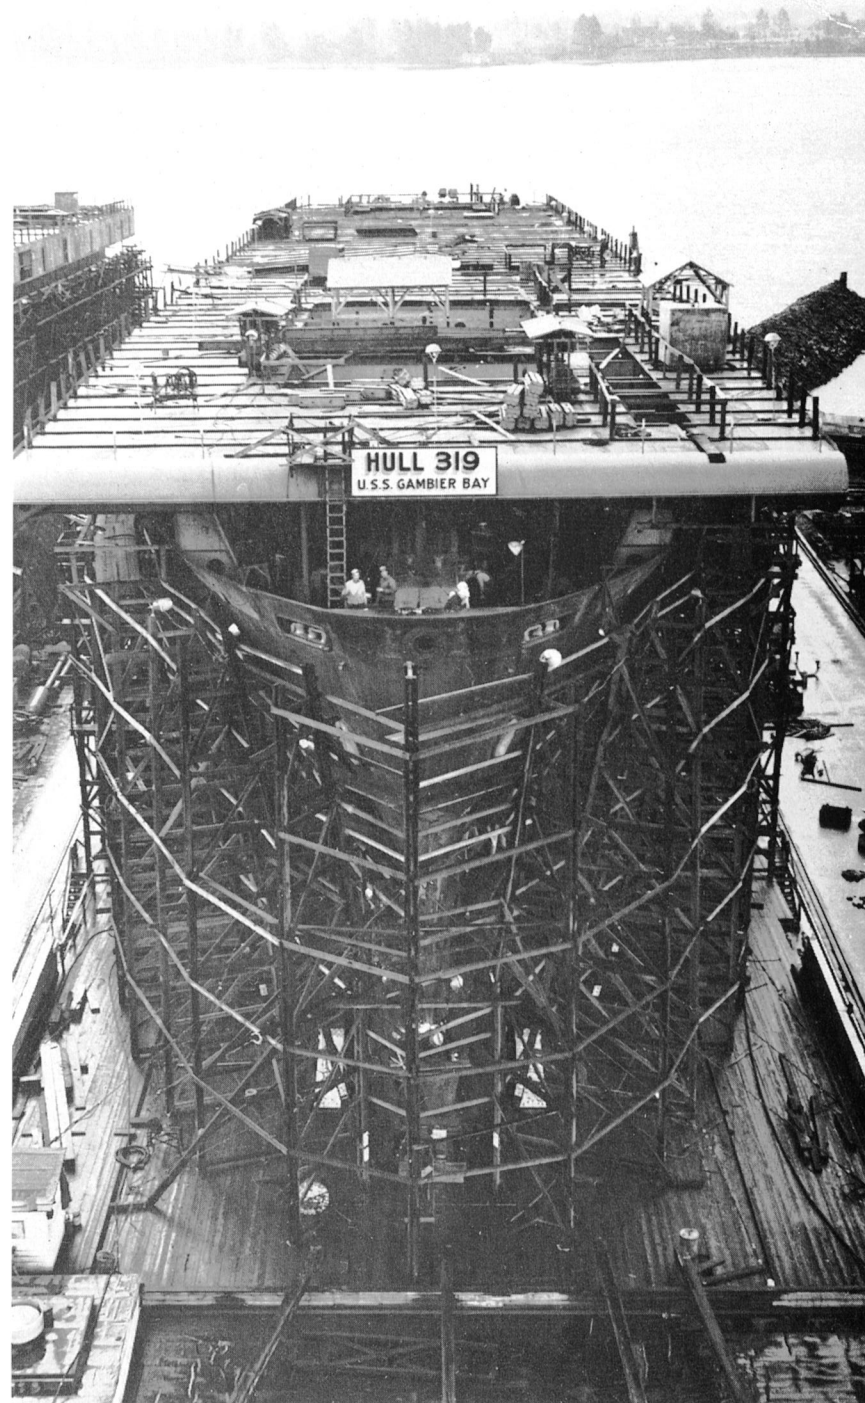
Various stages of *Gambier Bay* under construction. In the first photograph, the tank tops are under construction; in the next, the hangar deck appears just about completed; last, the flight deck is nearly finished and the ship almost ready for launching. (A Potochniak collection)

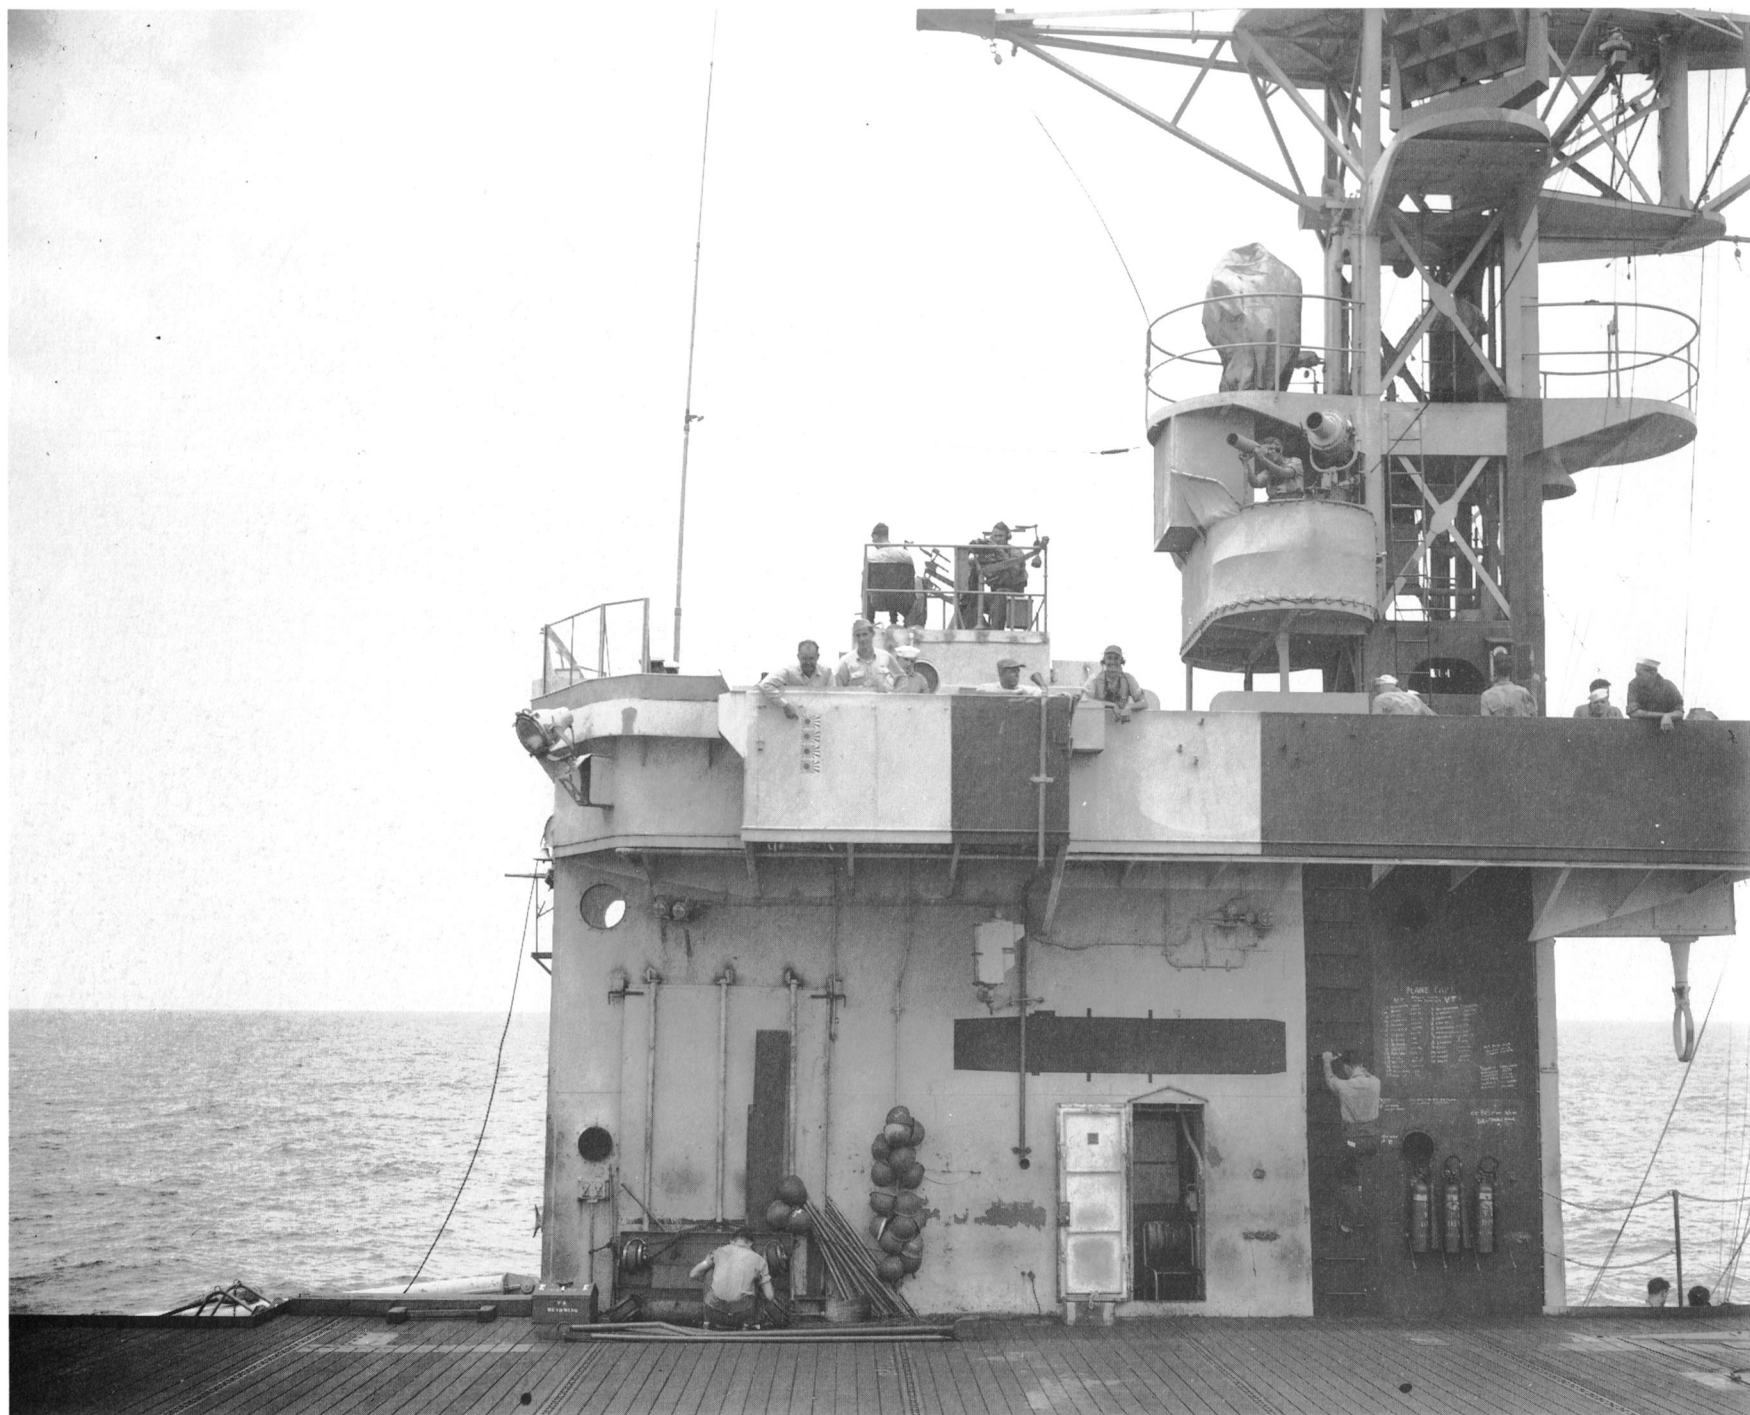
The port side of *Gambier Bay's* superstructure. Sky lookouts have replaced the 2.5m optical rangefinder and the aft 24in searchlight has been removed from its platform. (National Archives 80-G-243853)

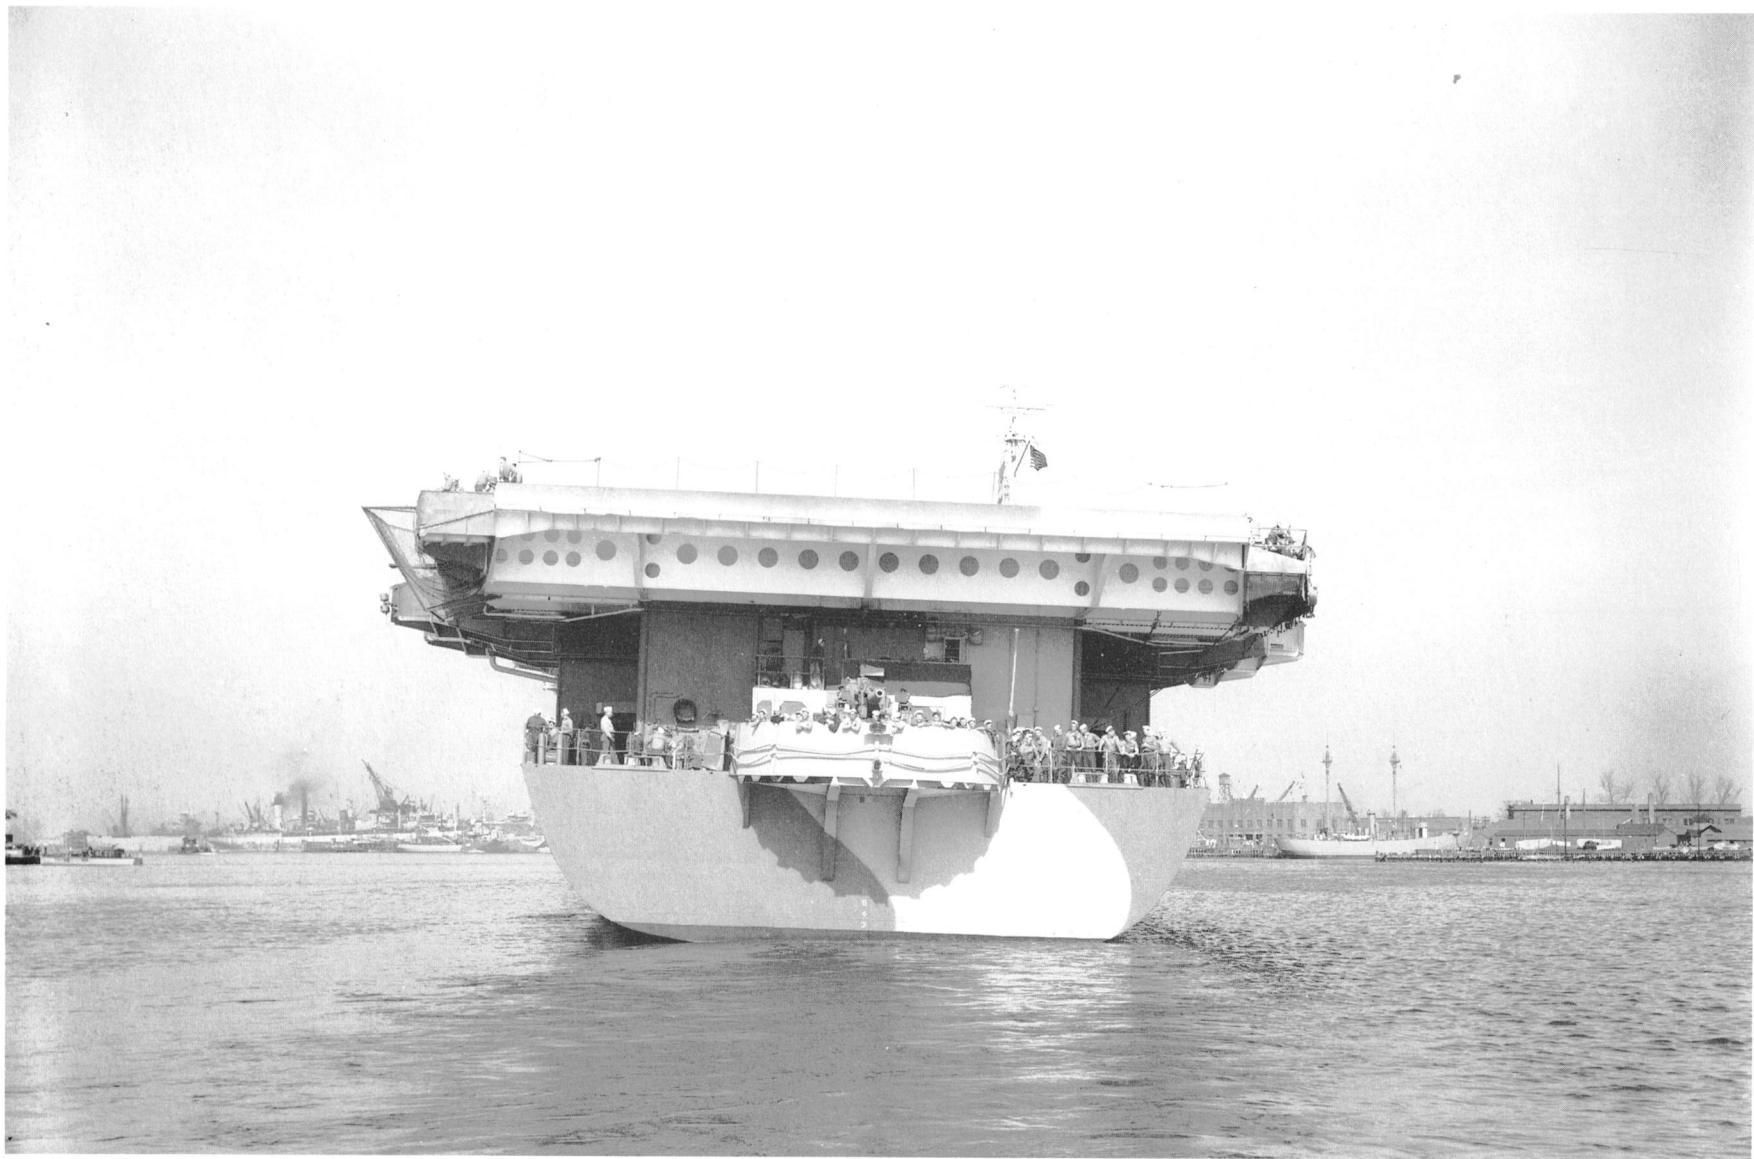
The broad flat transom of the *Casablanca* required the 5in/38 mount aft be heavily supported by girders. (National Archives 19-N-74931)

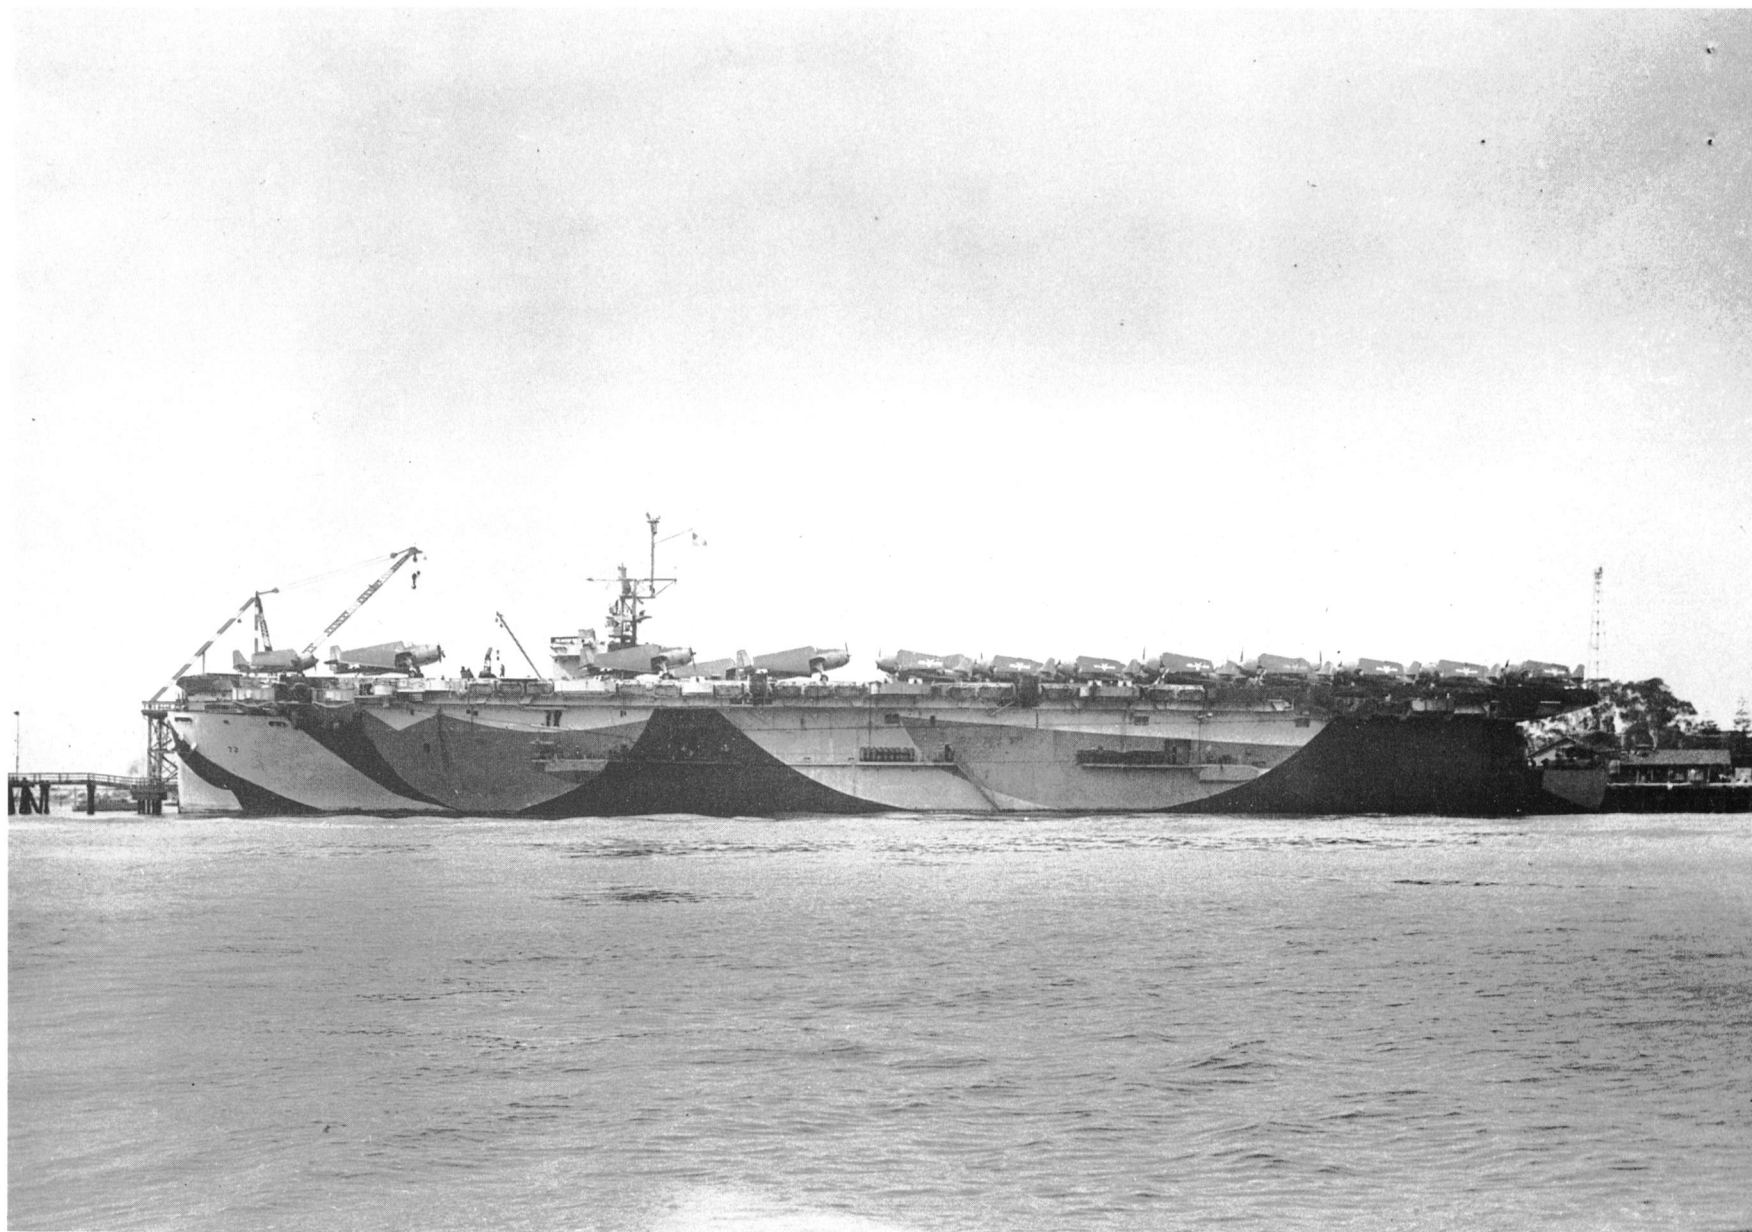
Port side of the Measure 32/15a carried by  
*Gambier Bay* at the time of her loss.  
Apparently, the censor has airbrushed out  
the SG and SK antennae, as neither are  
visible on the original print. (*National  
Archives 80-G-46892*)

*Gambier Bay* is known to have carried at least two schemes during her short life. Until February 1944 she was painted in Measure 14 – overall ocean grey (5-O). At the time of her loss, in October 1944, she was painted in Measure 32/15a – pale grey (5-P), light grey (5-L), ocean grey (5-O), and black. Exposed metal decks were painted deck blue (20-B), while the flight deck was either blue flight deck stain (No. 21) or a later, darker stain similar to deck blue. Flight deck stripes were originally white or light grey, but photos taken in mid-1944 show the stripes as either worn completely off or painted a shade similar to the flight deck. A large black '73' was carried on the forward end of the flight deck.

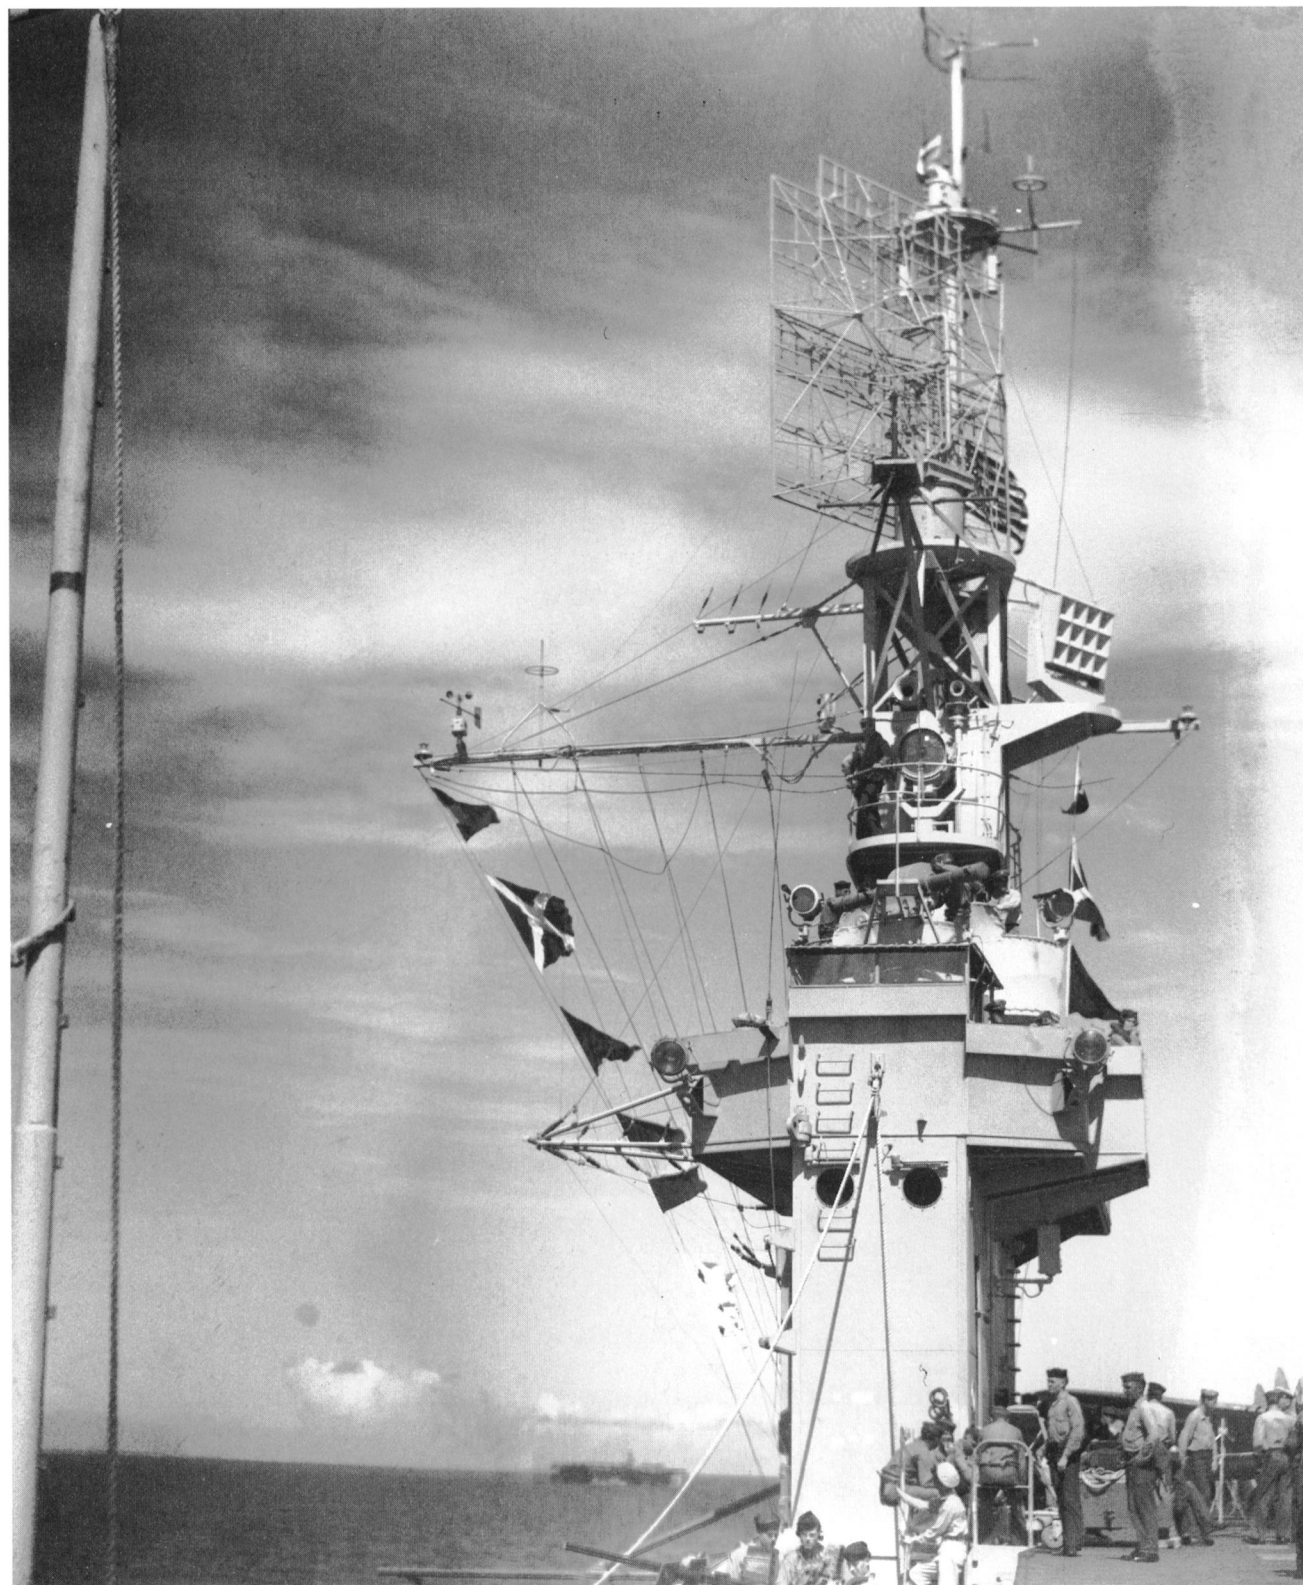
The compact size of the island is apparent in this photo of *Natoma Bay* (CVE-62) taken on 16 June 1944. (National Archives 80-G-275983)

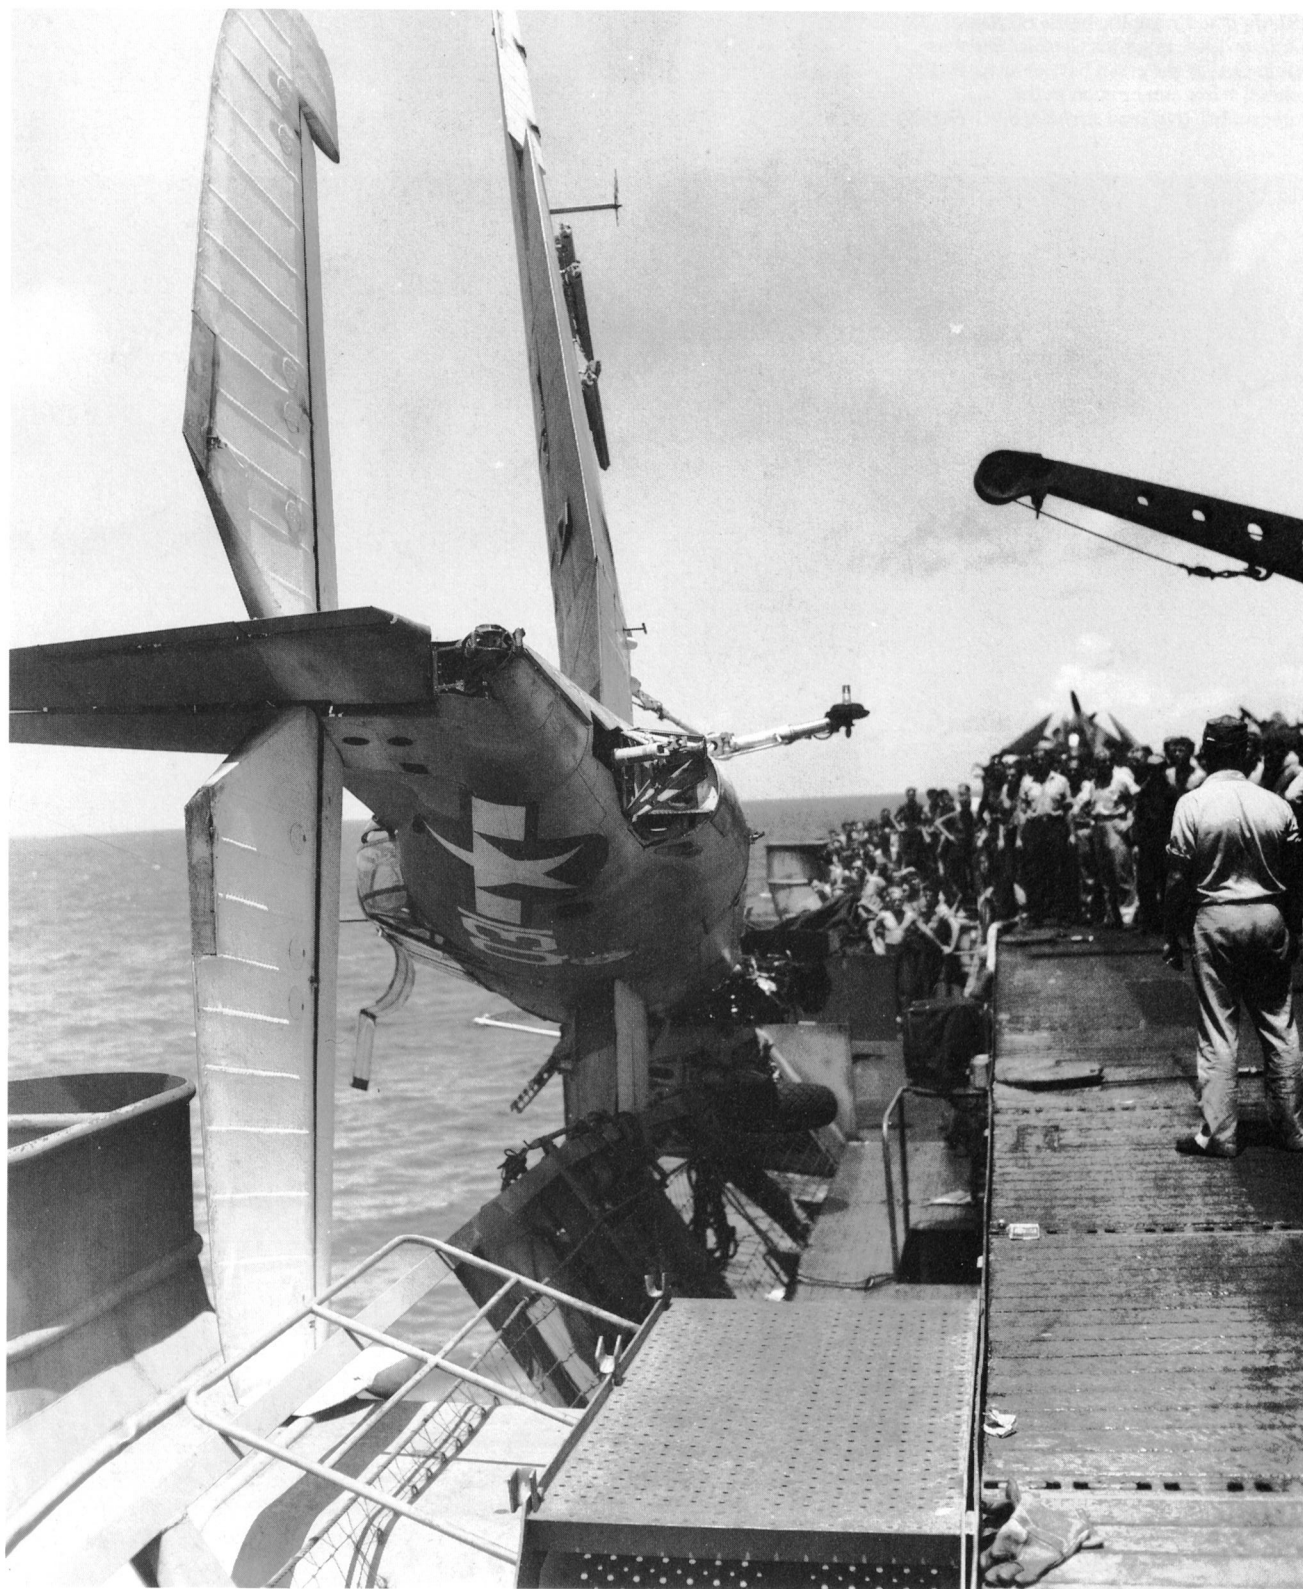
'Any landing you can walk away from . . .'  
This TBM-1C came to grief on *Kalinin Bay*  
(CVE-68) on 7 June 1944. Details of the  
uptake and the walkway over it are plainly  
visible. (National Archives 80-G-235942)

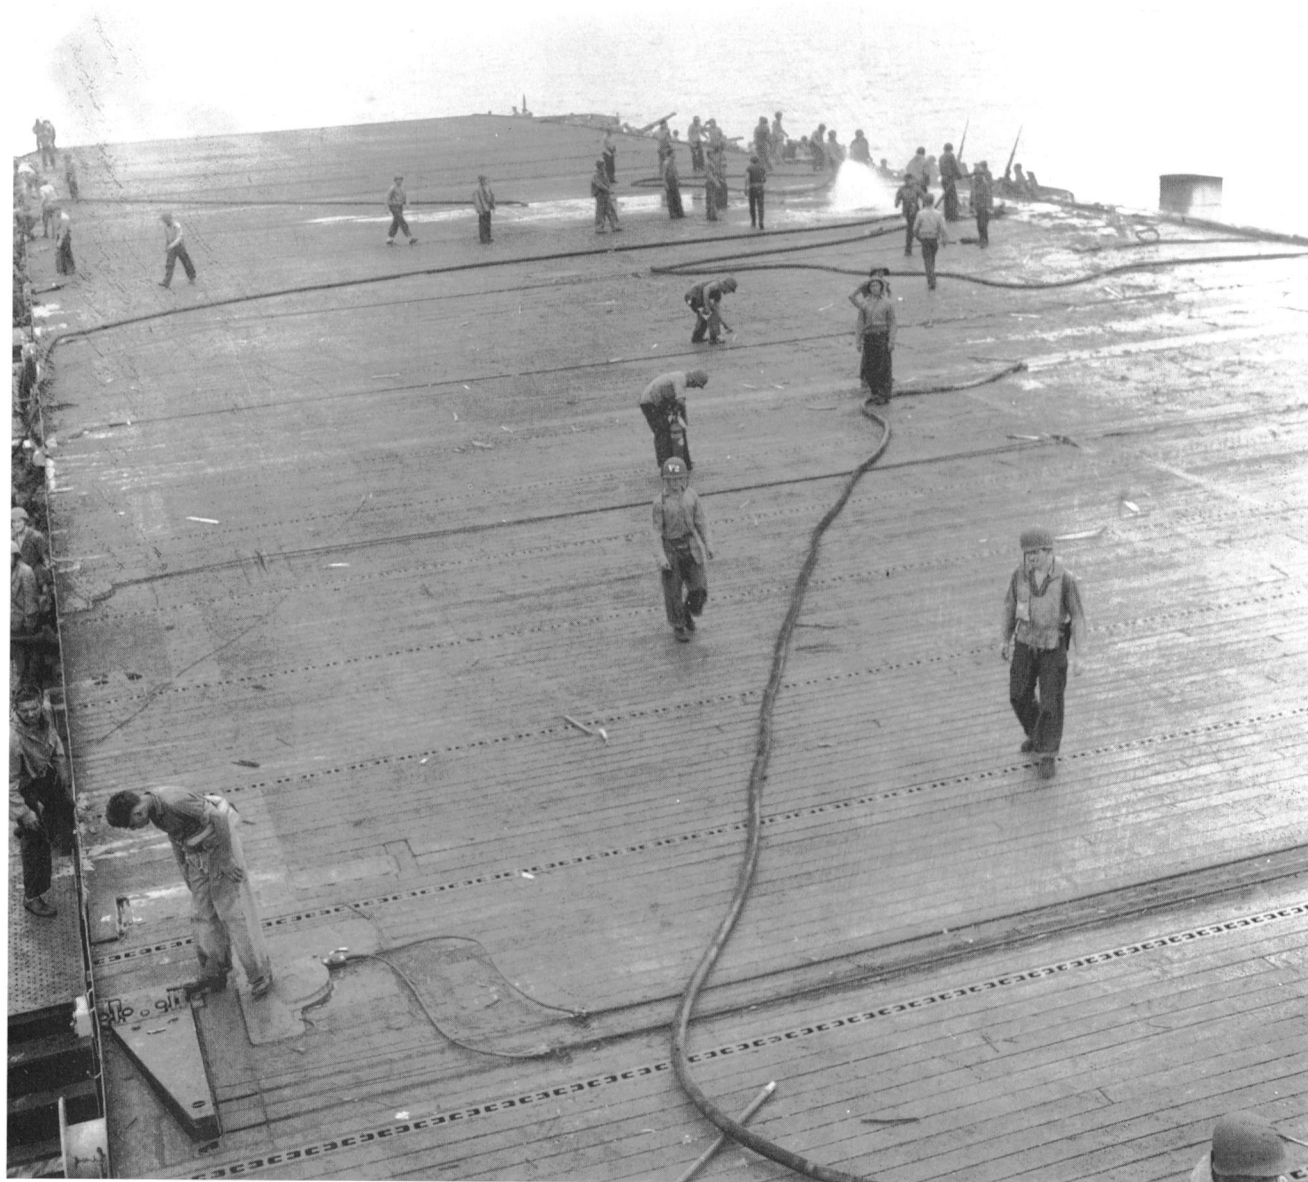
*Kalinin Bay during the battle off Samar, 25 October 1944, in which Gambier Bay was sunk. One of the crash barrier arms and related wires can be seen in the foreground. (National Archives 80-G-270509)*
