# The Escort Carrier **GAMBIER BAY**

Al Ross

# The Drawings

## A General arrangement

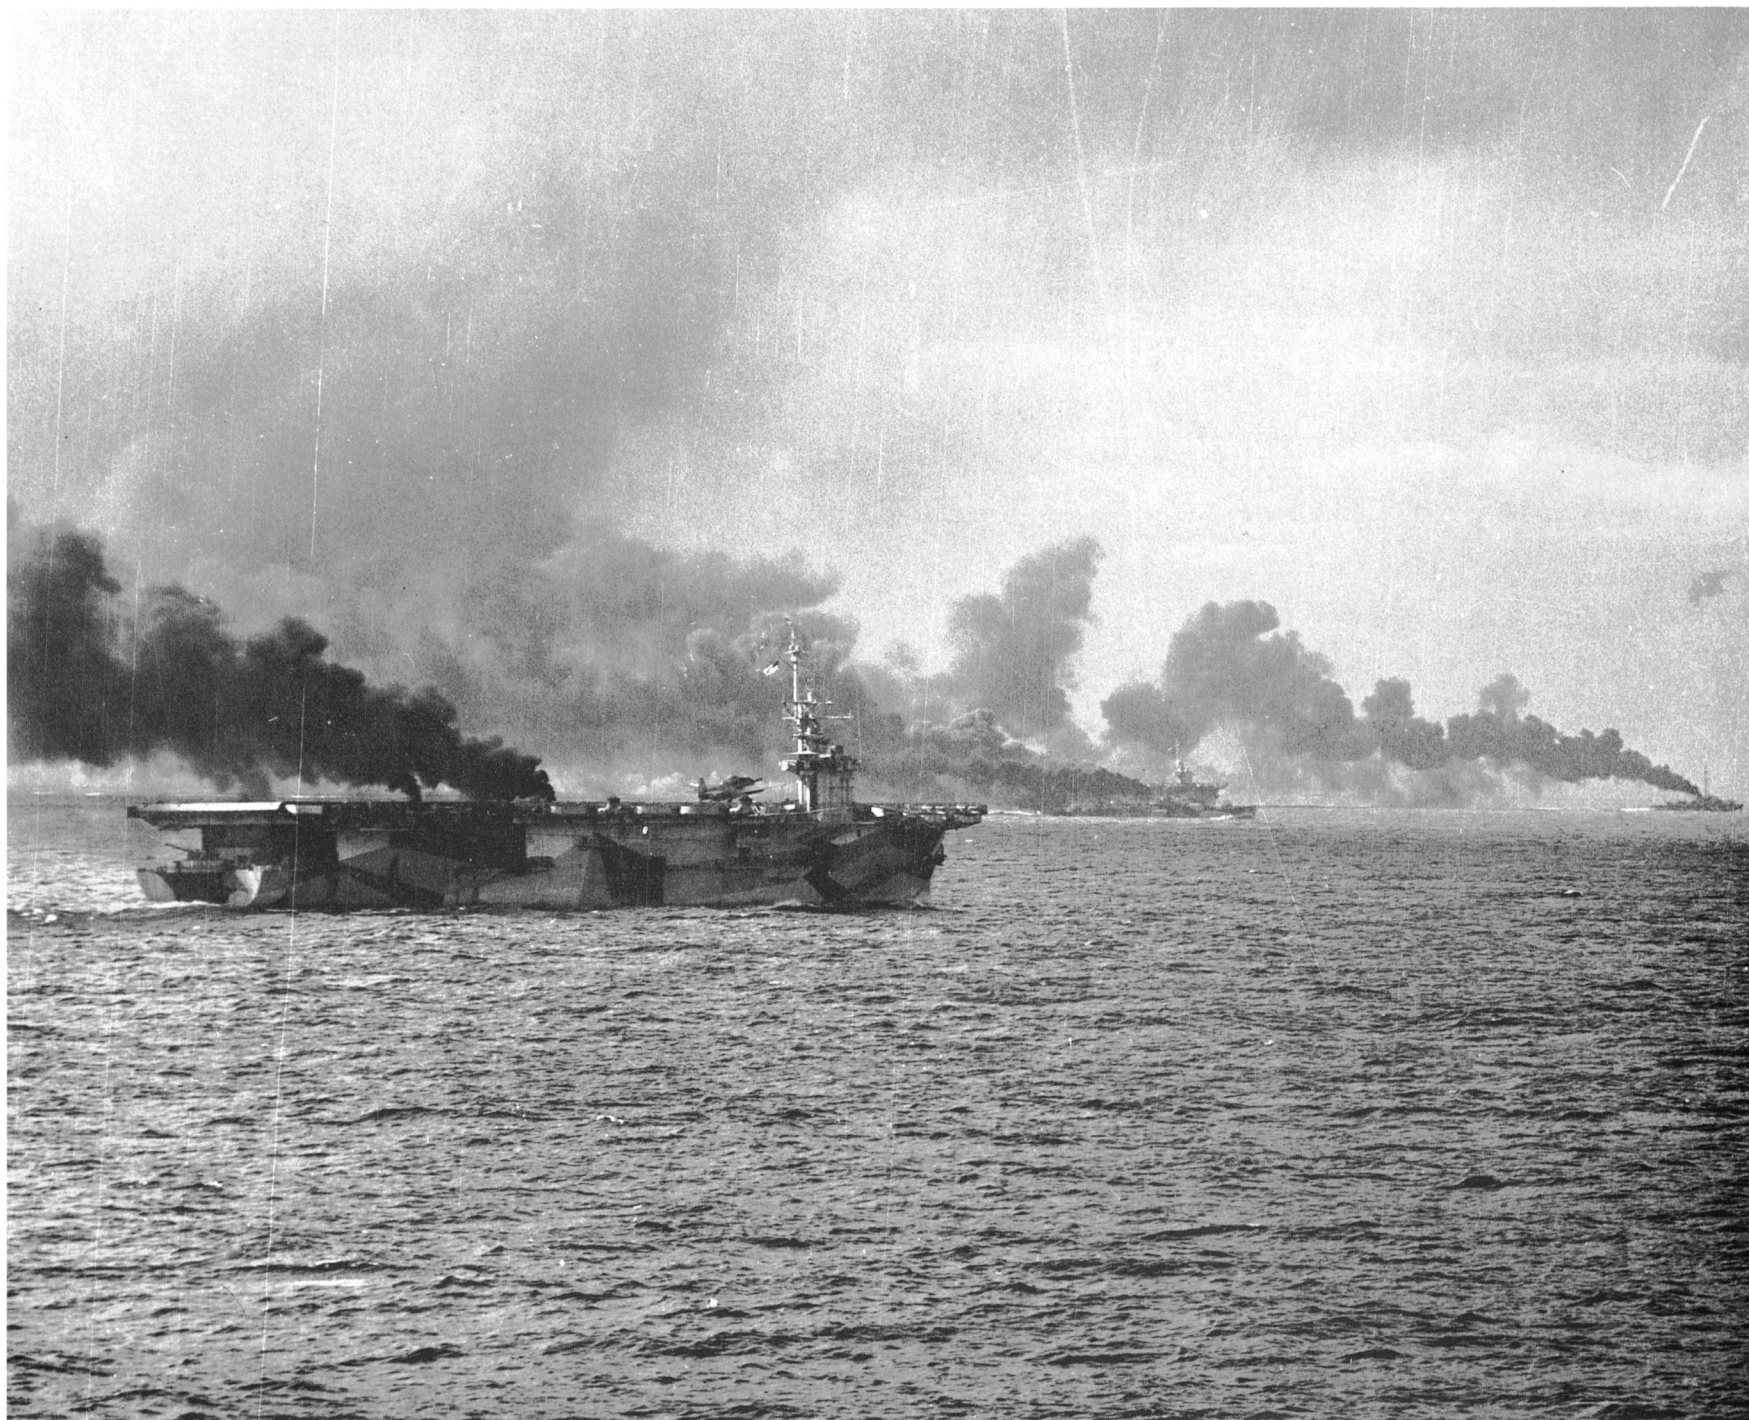
*Gambier Bay* making smoke during the battle off Samar, 25 October 1944. Lt Hank Pyzdrowski's Avenger can be seen on the catapult. It was later launched, unmanned, to clear the deck. (National Archives 80-G-288159)

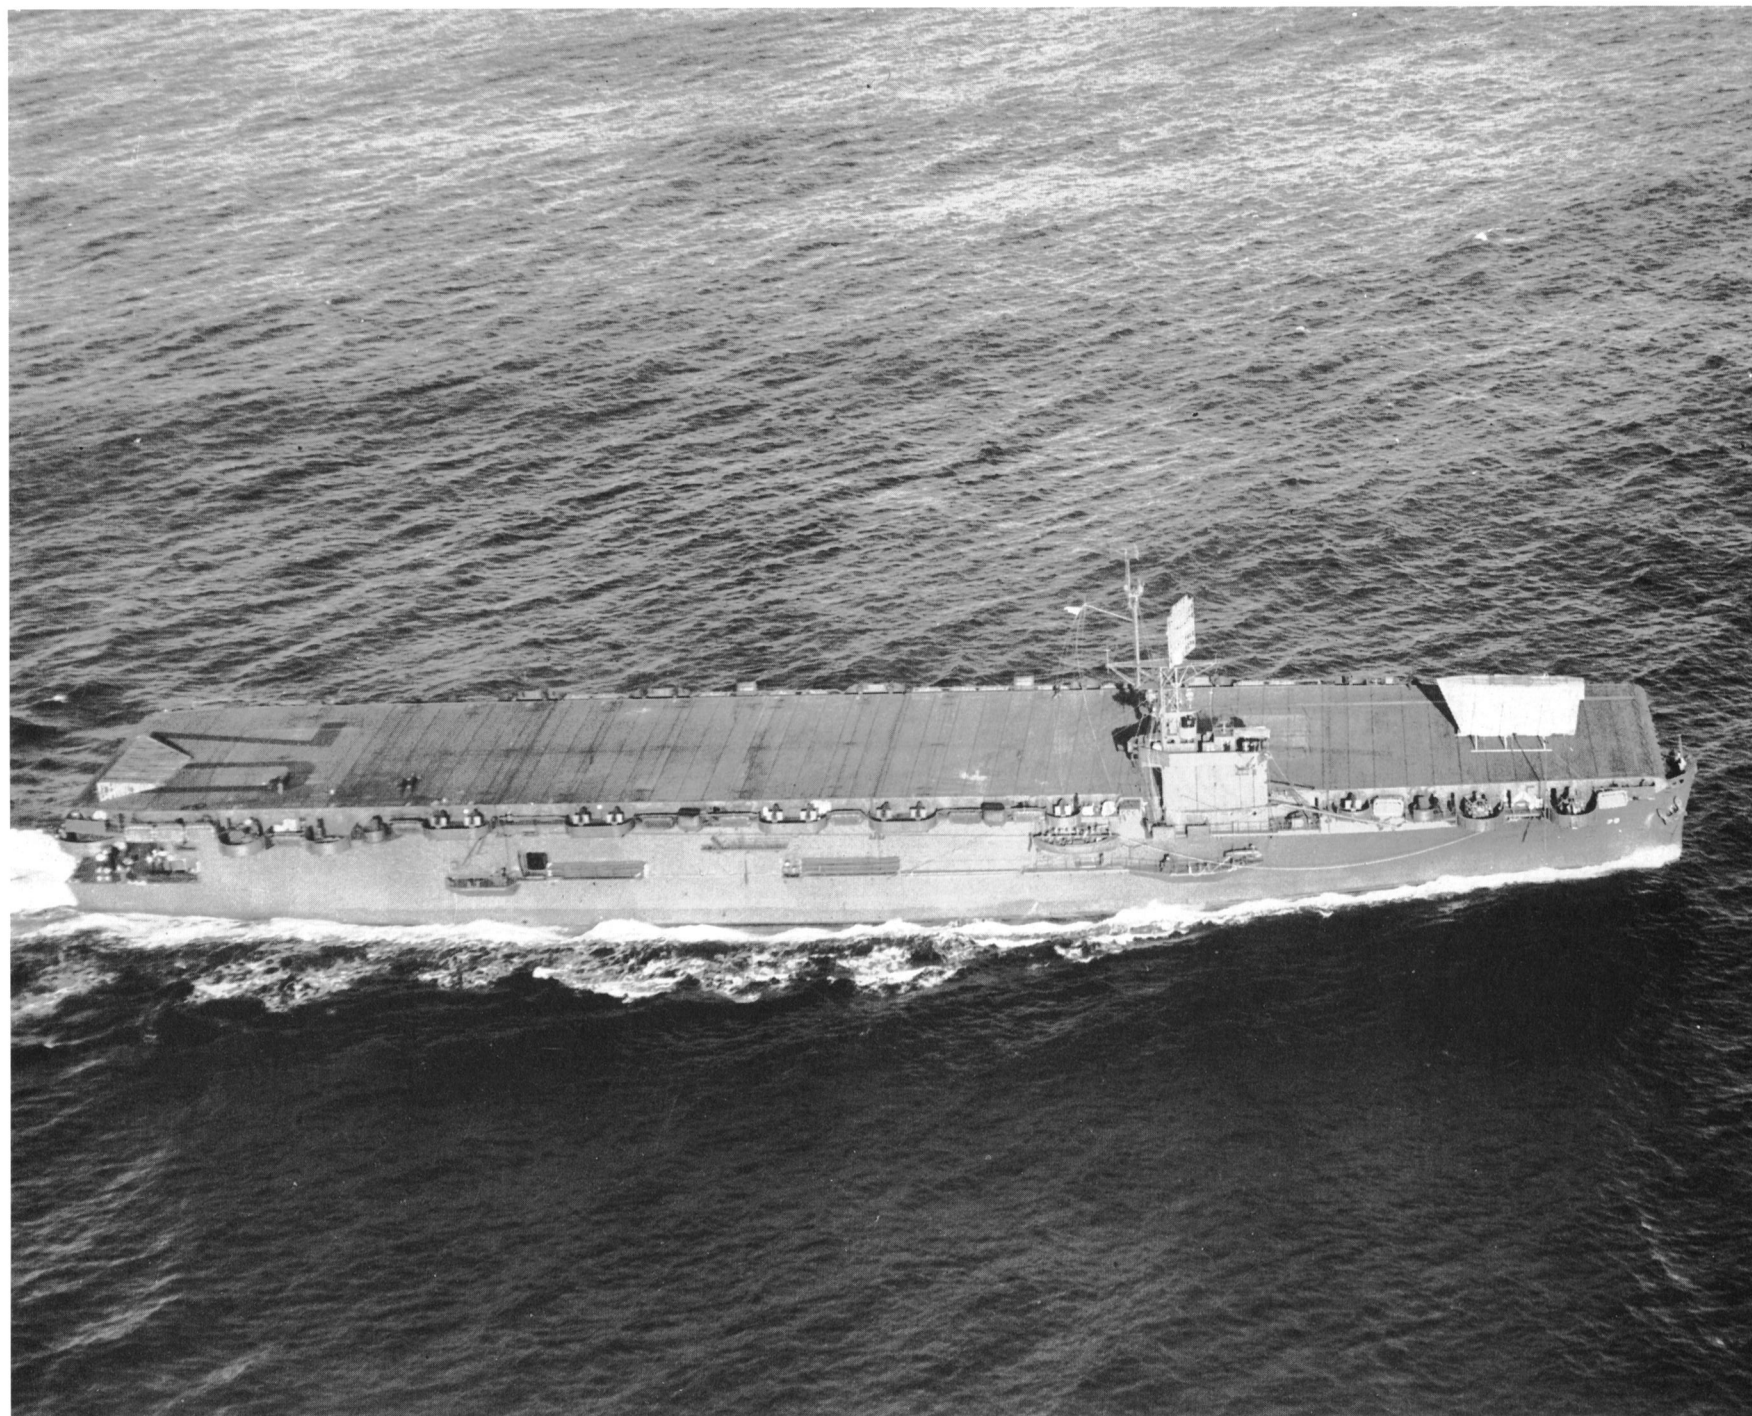
Fanshaw Bay (CVE-70) displaying the Measure 14 camouflage carried by *Gambier Bay* prior to being repainted in Measure 32/15a. Unlike *Gambier Bay*, she carried her flight deck number aft. (National Archives 80-G-214084)

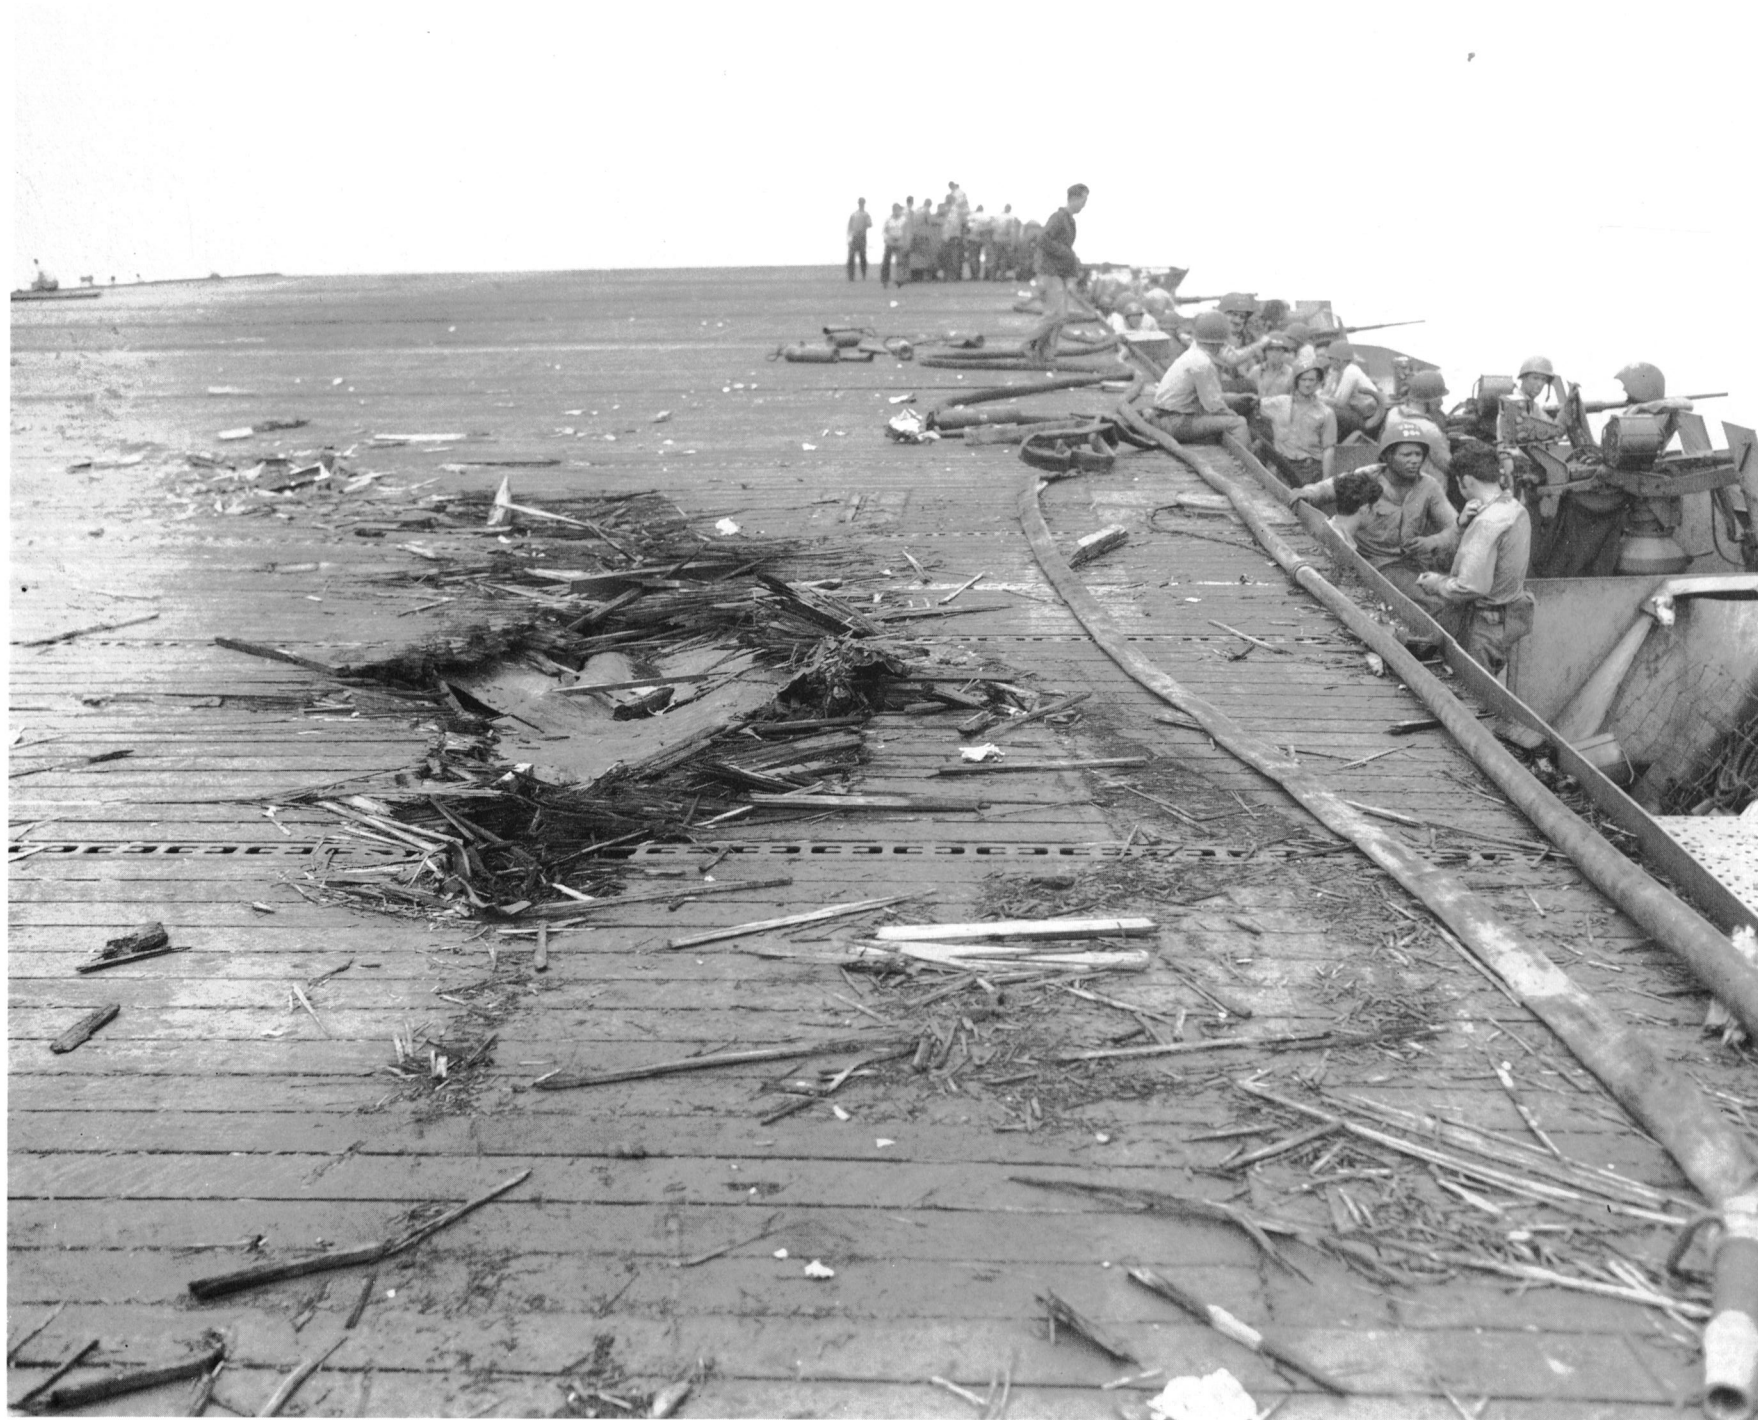
*Kalinin Bay (CVE-68) took a number of hits during the action off Samar. Gambier Bay suffered similar flight deck damage. (National Archives 80-G-270510)*

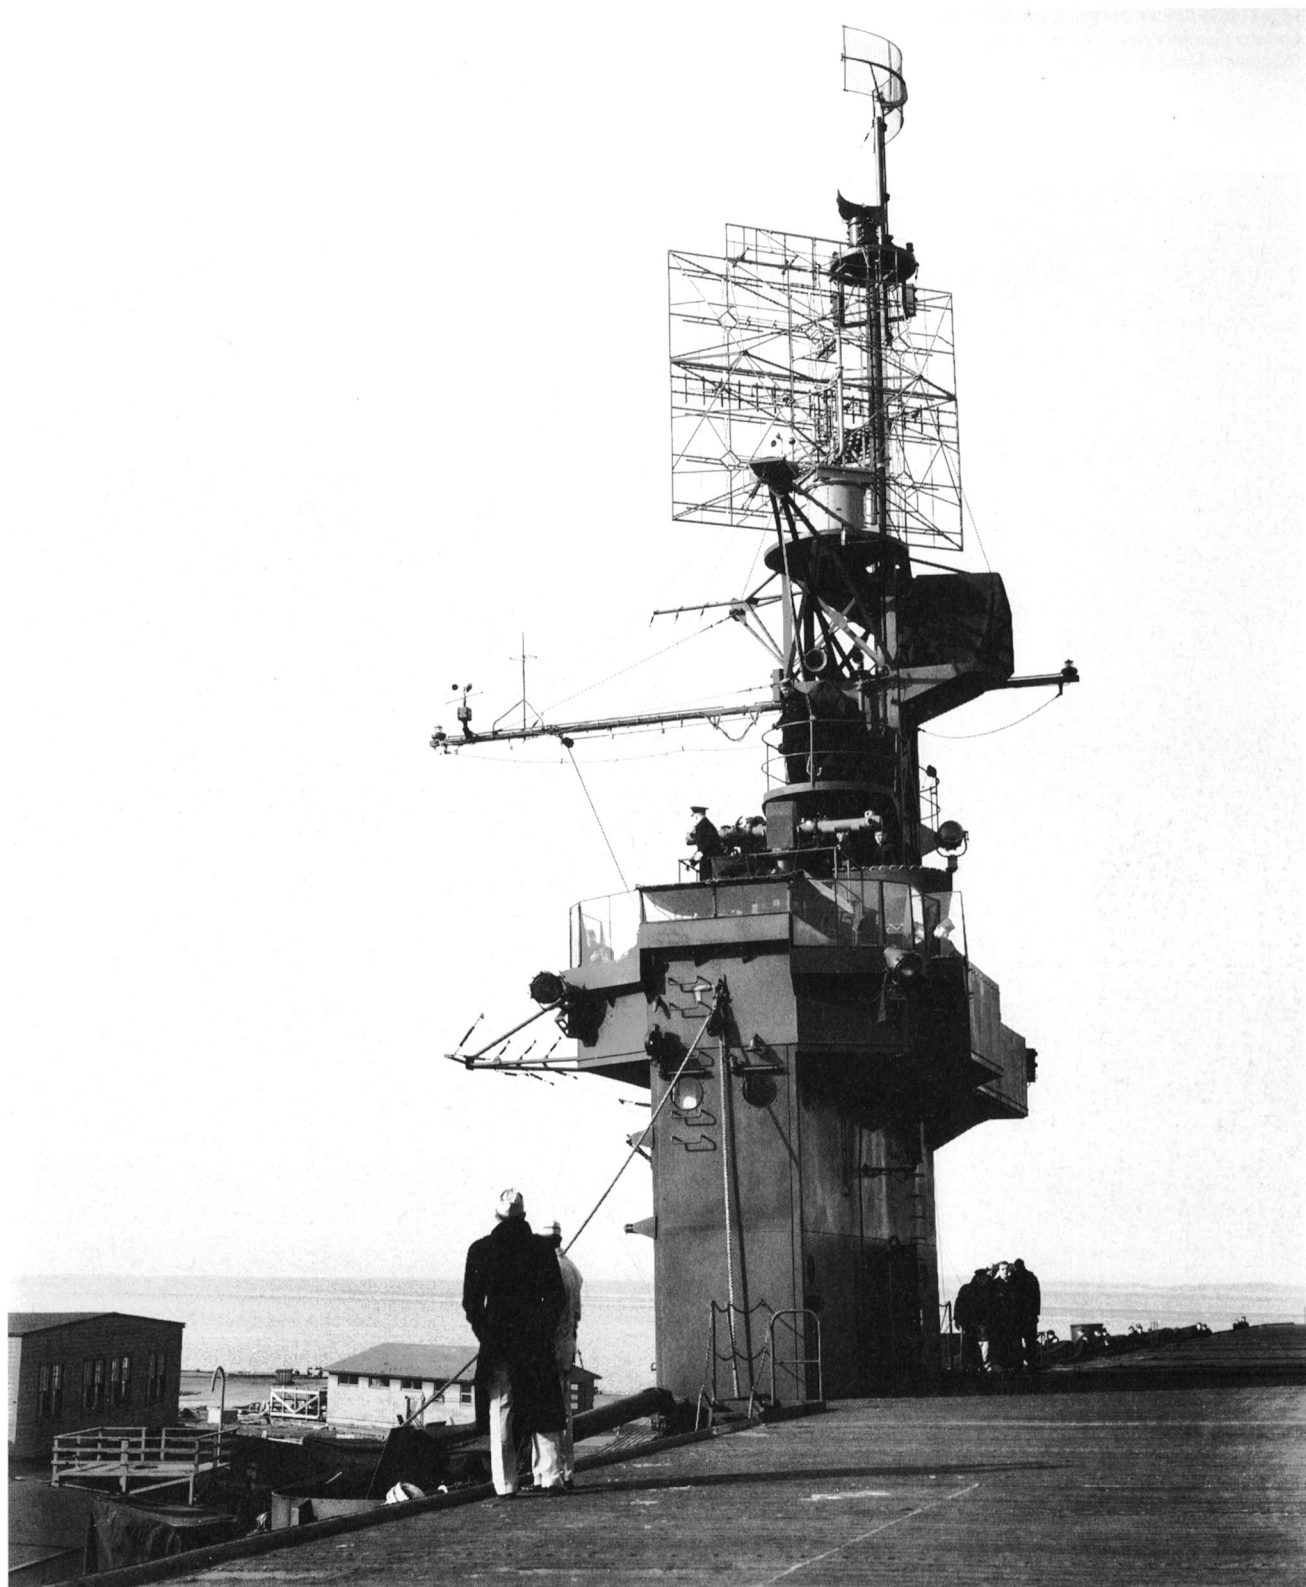
*Gambier Bay's radar suite comprised YE (top), SG (just below the YE), and SK (large antenna). (National Archives 80-G-218332)*

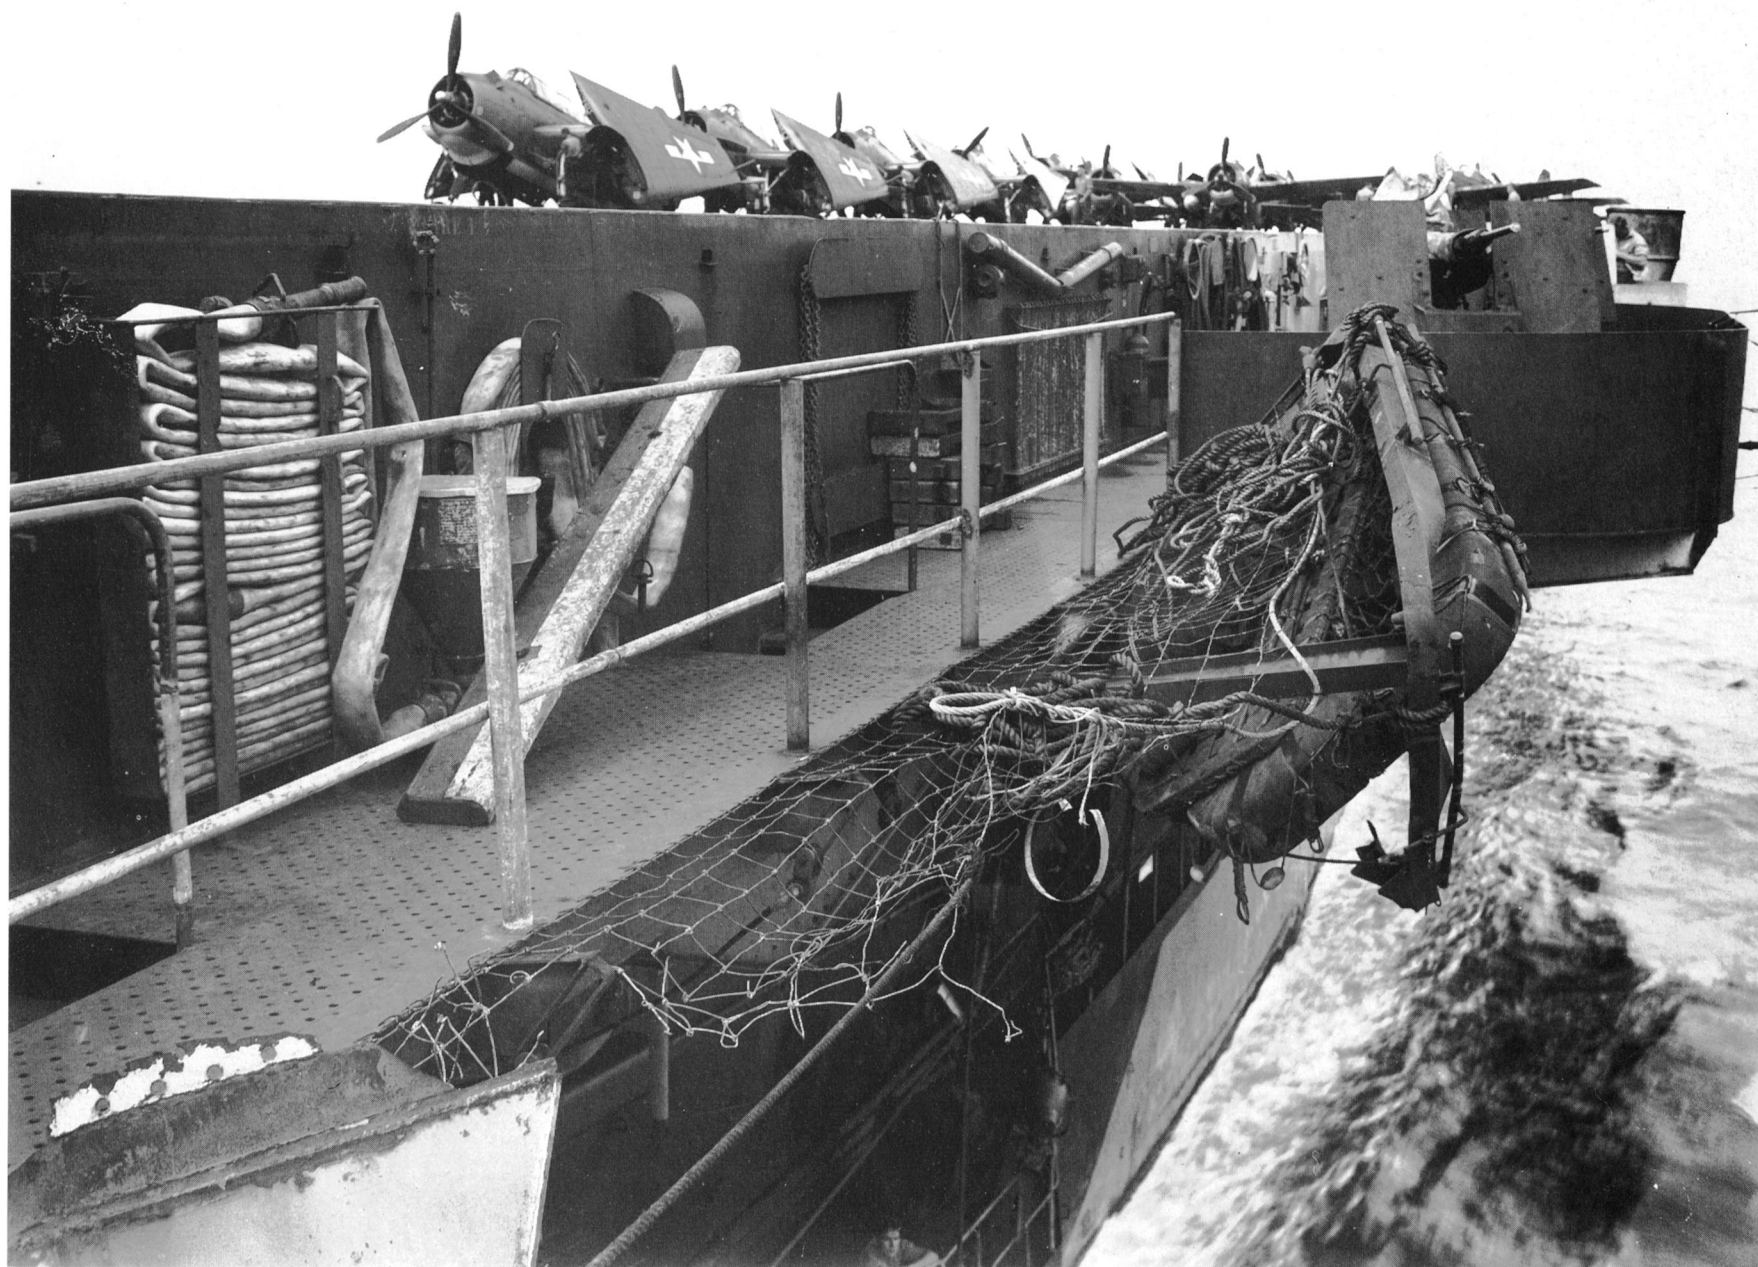
CVE catwalks provided storage for fire hoses and other gear. (National Archives 80-G-289812)

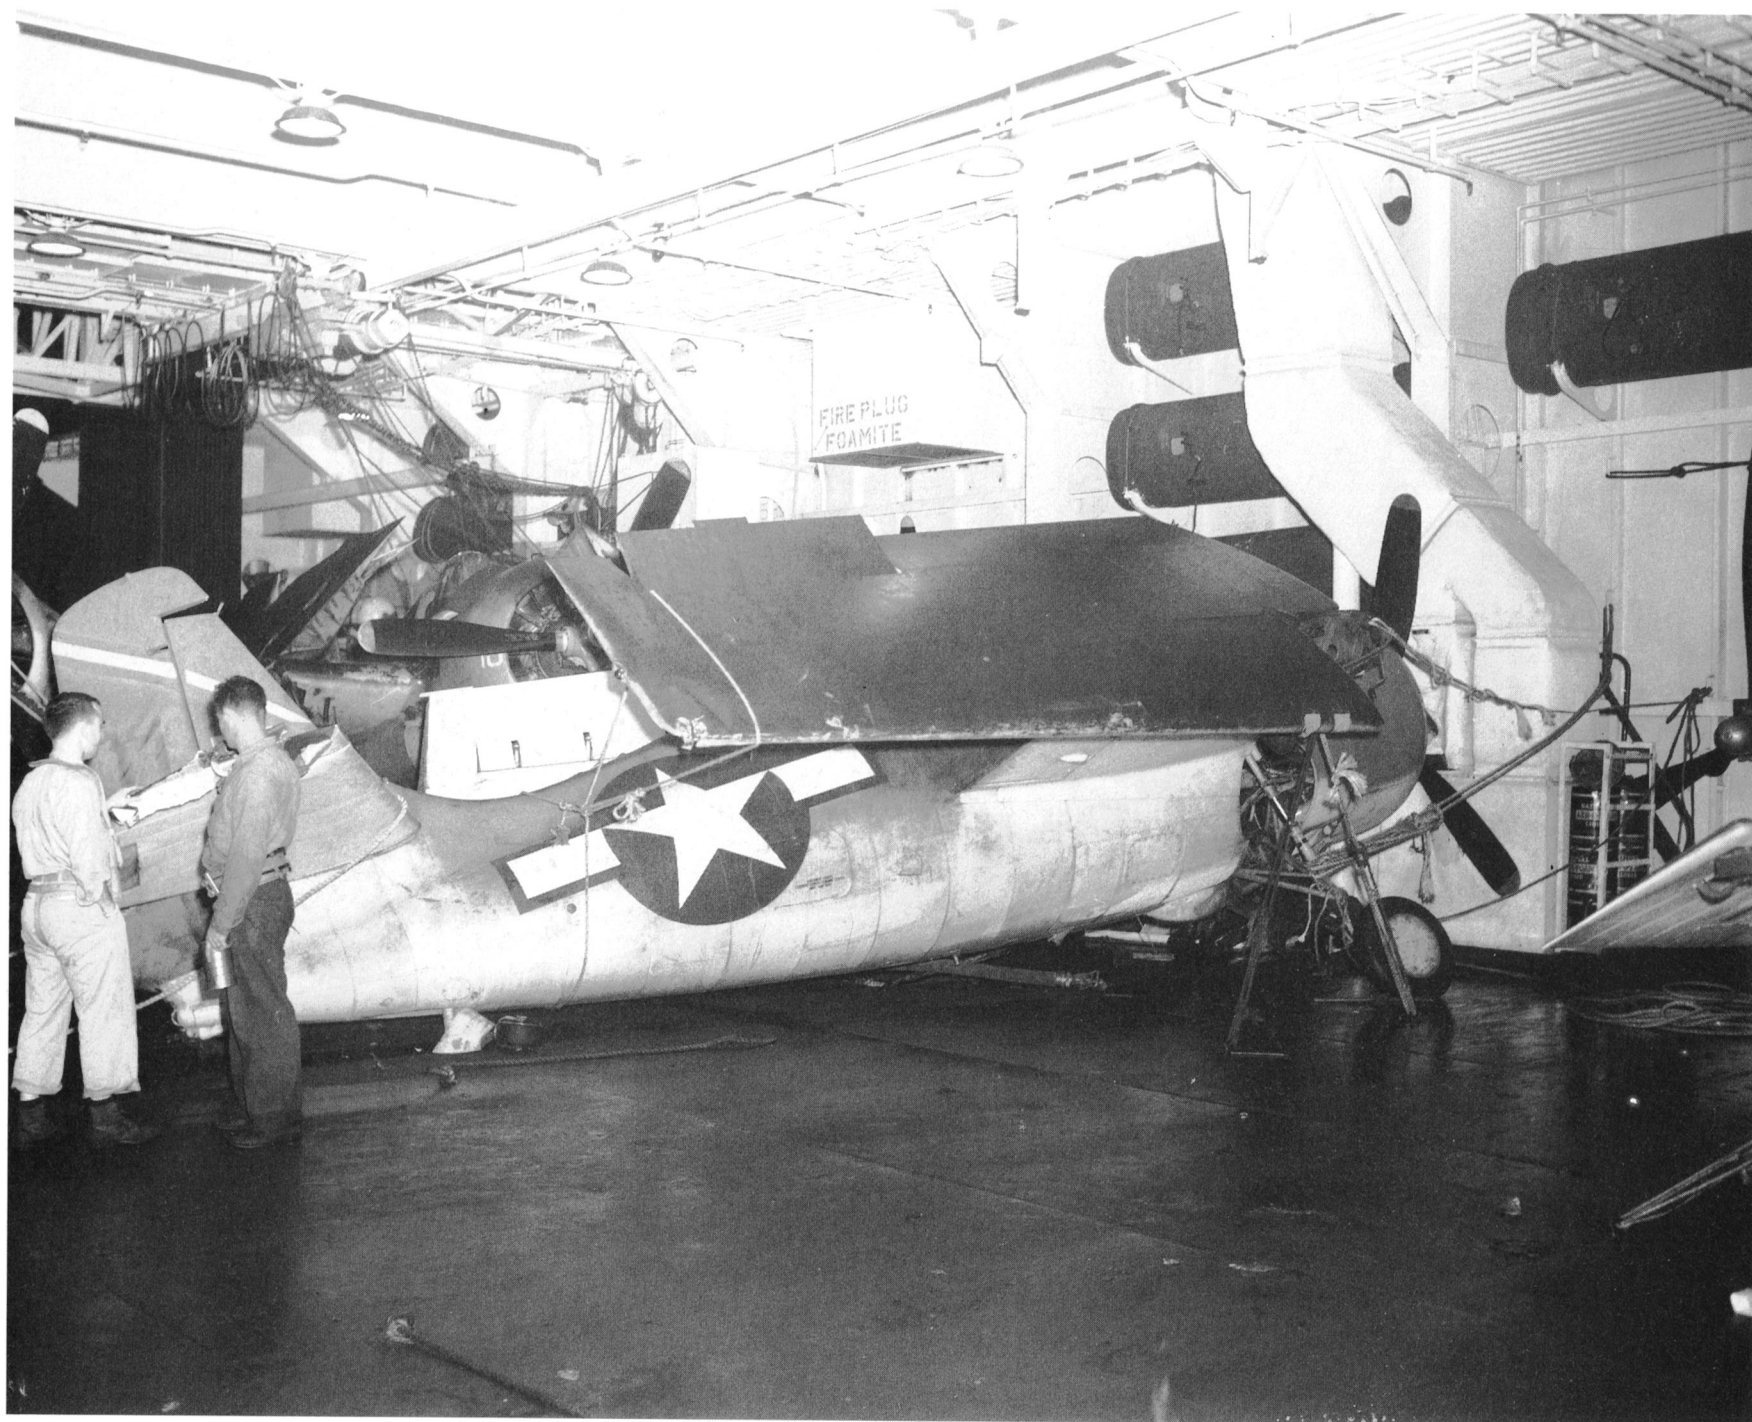
The hangar deck of a *Casablanca* class CVE was not overly spacious, but provided sufficient storage and repair space for the small air units carried. (*National Archives 80-G-298057*)

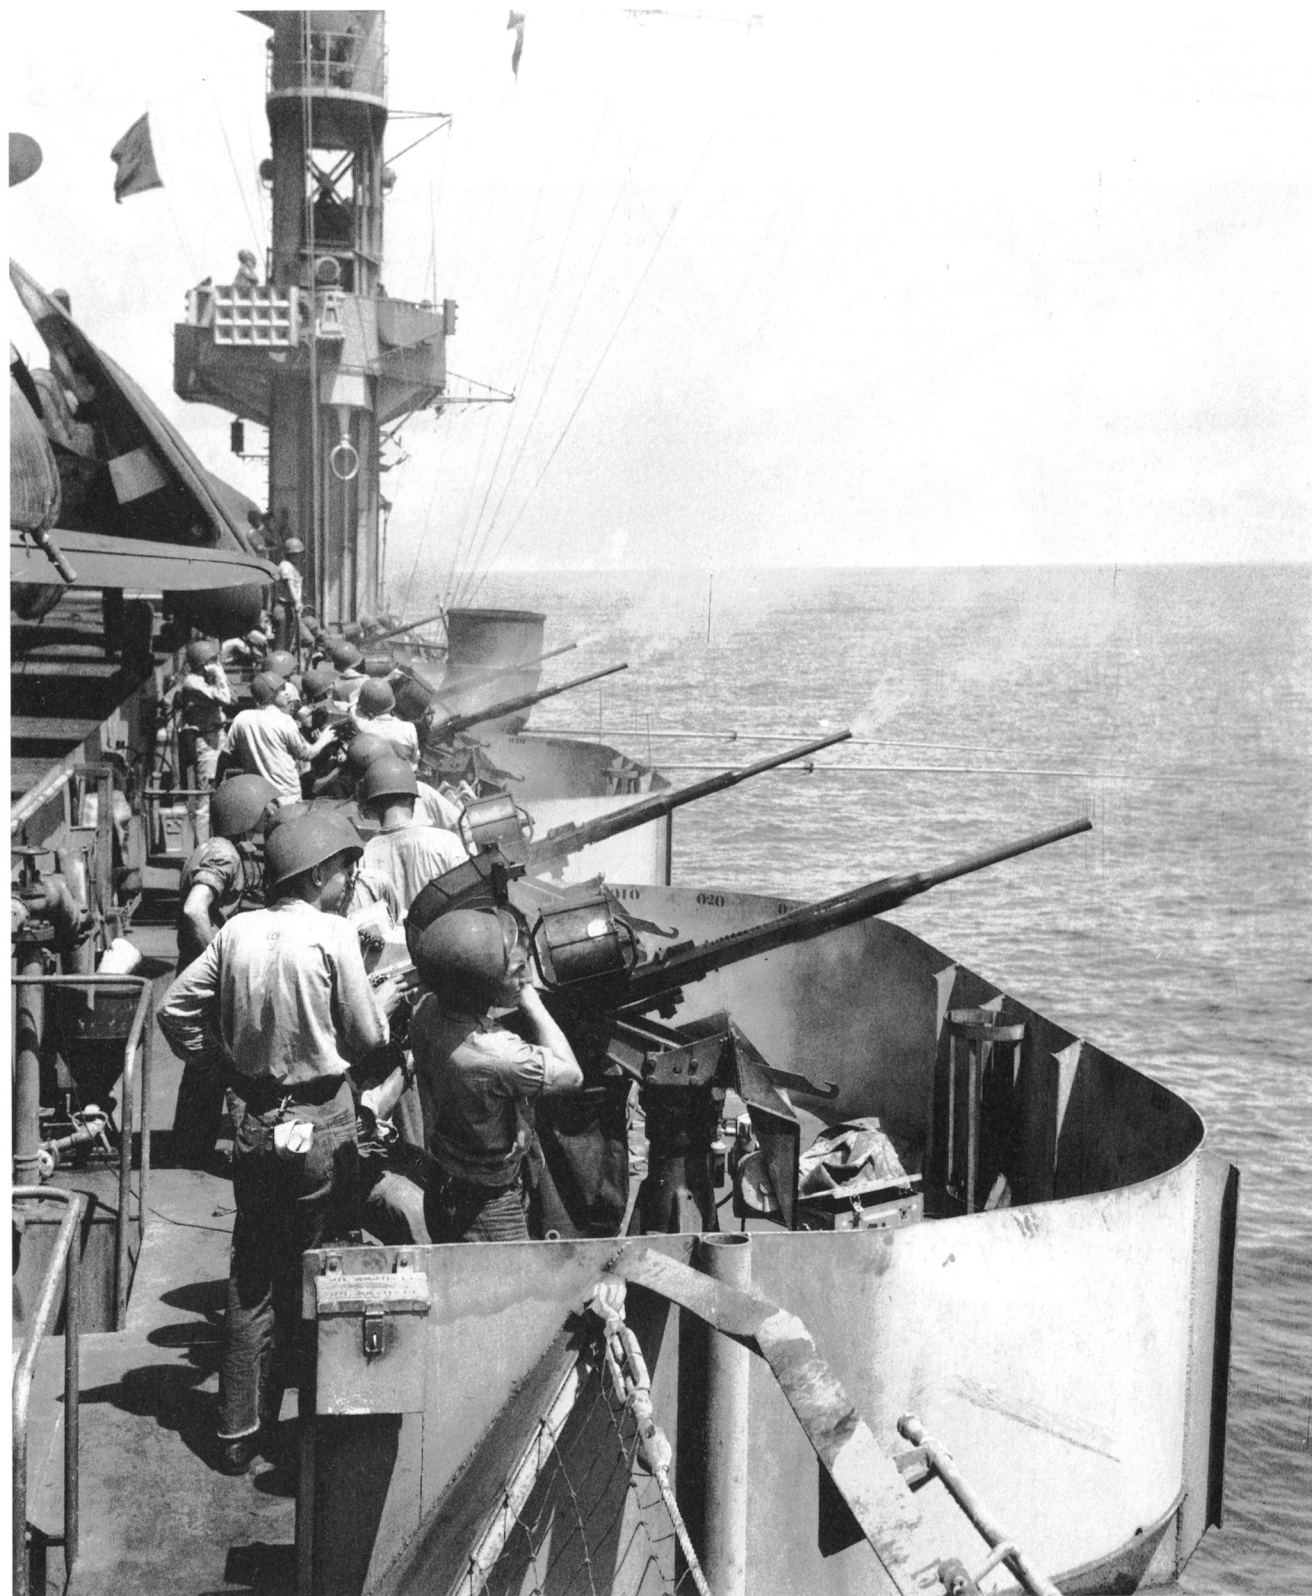
*Gambier Bay and her sisters normally carried twenty 20mm Oerlikons in tubs on either side of the gallery deck. (National Archives 80-G-262716)*

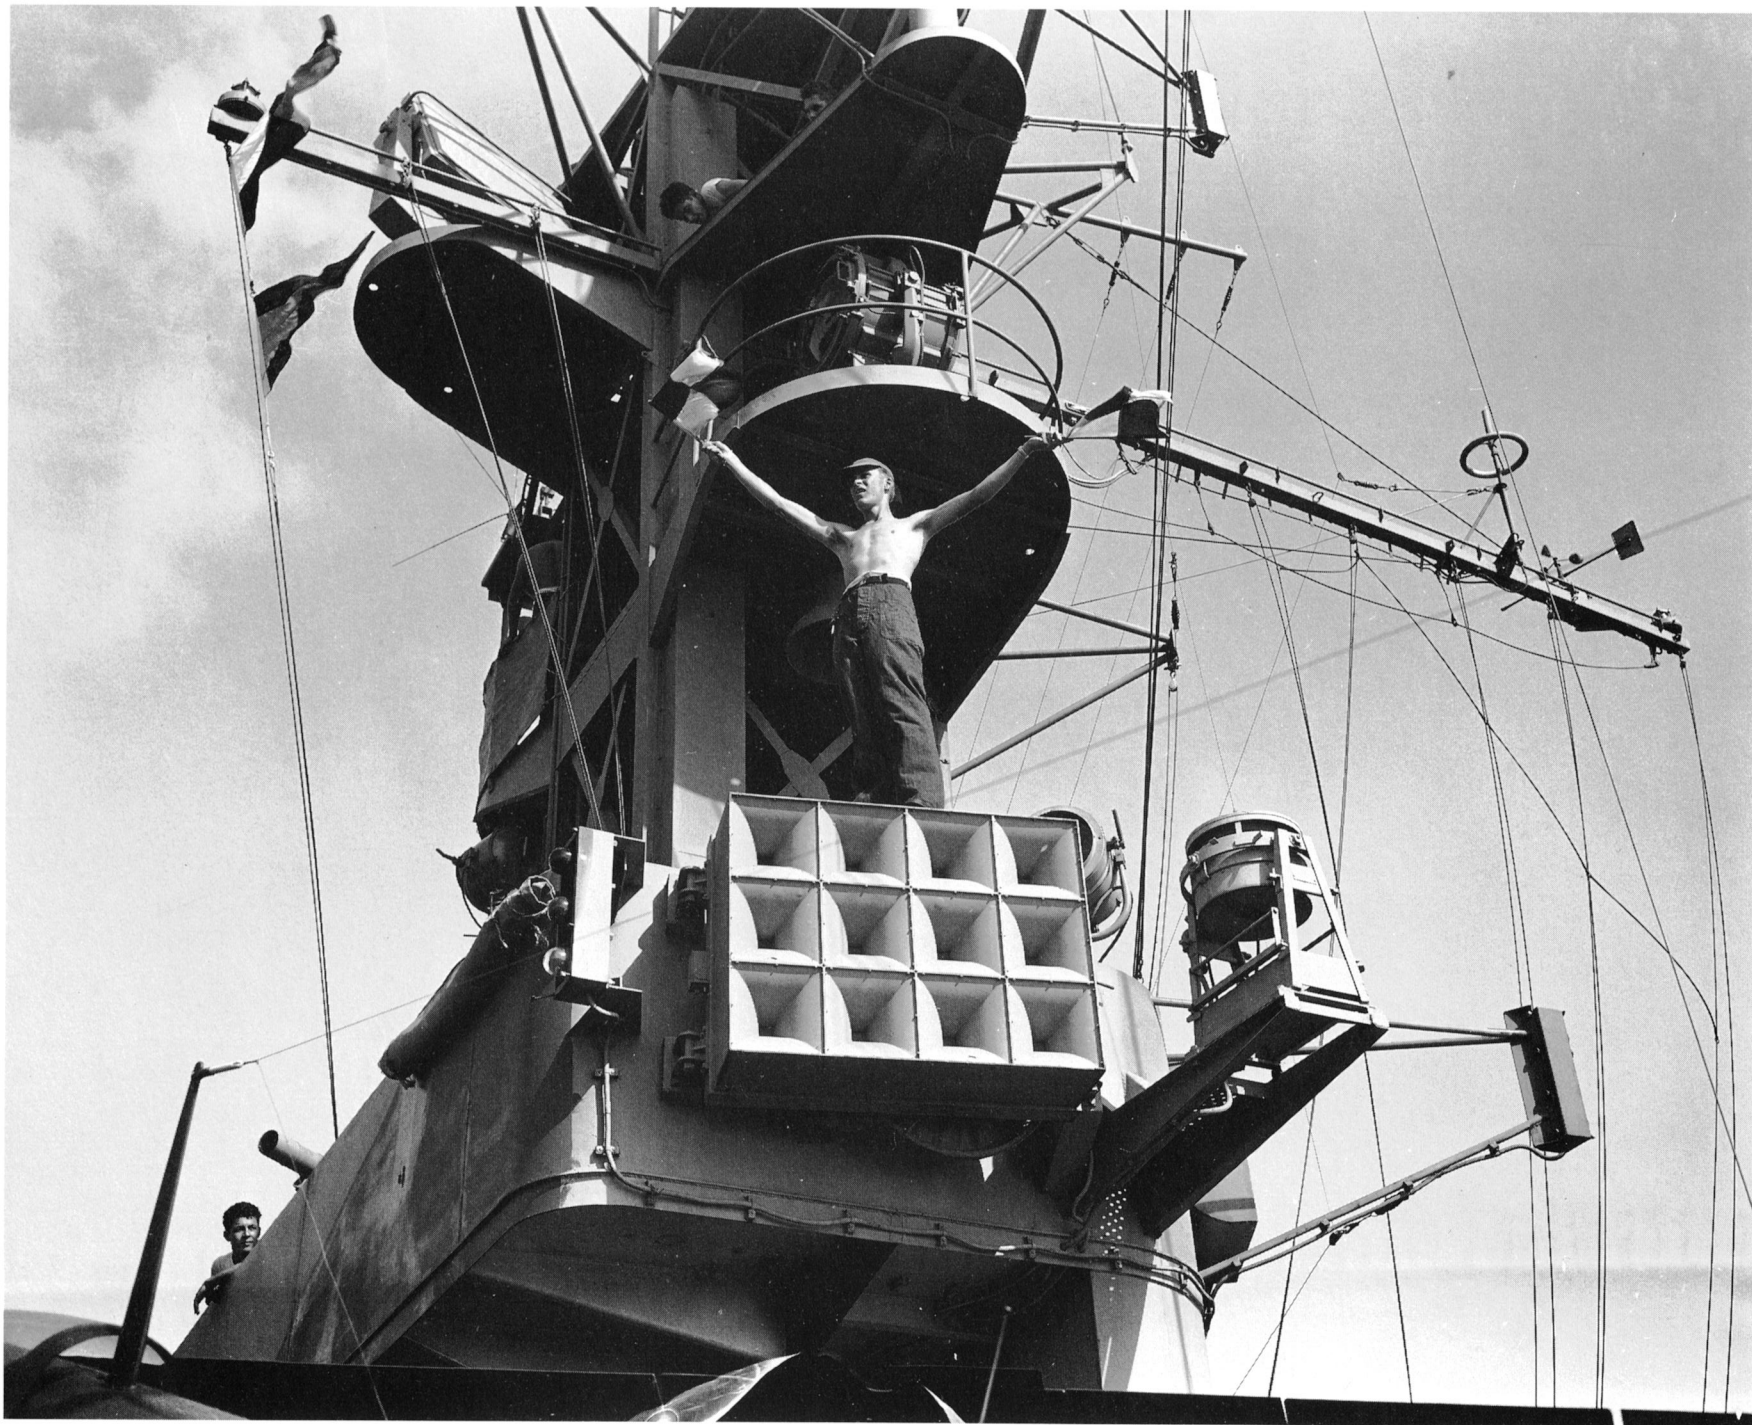
The mast was a relatively complex structure supporting radar, searchlights, and various other electronic gear. (*National Archives 80-G-262708*)

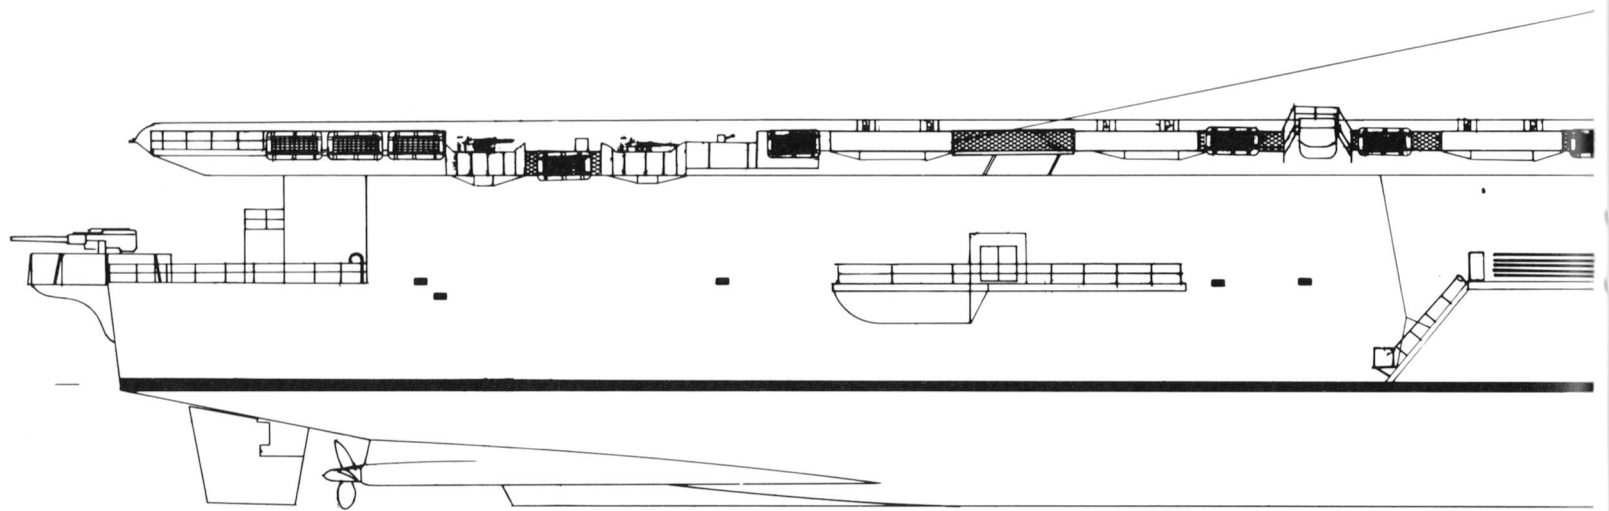
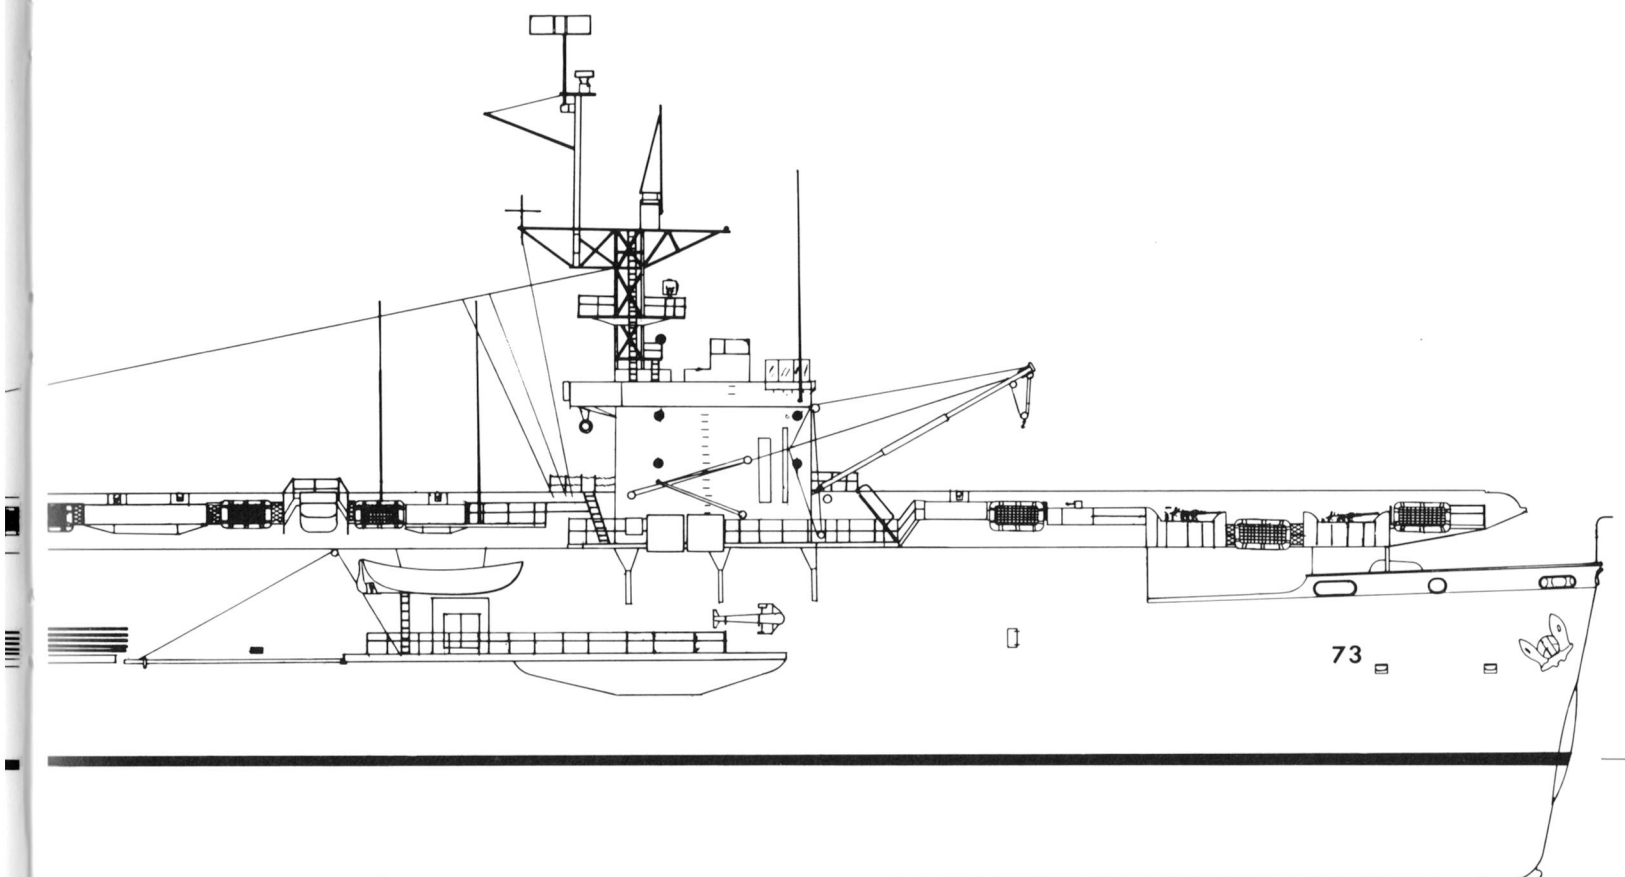
A1 OUTBOARD PROFILE  
(1/384 scale)

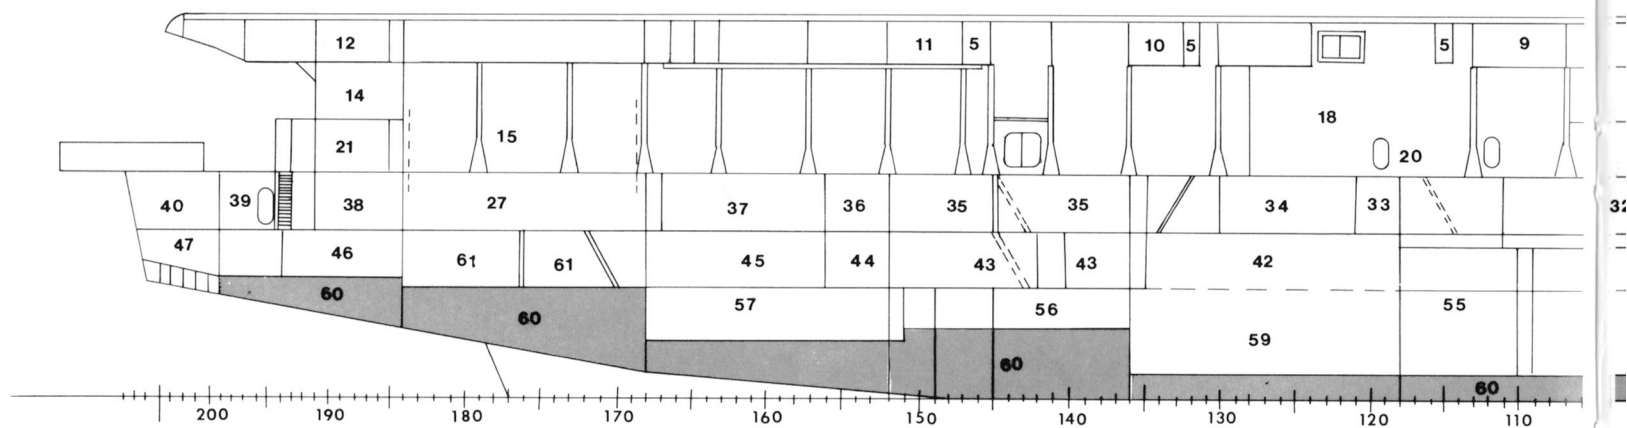
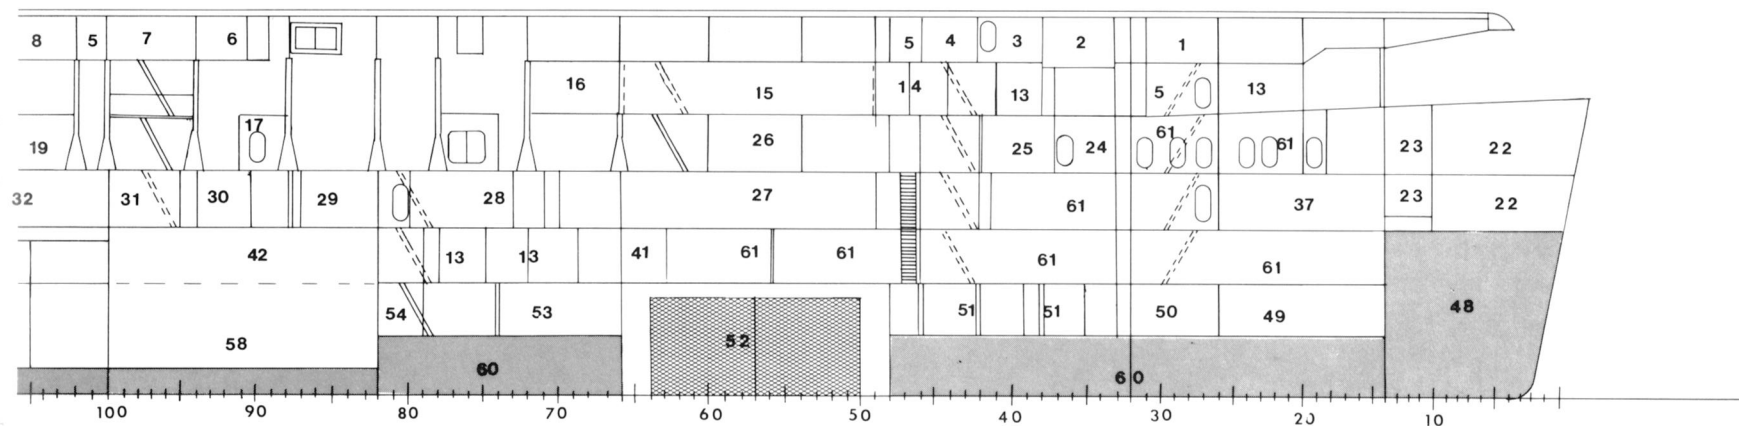
A2 INBOARD PROFILE (1/384 scale)

1	Ammunition handling	10	Duct	19	Master at arms office
2	Catapult machinery room	11	Aviation belting & belt link stowage	20	Torpedo repair shop
3	Head	12	Oxygen room	21	Aviation shop
4	Navigation officer's stateroom	13	Wardroom/stateroom	22	Bosun's stores
5	Passage	14	Elevator machinery room	23	Chain locker
6	Flight crew lockers	15	Elevator	24	CPO head
7	Ready room	16	Motion picture projection room	25	CPO berthing
8	Photo lab	17	Raincoat locker	26	Carpenter's shop
9	IC room & emergency switchboard	18	Hangar	27	Elevator pit

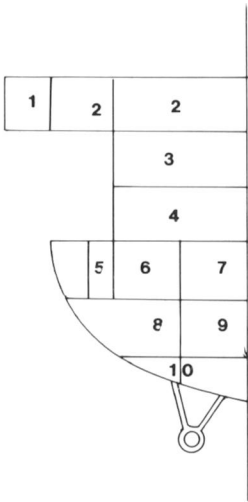
A3/1 Frame 184 looking aft

- 1 Fan room
- 2 Passage
- 3 Elevator machinery
- 4 Aviation shop
- 5 Passage
- 6 Crew shower
- 7 Crew head
- 8 5in powder stowage
- 9 Steering gear platform
- 10 Fuel oil tank

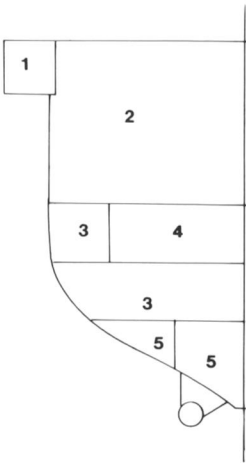
A3/2 Frame 168 looking aft

- 1 Radar room
- 2 Hangar
- 3 Crew's berthing
- 4 Elevator pit
- 5 Fuel oil tank
