# The Escort Carrier **GAMBIER BAY**

Al Ross

# The Drawings

## A General arrangement

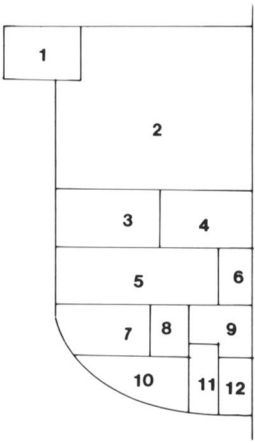
A3/3 Frame 136 looking aft

- 1 Flight deck gear & repair
- 2 Hangar
- 3 Vegetable preparation room
- 4 Crew's galley
- 5 Dry provisions
- 6 Butcher's shop
- 7 Clothing & small stores
- 8 Stowage
- 9 Aircraft ammunition stowage
- 10 Void
- 11 Shaft
- 12 Fuel oil tank

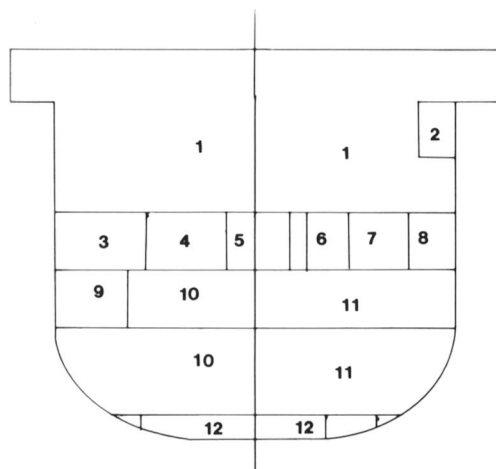
A3/4 Frame 118 looking aft/Frame 100 looking forward

- 1 Hangar
- 2 Platform
- 3 Ship's store
- 4 Crew's mess & parachute packing
- 5 Navigation & gunnery officers' stores
- 6 Passage
- 7 Chaplain's office
- 8 Cleaning gear locker
- 9 Machinery flat
- 10 Aft engine & boiler room
- 11 Forward engine & boiler room
- 12 Fuel oil tank

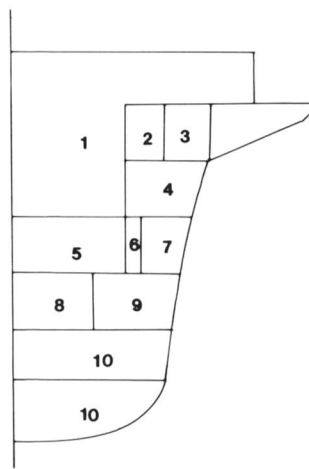
A3/5 Frame 66 looking forward

- 1 Hangar
- 2 Lobby
- 3 Engineer's stateroom
- 4 Aviation ready issue
- 5 Elevator pit
- 6 Passage
- 7 Medical stores
- 8 Gas pump room
- 9 Crew's berthing
- 10 Cofferdam

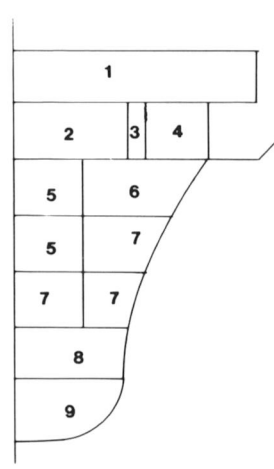
A3/6 Frame 48 looking forward

- 1 Passage
- 2 Elevator machinery room
- 3 Lobby
- 4 Wardroom/stateroom
- 5 Passage
- 6 CPO berthing
- 7 20mm & 40mm magazine
- 8 Fuel oil tank

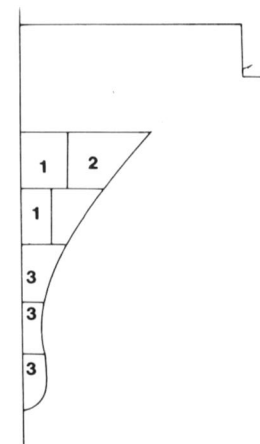
A3/7 Frame 14 looking forward

- 1 Chain locker
- 2 Void
- 3 Fuel oil or salt water ballast

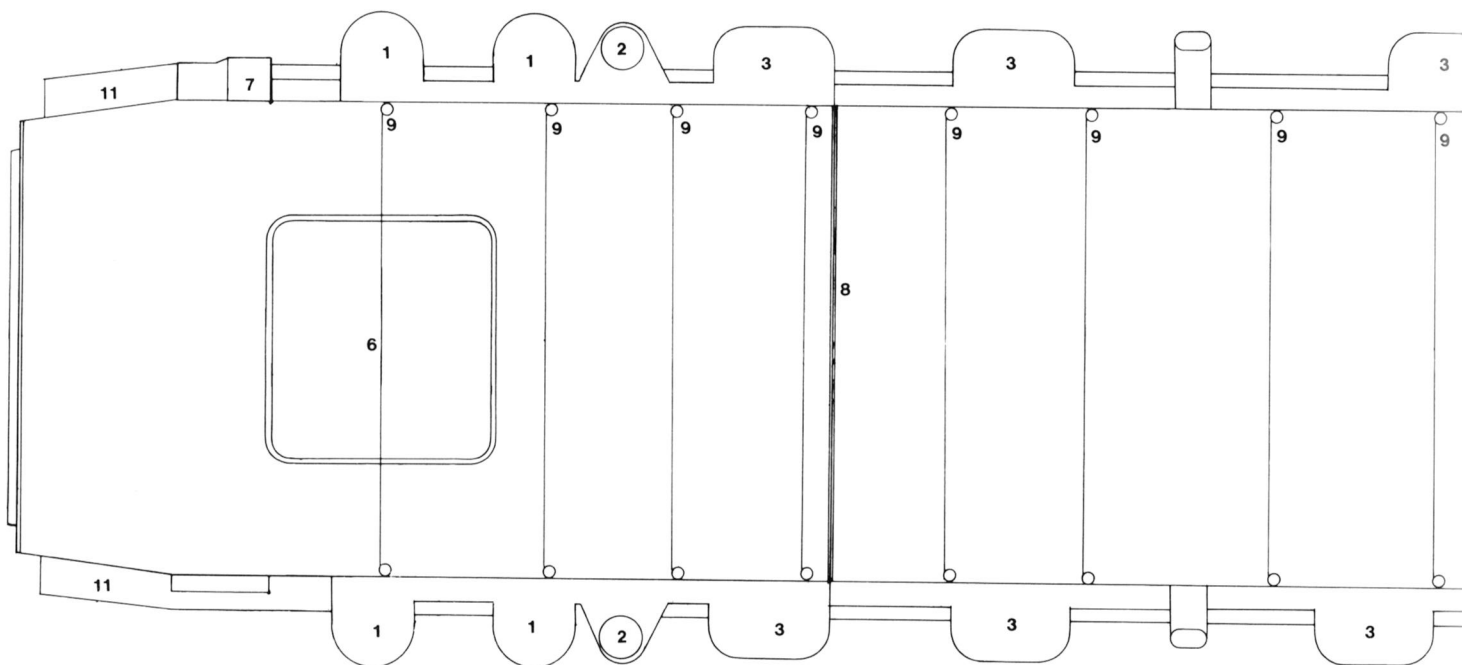
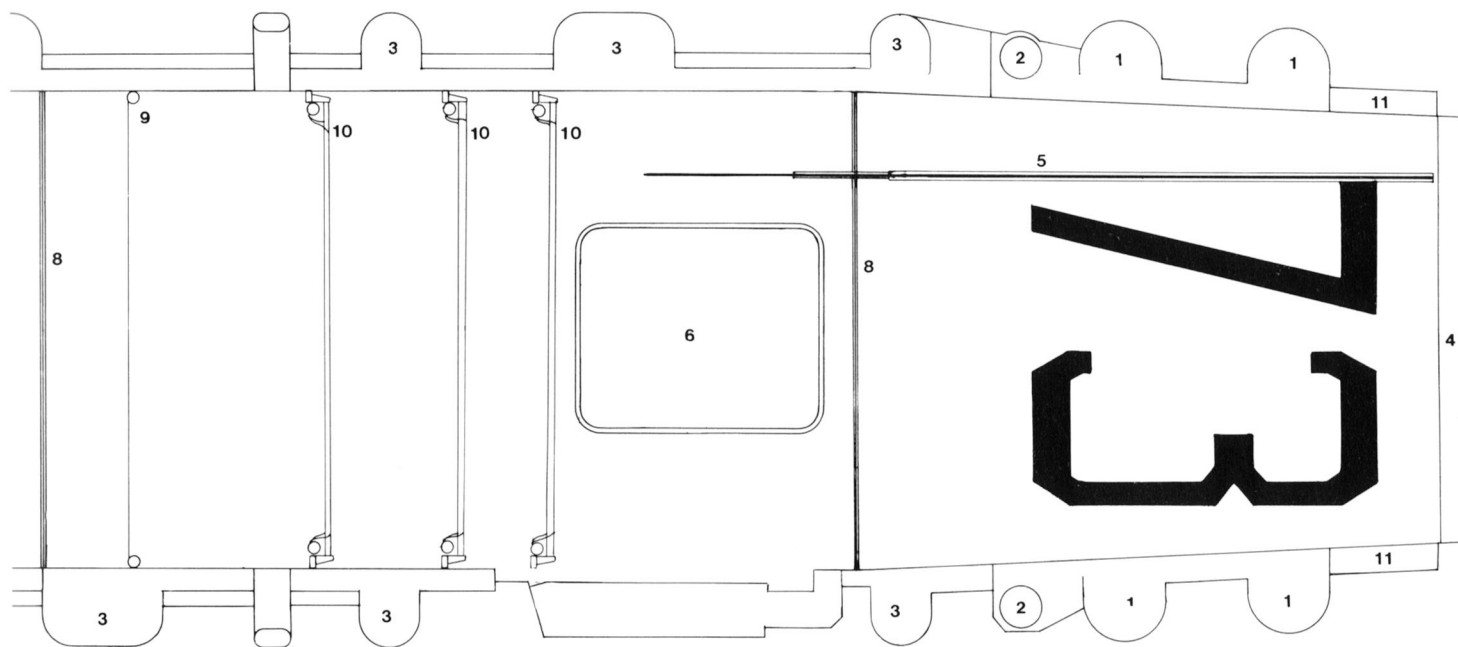
A4

- 1 40mm position
- 2 MK51 director
- 3 20mm position
- 4 Ramp
- 5 H2-1 catapult
- 6 Elevator
- 7 LSO platform
- 8 Expansion joint
- 9 Arresting gear
- 10 Crash barrier
- 11 Sky lookout

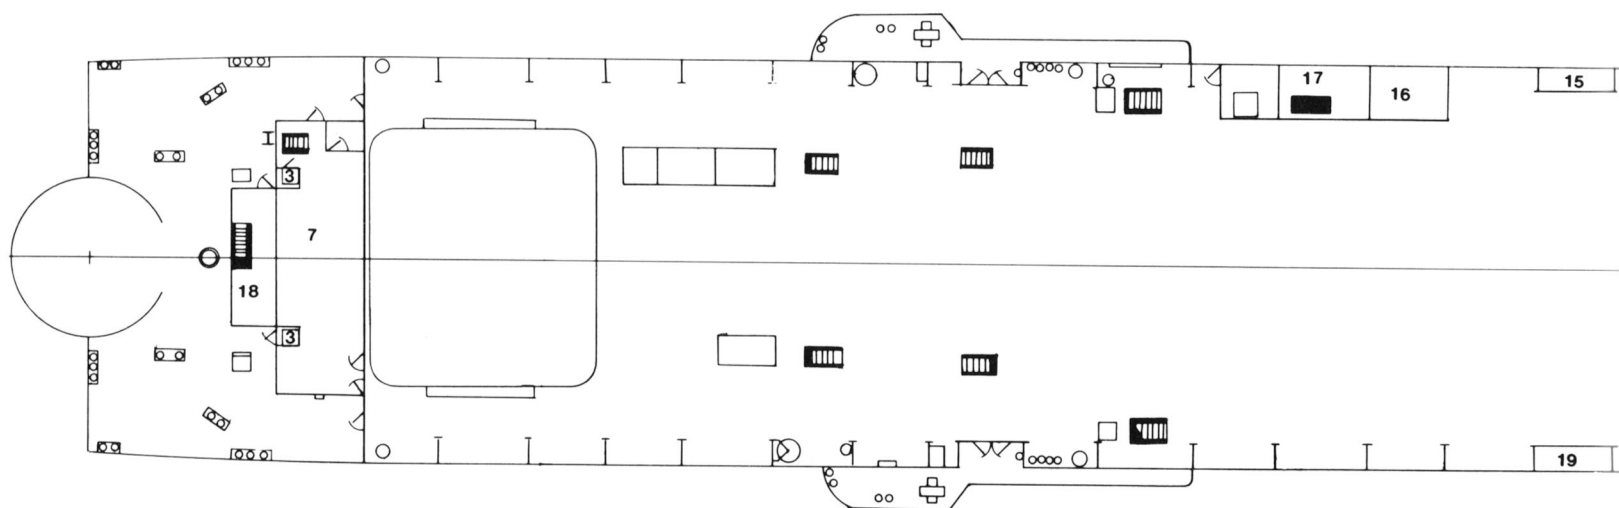
## A7 UPPER DECK (1/384 scale)

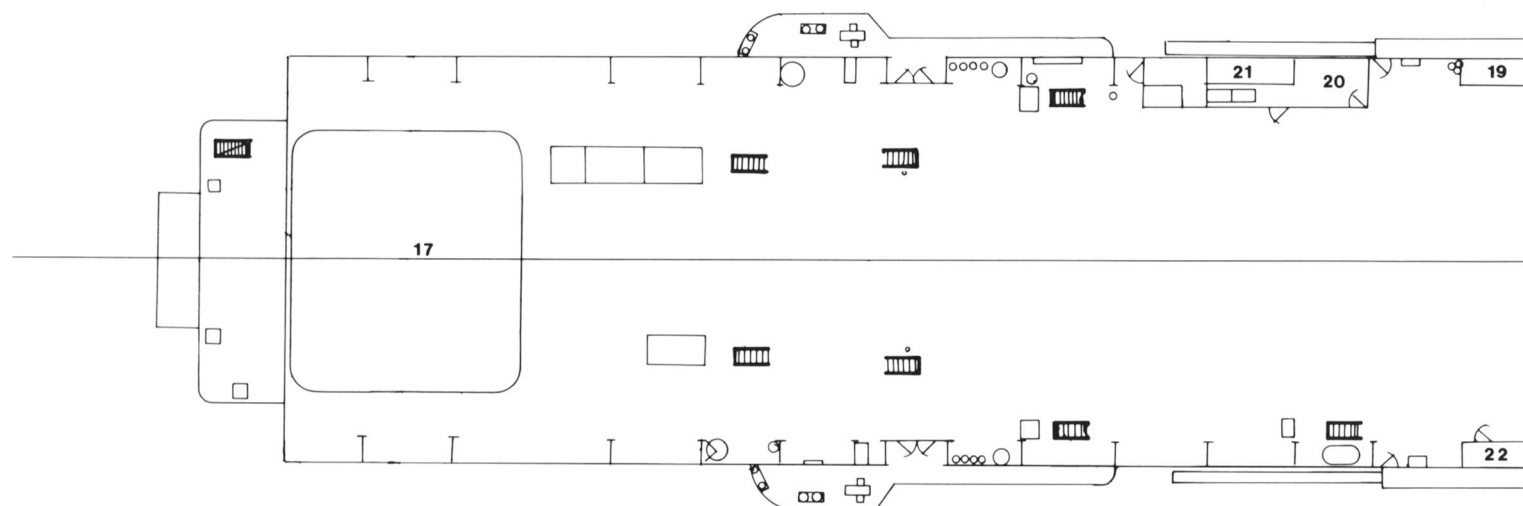
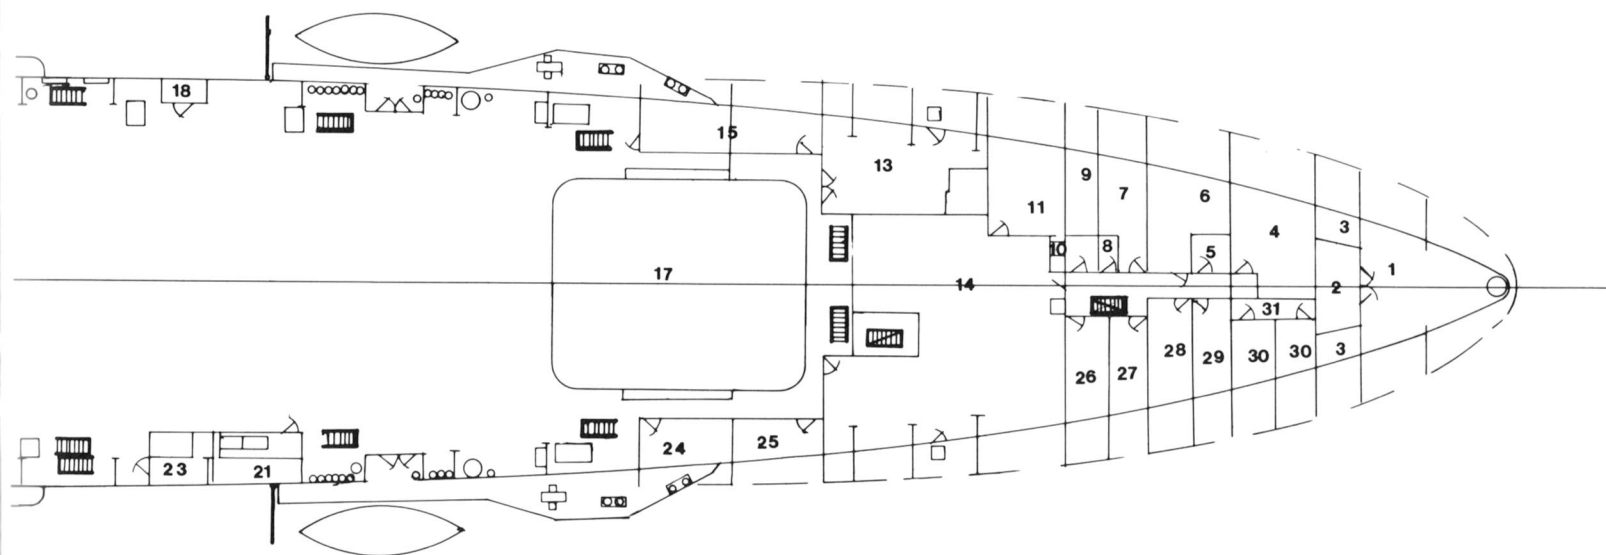
## A8 HANGAR DECK (1/384 scale)

1	Bosun's stores	12	Ammunition hoist	23	Reserve
2	Chain locker	13	Carpenter and pipe-fitter shop	24	Aviation ready issue
3	Void	14	CPO berthing	25	Hangar deck gear
4	Parachute repair & canvas shop	15	Plate & bar stowage	26	Deck gear
5	Lamp room	16	Passage	27	Fan room
6	Paint room	17	Elevator pit	28	Lucky bag
7	Wardroom stores	18	Raincoat locker	29	Resistor room
8	Reg. Pubs. locker	19	Master at Arms office	30	Cell
9	CPO showers	20	Torpedo repair and tool room	31	Brig
10	Escape trunk	21	Boiler uptake		
11	CPO wardroom and head	22	Deck office

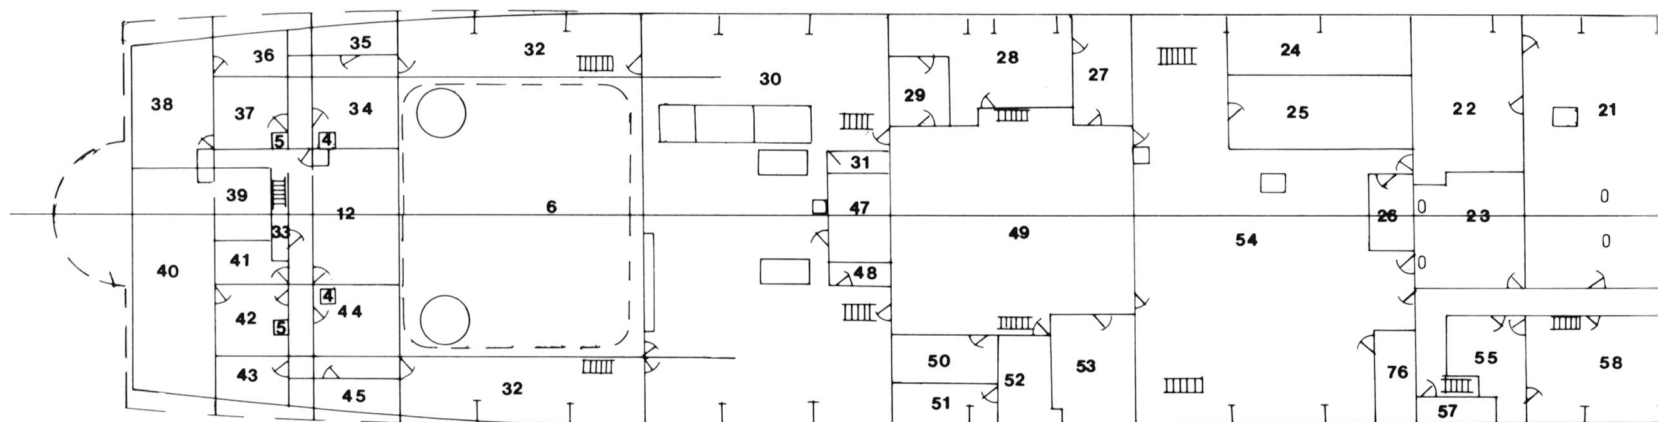
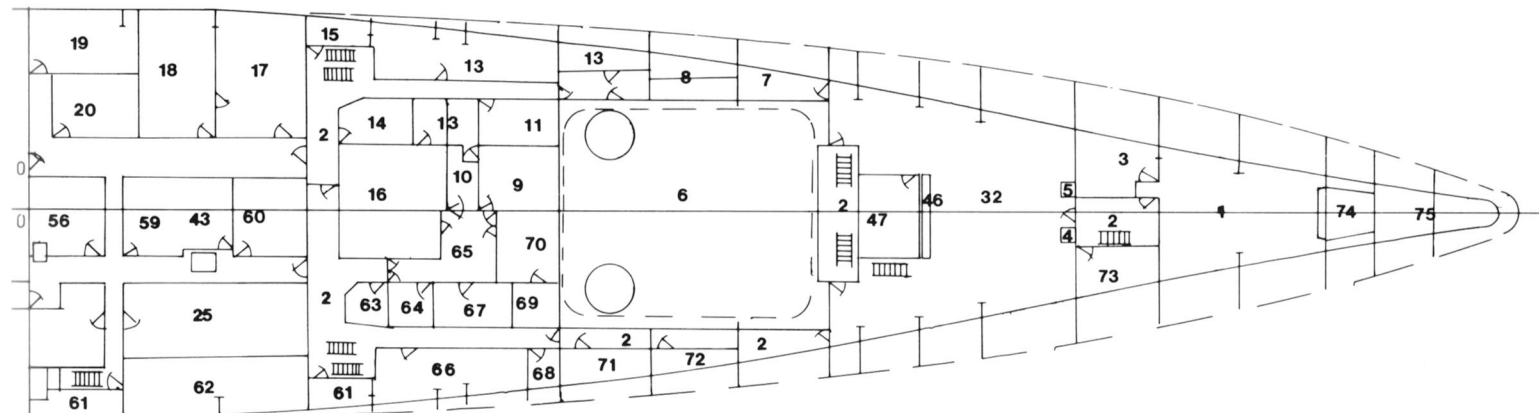
### A9 SECOND DECK (1/384 scale)

1	Crews' water closet	12	Head	22	Officers' galley	33	Cleaning gear locker
2	Passage	13	Officers' head	23	Main issue room	34	Barber shop
3	Crew's shower room	14	Dentist's head	24	Engineer's stowage	35	Tailor shop
4	Ammunition hoist	15	Linen locker	25	Machinery room	36	Mess attendants' head
5	Escape trunk	16	Sick bay	26	Ship's service store	37	Post office
6	Elevator pit	17	Supply officer's stores	27	Provision issue room	38	Mess attendants' berthing
7	Acid locker	18	Disbursing office	28	Bakery	39	Capstan room
8	Deck locker	19	Captain's office	29	Bread room	40	Laundry
9	Isolation ward	20	1st Lieutenant & damage control office	30	Crew mess & bomb handling	41	Resistor room
10	Diet pantry	21	Wardroom mess and recreation room	31	Cot locker	42	Issue room
11	Medical officer's stateroom			32	Crew's berthing	43	Linen room

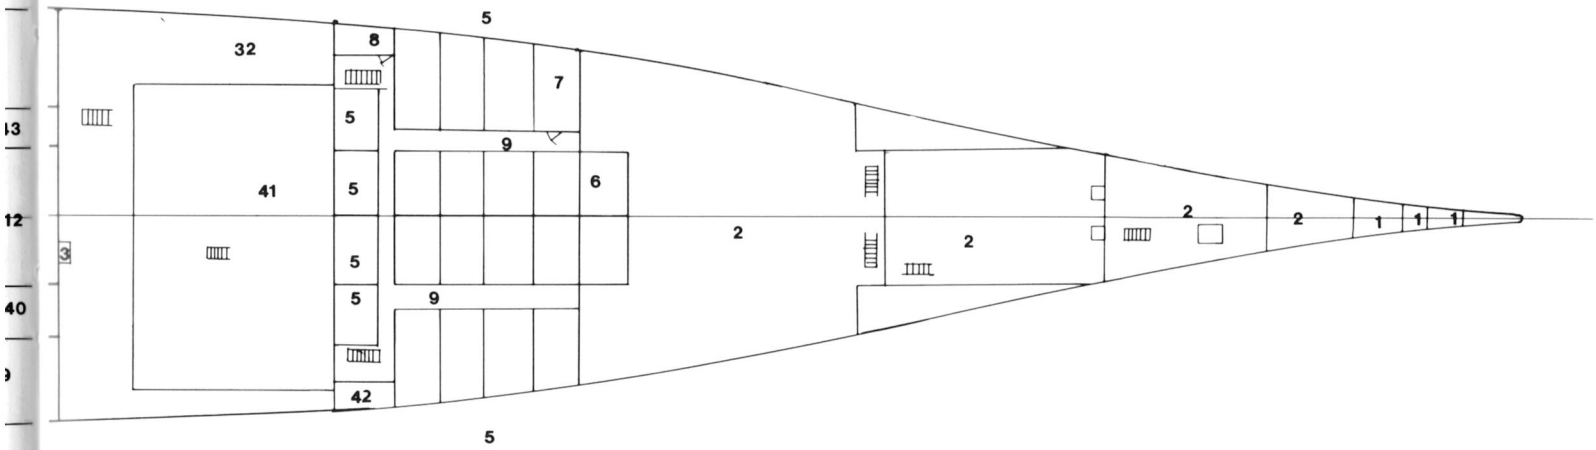
A10 PLATFORM DECK (1/384 scale)

1	Salt water ballast	13	Generator room	25	Pyrotechnic stowage	37	Kerosene locker
2	Crew berthing	14	Milk preparation	26	Steering gear platform	38	Engineer's locker
3	Escape trunk	15	Dairy	27	5in projectile stowage	39	Electrical workshop
4	Ammunition hoist	16	Fruit	28	5in powder stowage	40	Gyro room
5	Wardroom	17	Ice	29	Aircraft ammunition	41	Upper part forward engine & boiler room
6	Gas pump room	18	Fresh water settling tank	30	Dry provision	42	Linen locker
7	Inert gas	19	Vegetables	31	Butcher shop	43	Machine-gun repair
8	Cleaning gear locker	20	Meat	32	Machinery flat		
9	Passage	21	Dummy drill material	33	Upper part aft engine & boiler room		
10	Aviation armoury	22	Bomb vanes	34	Fresh water tank		
11	Ship's armoury	23	Aviation stores	35	CO <sub>2</sub> room		
12	Fuel oil settling tank	24	20mm & 40mm ammunition stowage	36	Spare parts stowage

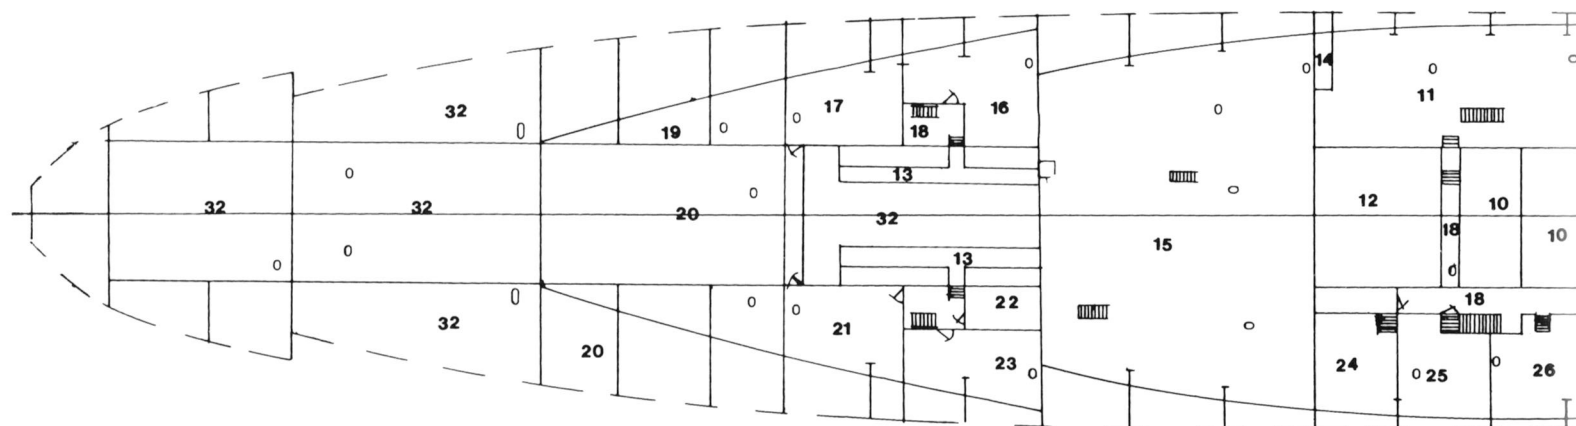
A11 TANK TOP (1/384 scale)

1	Salt water ballast	9	Forward engine & boiler room	17	Ordnance stores	25	Captain's store stowage
2	Incendiary bomb magazine	10	Fuel oil settling tank	18	Passage	26	C & R stores
3	Ammunition hoist	11	Machine shop	19	Aircraft ammunition stowage	27	Lube oil
4	Escape trunk	12	Fresh water tank	20	Bomb stowage	28	GSK & SD stores
5	Handling room	13	Shaft alley flat	21	Ship's service store stowage	29	Bomb fuse magazine
6	Aviation gas tank	14	Diesel oil	22	Clothing & small stores issue room	30	Dry provision stores
7	Cofferdam	15	Aft engine & boiler room	23	Clothing & small bulk stores	31	20mm & 40mm magazine
8	Lube oil	16	Chemical warfare equipment	24	Engineer's store & stock issue room	32	Fuel oil tank

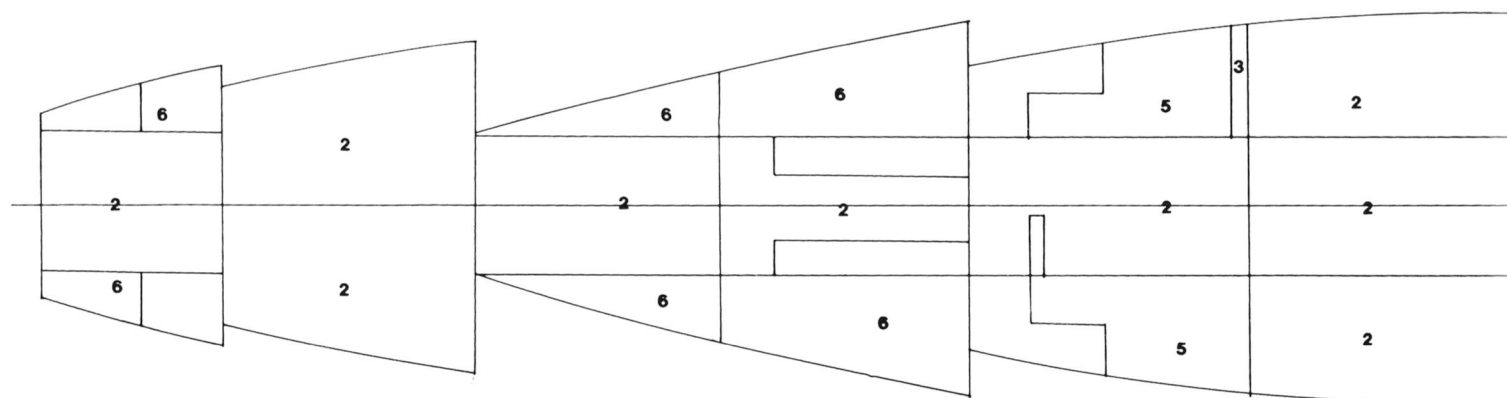
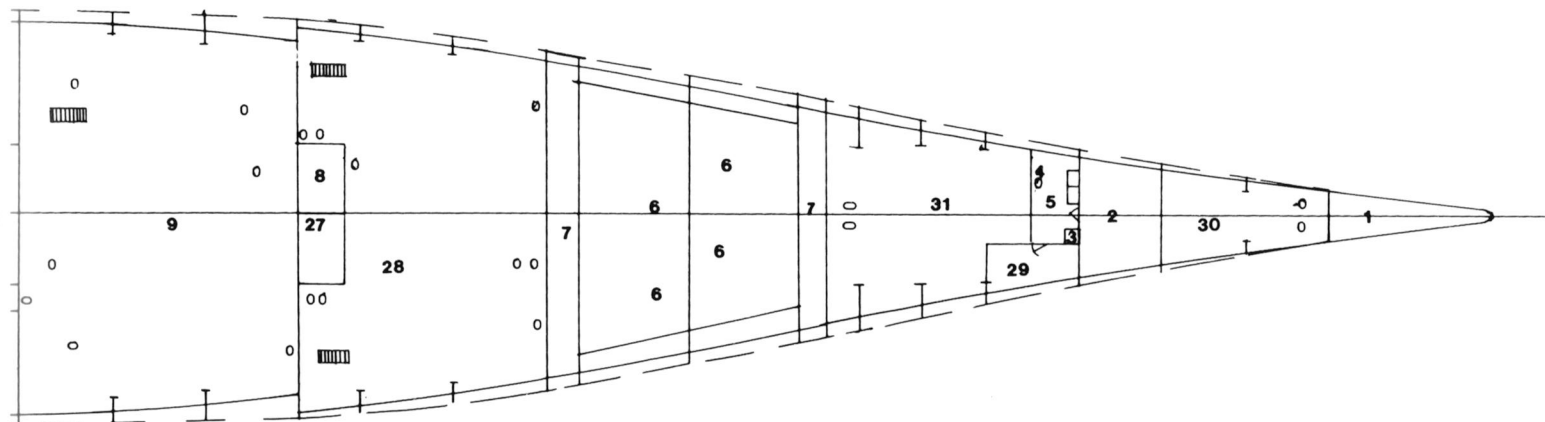
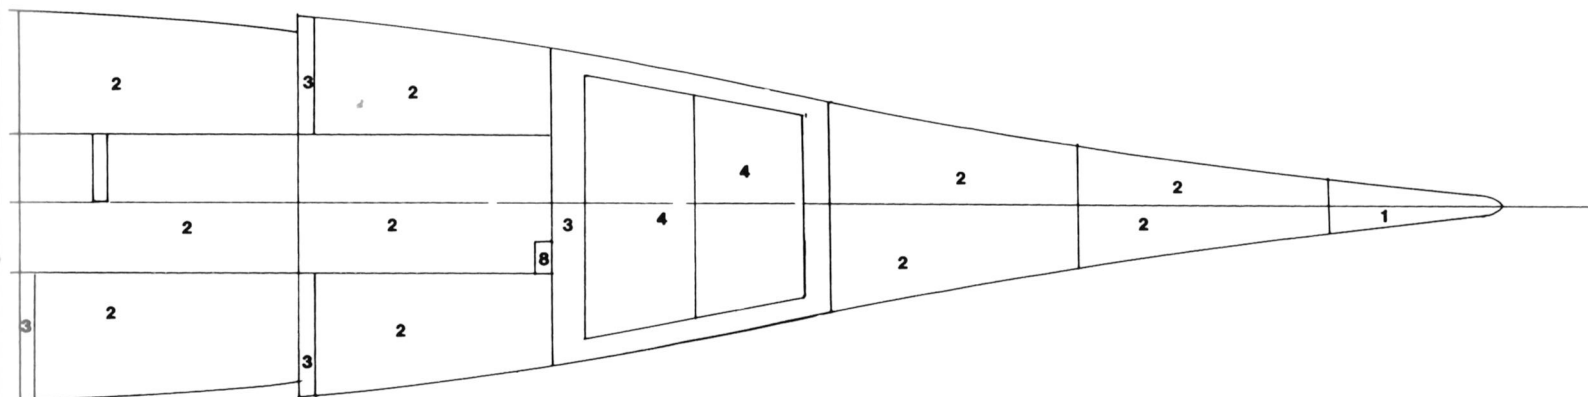
A12 DOUBLE BOTTOM (1/384 scale)

1	Salt water ballast
2	Fuel oil tank
3	Cofferdam
4	Aviation gas tank
5	Water tank
6	Void
7	Sump tank
8	Fathometer

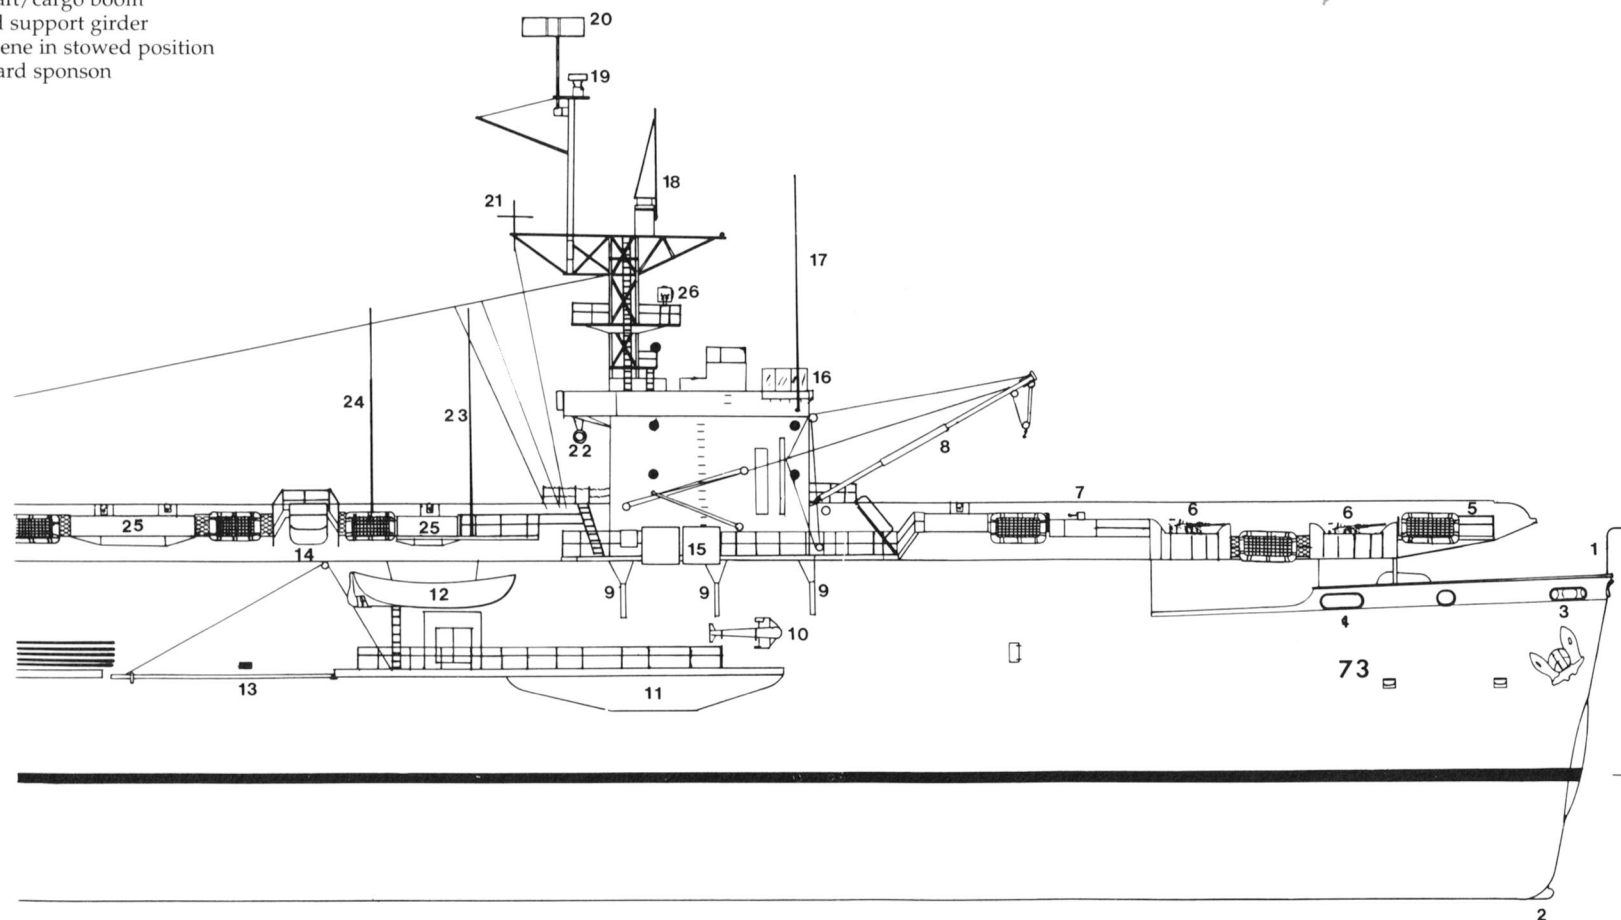
A13 DETAILS FORWARD (1/384 scale)

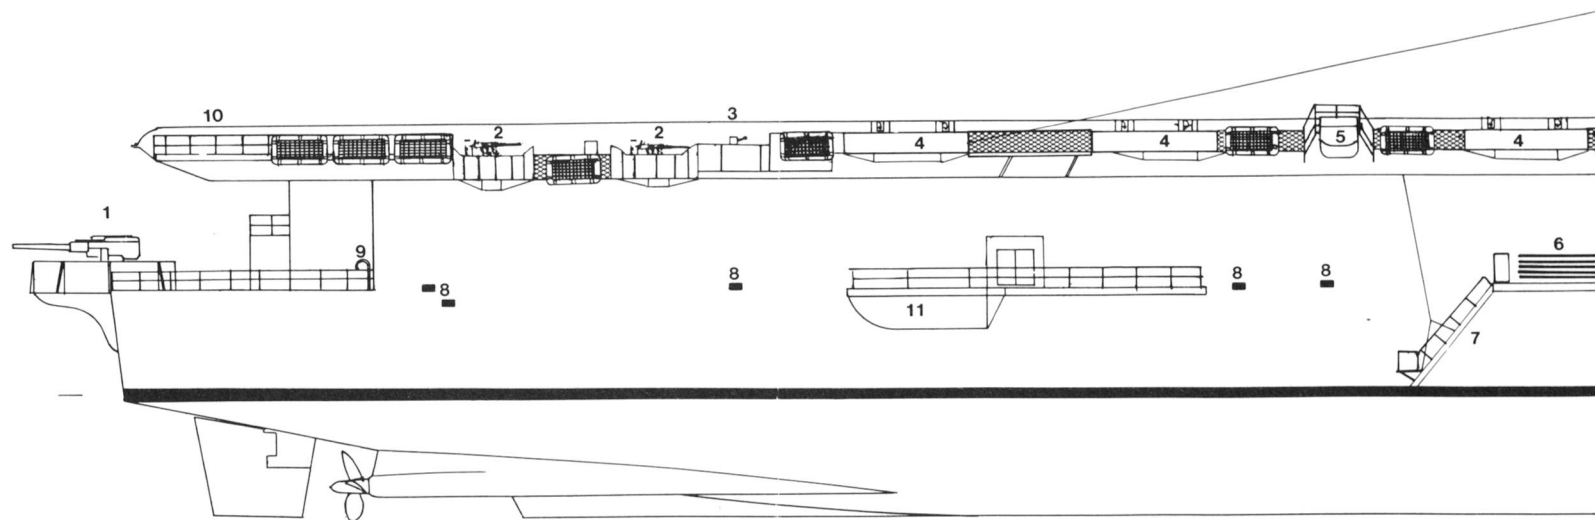
A14 DETAILS AFT (1/384 scale)

- 1 5in/38 mount
- 2 40mm mount
- 3 MK51 director
- 4 20mm mount
- 5 Uptake
- 6 Refuelling hoses
- 7 Accommodation ladder
- 8 Freeing port
- 9 Gooseneck vent
- 10 Sky lookout

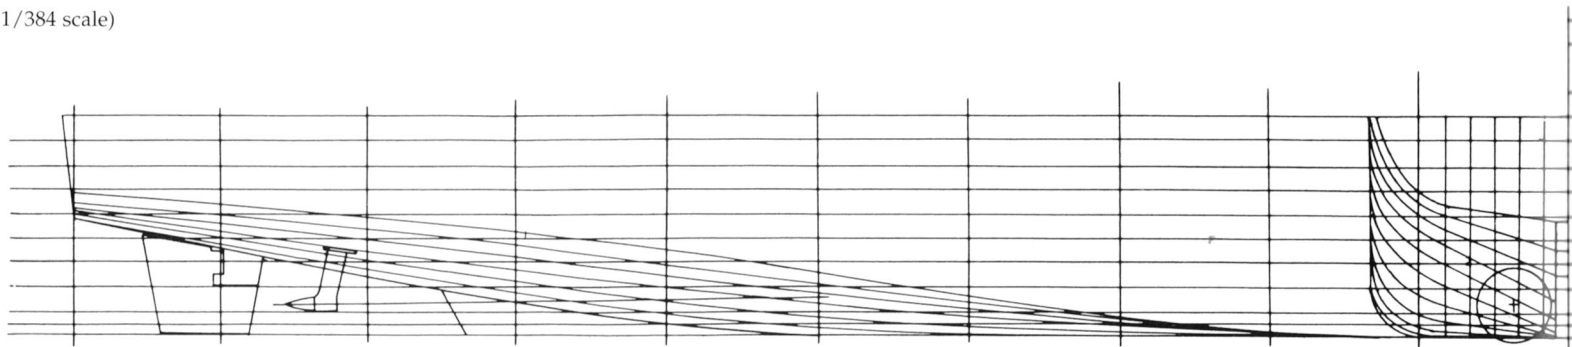
B1 SHEER DRAFT (1/384 scale)

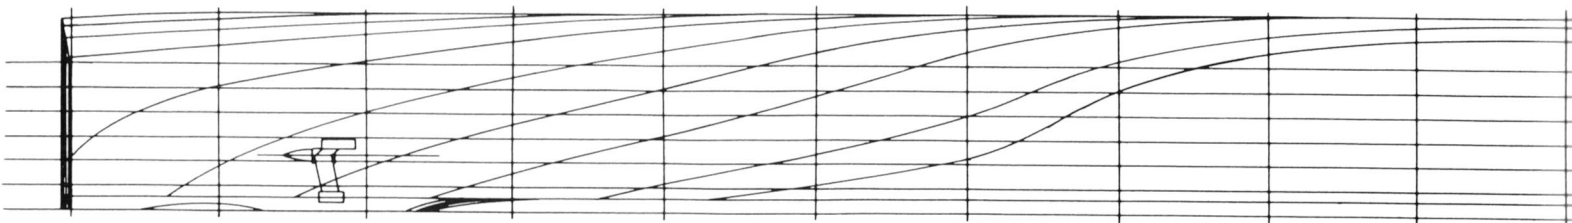
B2 PLAN VIEW (1/384 scale)

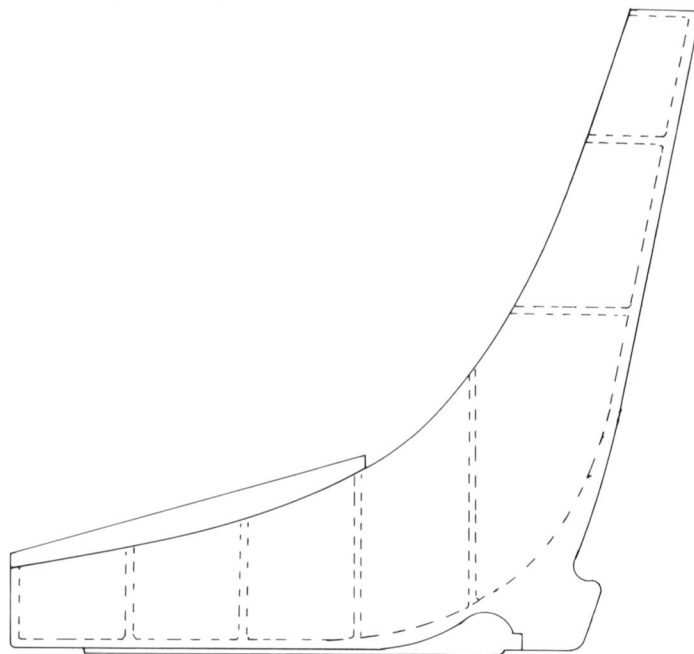
B3 STEM CASTING (1/64 scale)

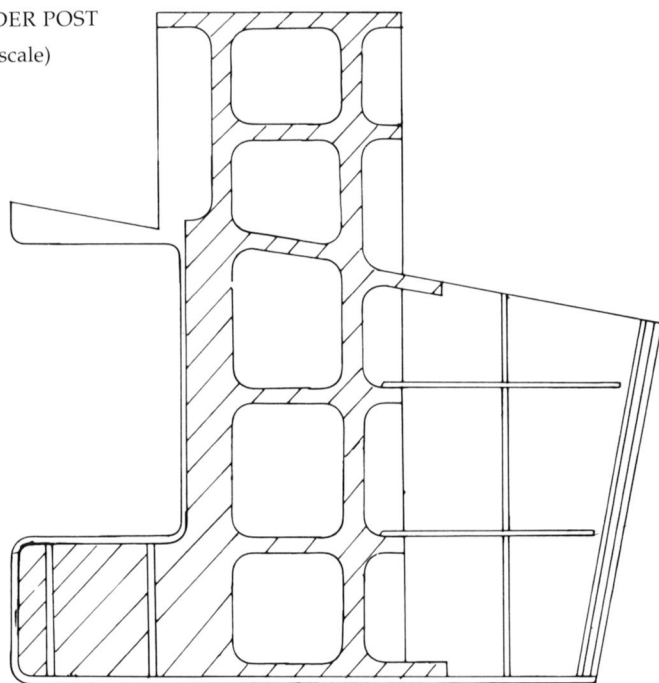
B4 RUDDER POST  
(1/32 scale)

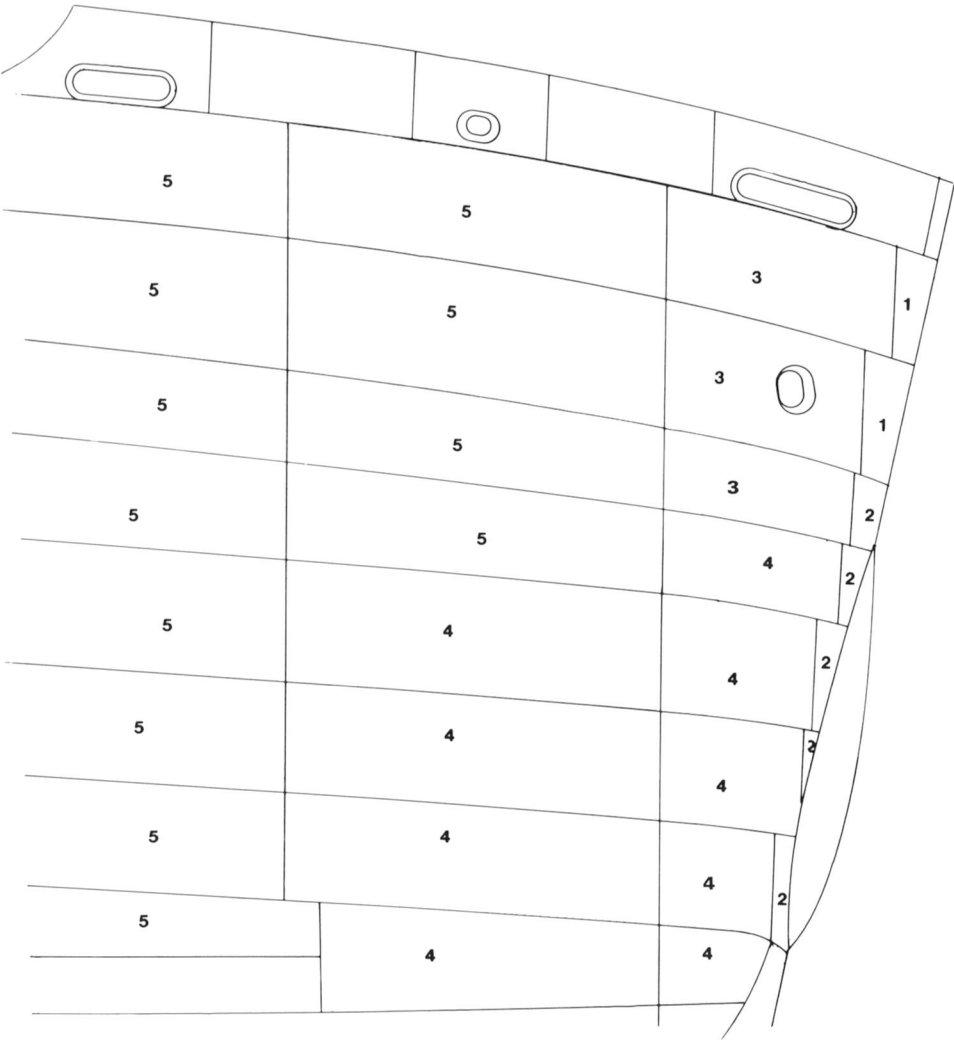
B5/1 Bow

- 1 20.4# STS
- 2 25.5# STS
- 3 35.6# STS
- 4 30.6# STS
- 5 22.95# STS

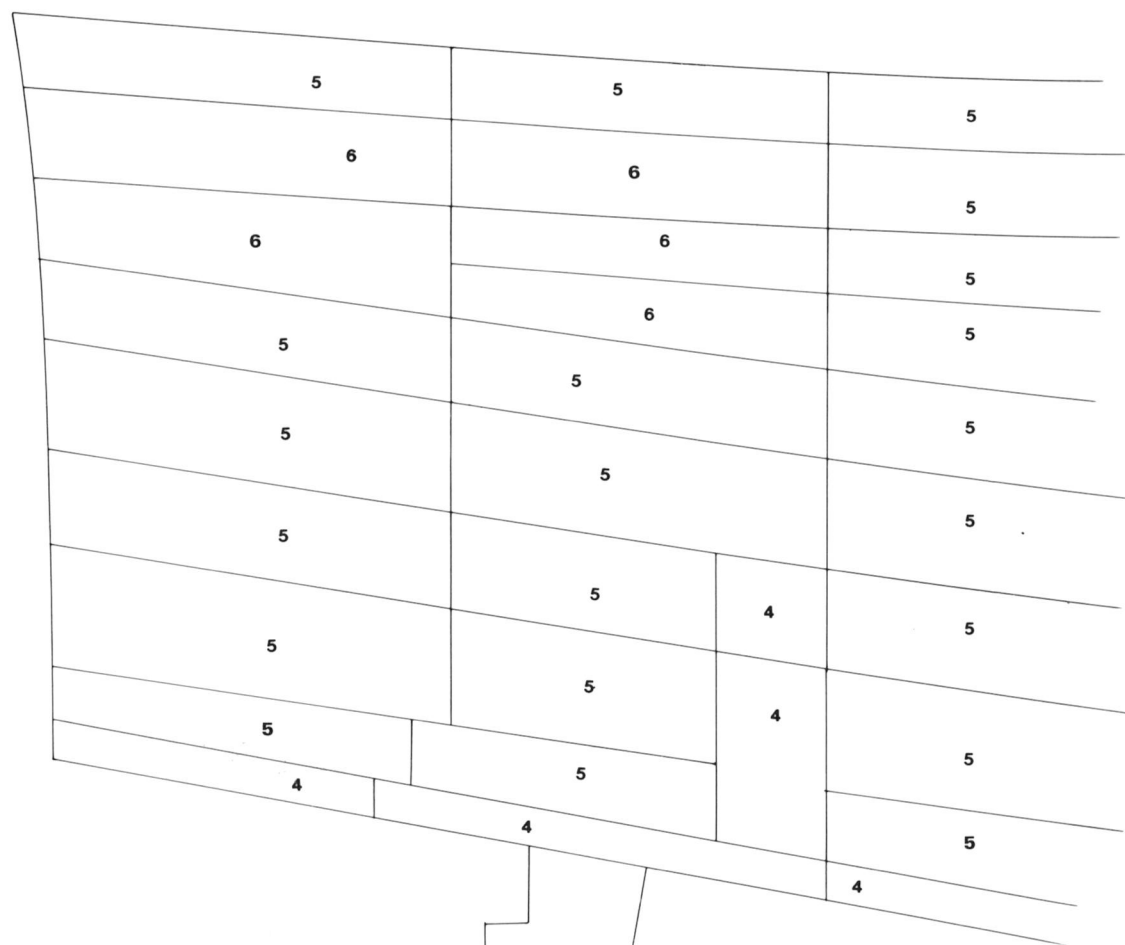
B5/2 Stern

- 1 20.4# STS
- 2 25.5# STS
- 3 35.6# STS
- 4 30.6# STS
- 5 22.95# STS
- 6 17.85# STS

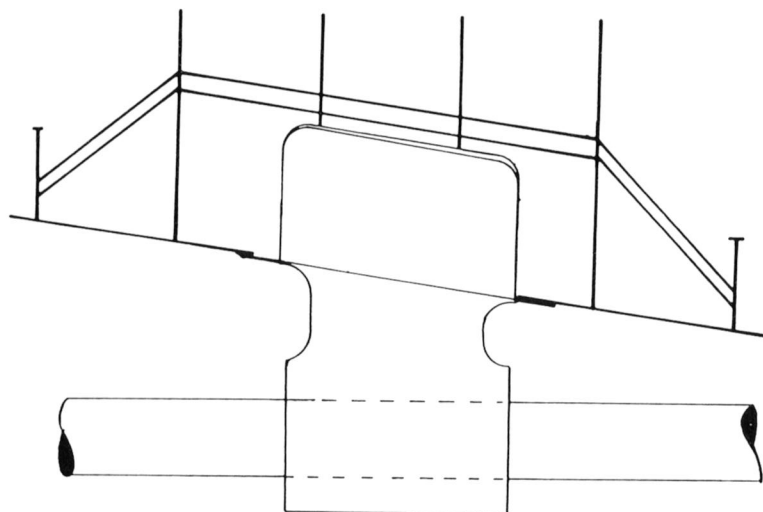
B6/1 Forward strut

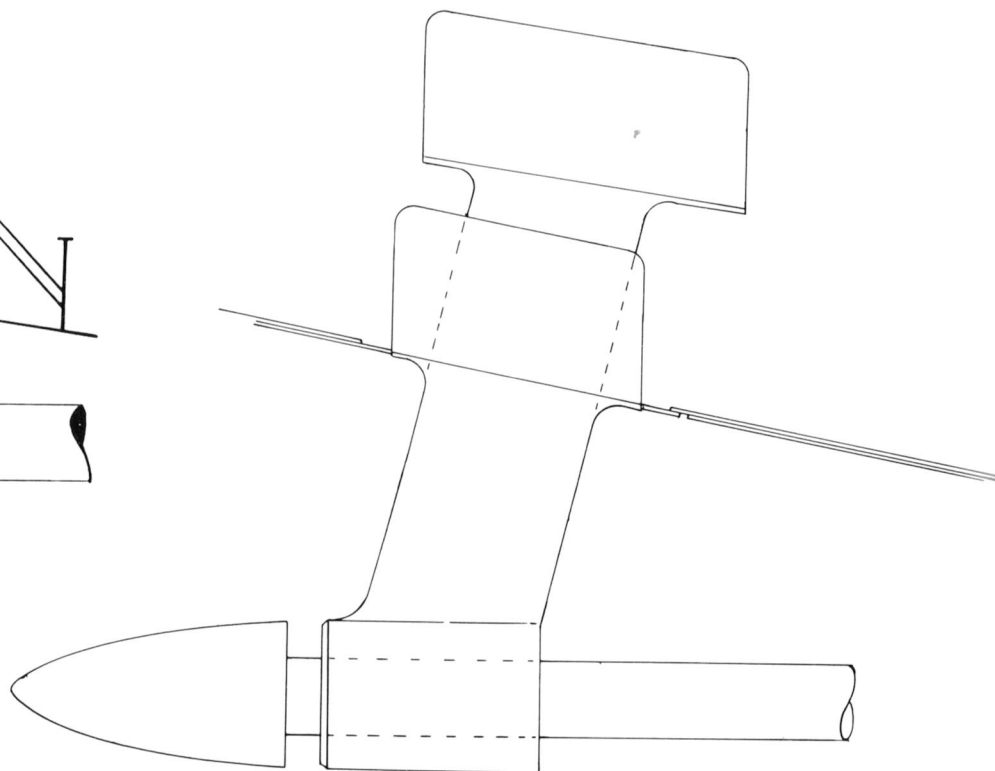
B6/2 Main strut side view

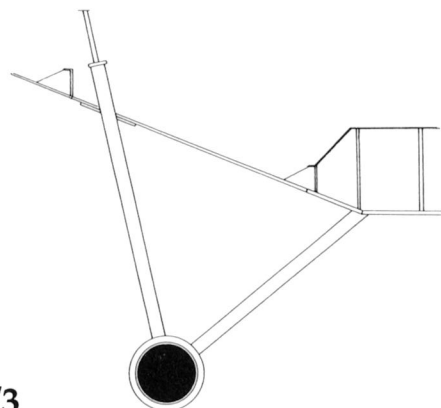
B6/3 Main strut front view

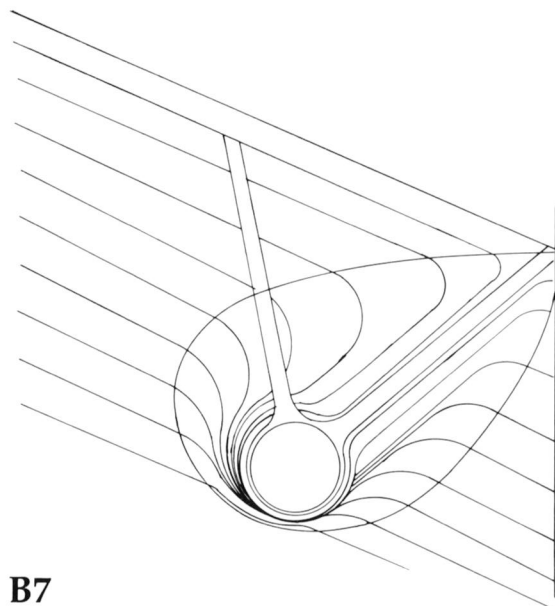
B7 PROPELLOR SHAFT HOUSING  
LINES (no scale)

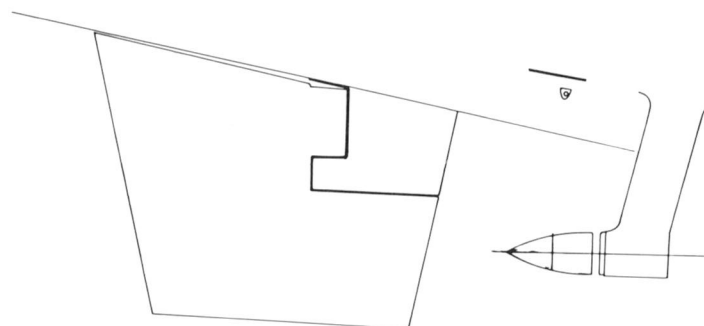
B8 RUDDER/SHAFT  
ARRANGEMENT (1/96 scale)

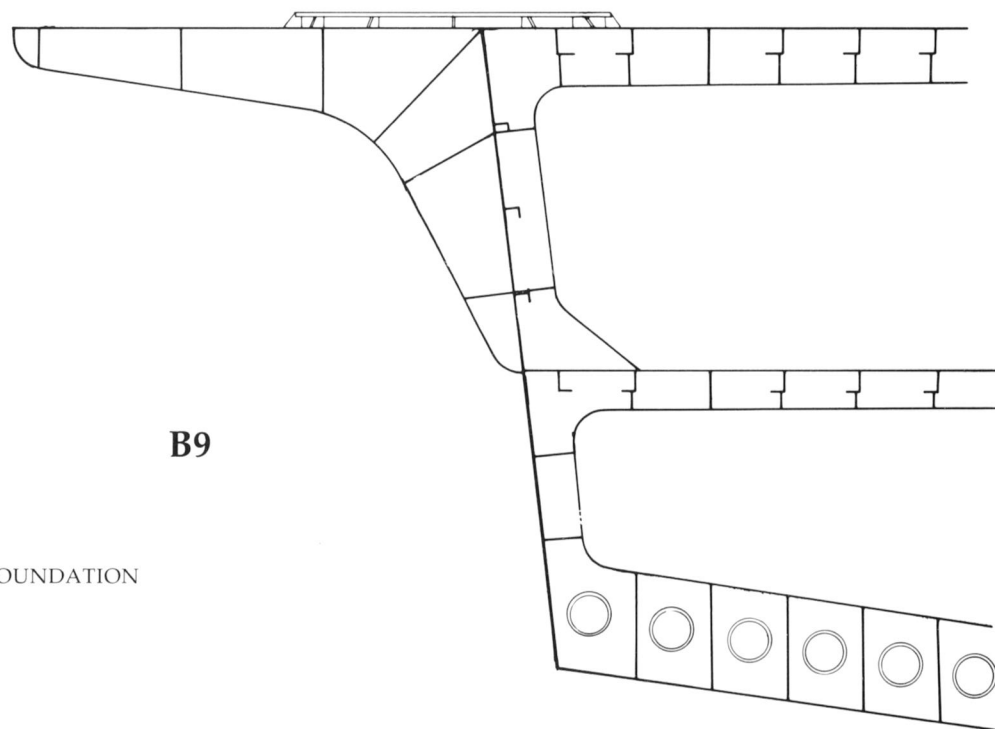
B9 5in GUN FOUNDATION  
(1/64 scale)

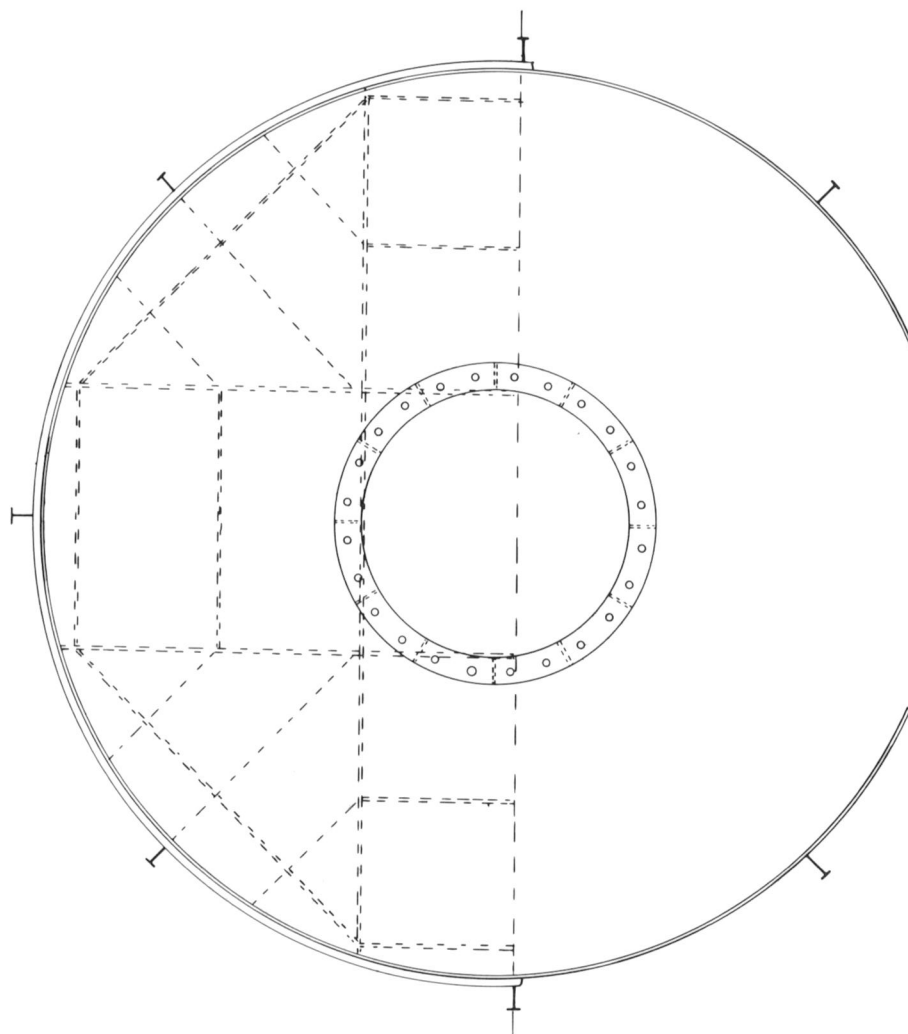
B10 5in GUNSHIELD FRAMING  
(1/64 scale)

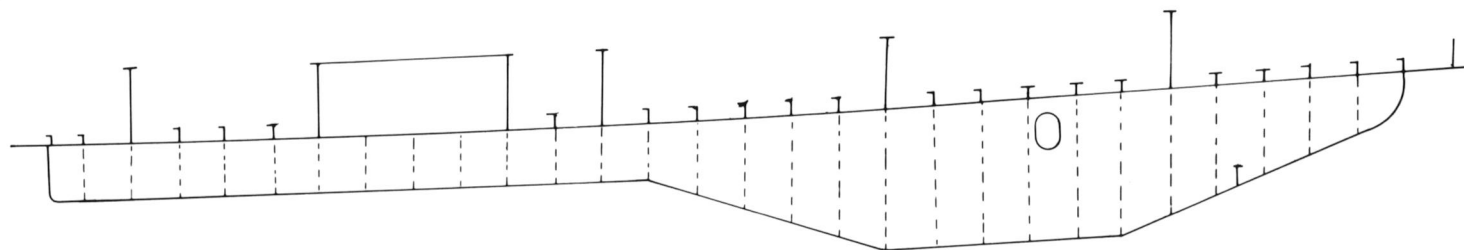
**B11/1**

B11/1 Forward

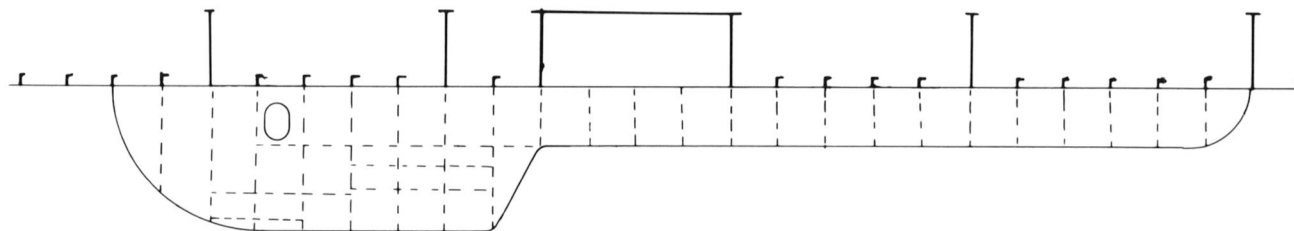
**B11/3**

B11/3 Aft

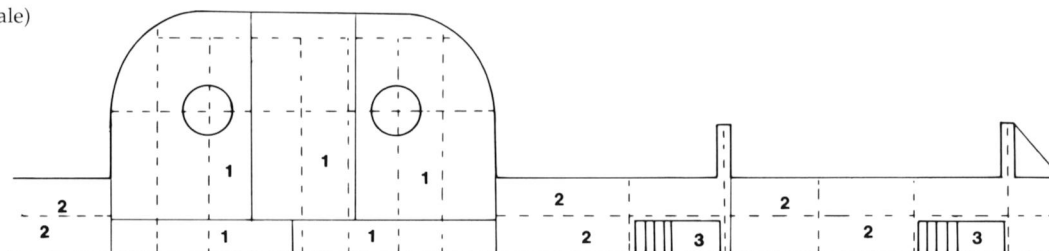
**B12**

B12 20MM PLATFORM (1/72 scale)

- 1 20# STS plating
- 2 7.65# CR plating
- 3 Inclined ladder

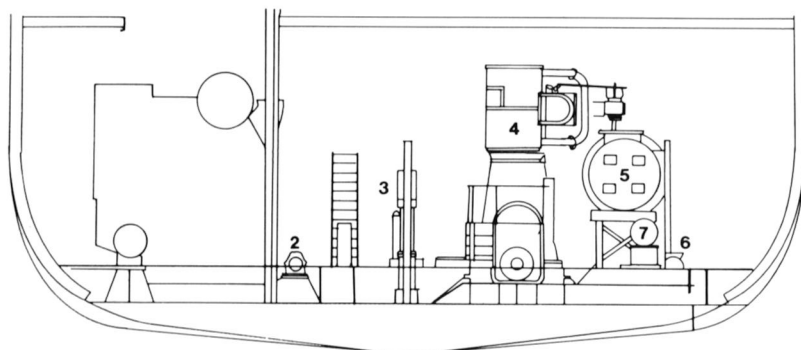
C1/1

- 1 Boiler
- 2 Forward engine shaft
- 3 Main feed pump
- 4 Aft engine
- 5 Main condenser
- 6 Main condensate pump
- 7 Main circulation pump

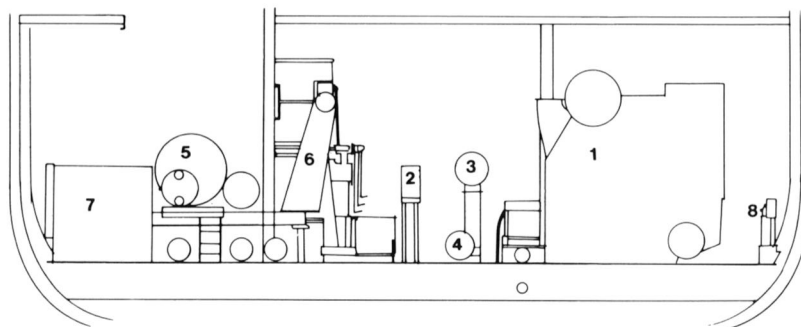
C1/2 Frame 100 looking aft

- 1 Boiler
- 2 Main feed pump
- 3 Auxiliary condenser
- 4 Auxiliary circulation pump
- 5 Main condenser
- 6 Aft engine
- 7 Feed water settling tank
- 8 Fuel oil service pump

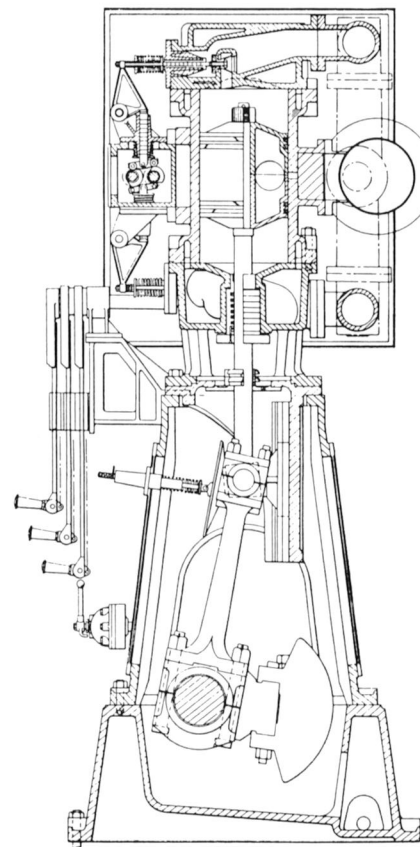
### C2 SECTION THROUGH UNIFLOW ENGINE (no scale)

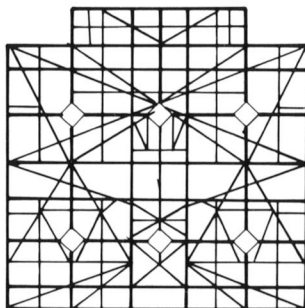
D1 SKI RADAR (1/128 scale)

D1/1 Framework

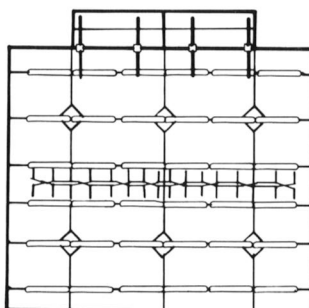
D1/2 Dipoles

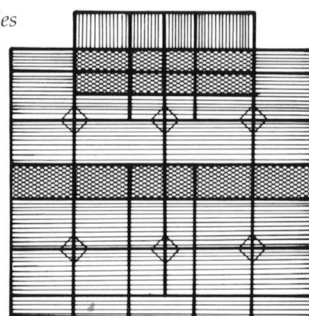
D1/3 Reflecting dipoles
