# The Escort Carrier **GAMBIER BAY**

Al Ross

# The Drawings

## A General arrangement

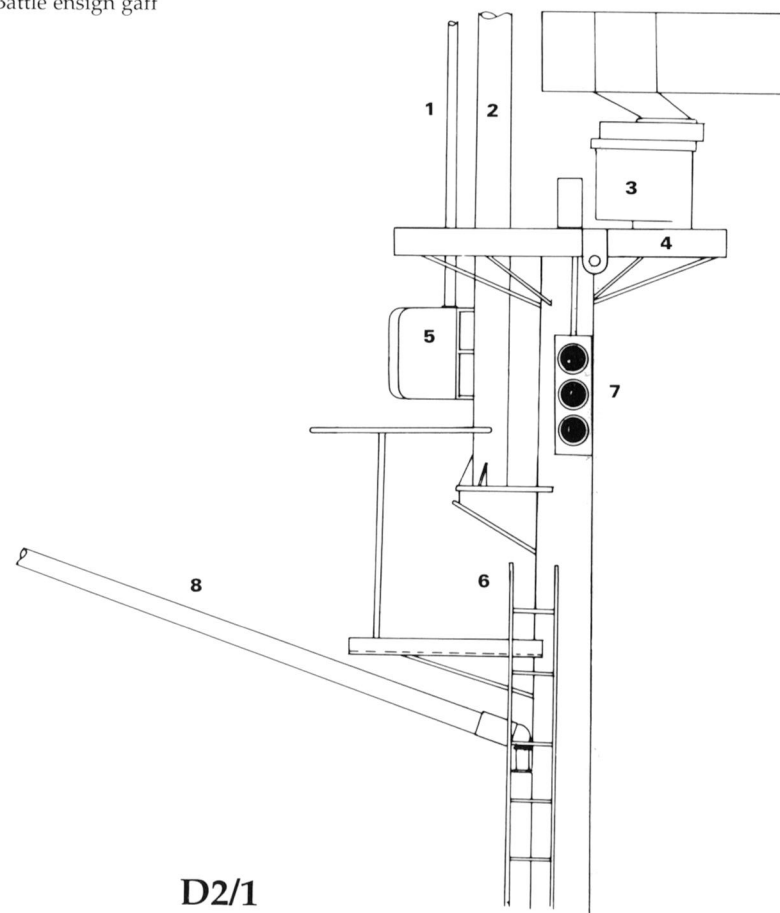
D2 SG RADAR (1/48 scale)

D2/1 SG RADAR PLATFORM

- 1 YE drive shaft
- 2 Topmast
- 3 SG radar drive
- 4 SG platform
- 5 YE drive motor
- 6 Vertical ladder
- 7 Vertical fighting lights
- 8 Battle ensign gaff

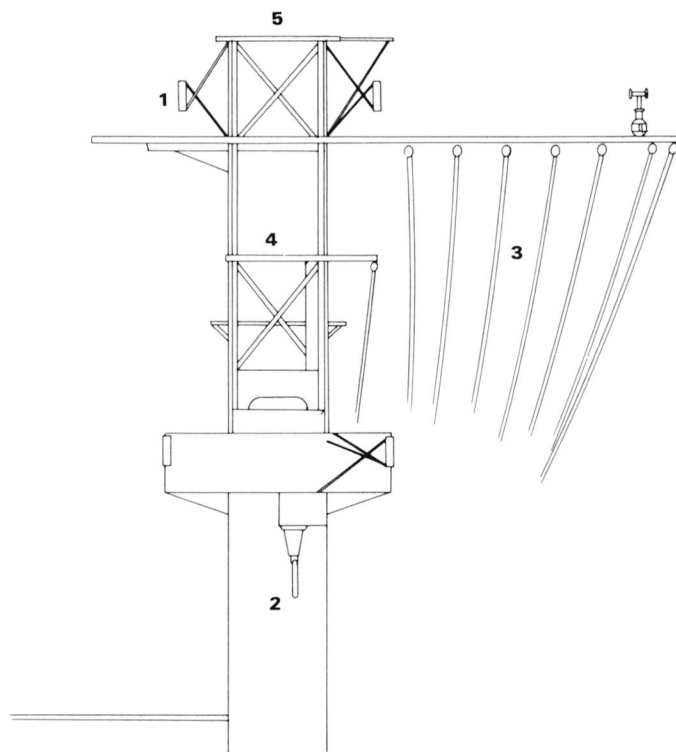
D3/1 Lower tower and island, looking forward

- 1 Fighting lights
- 2 RDF loop
- 3 Signal halyards
- 4 Searchlight platform
- 5 Radar platform

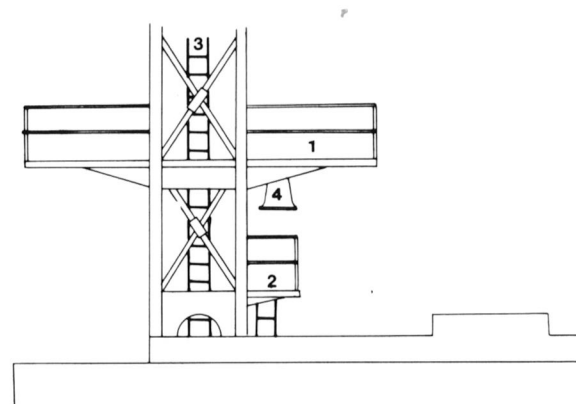
D3/2 Tower at searchlight level

- 1 24in searchlight platform
- 2 12in signal light platform
- 3 Vertical ladder
- 4 Ship's bell

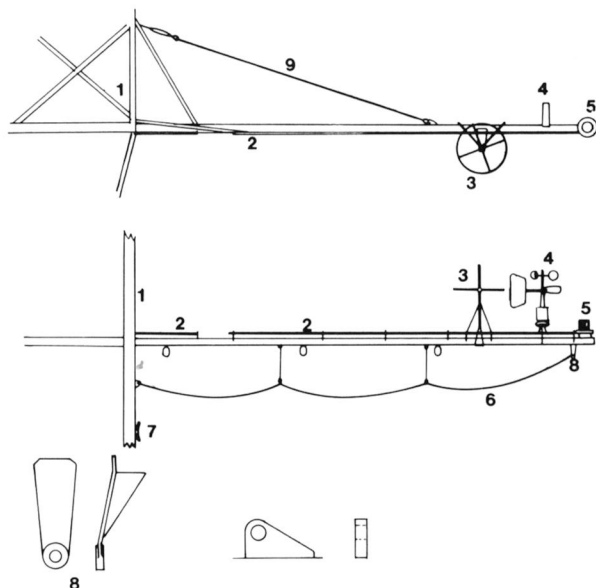
D3/5 *Signal yardarm*

- 1 Tower
- 2 Handrail
- 3 BN antenna
- 4 Anemometer
- 5 Blinker lamp
- 6 Foot rope
- 7 Cleat
- 8 Foot rope and bracket
- 9 Stay

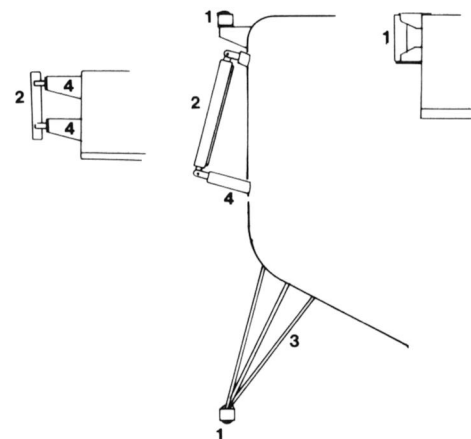
D4/2 *Plan and side views*

- 1 Fighting lights
- 2 Reproducer
- 3 Struts
- 4 Reproducer brackets

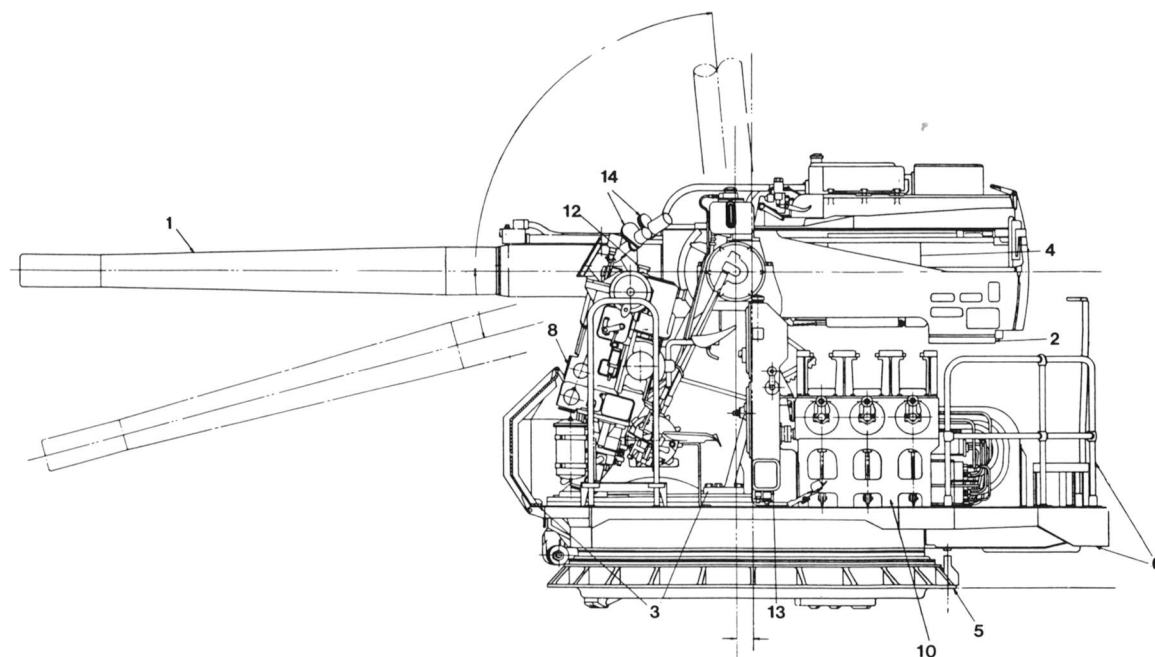
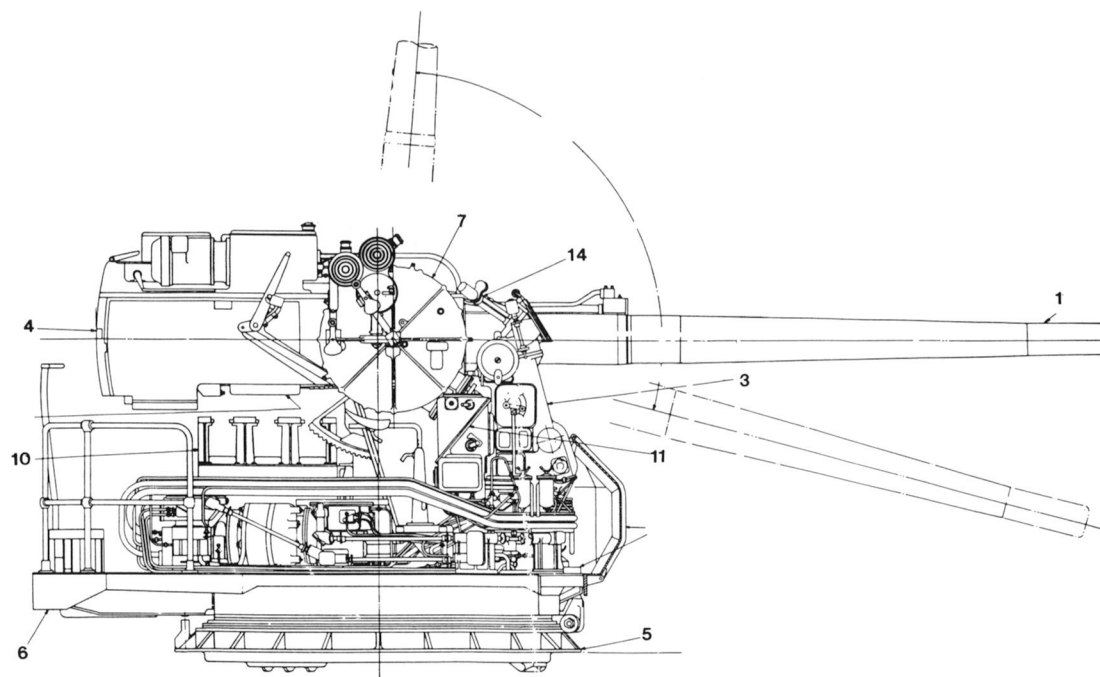
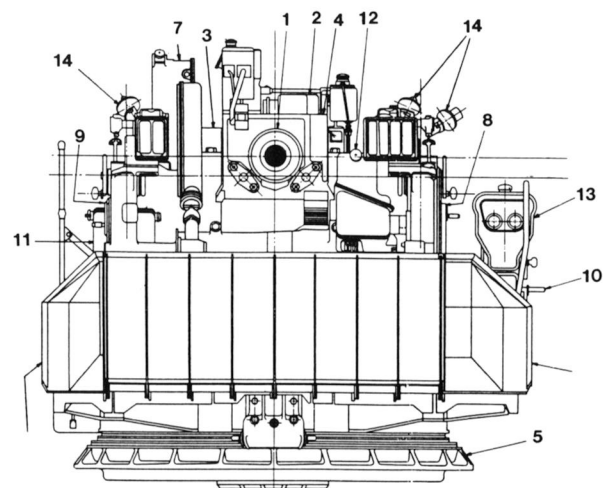
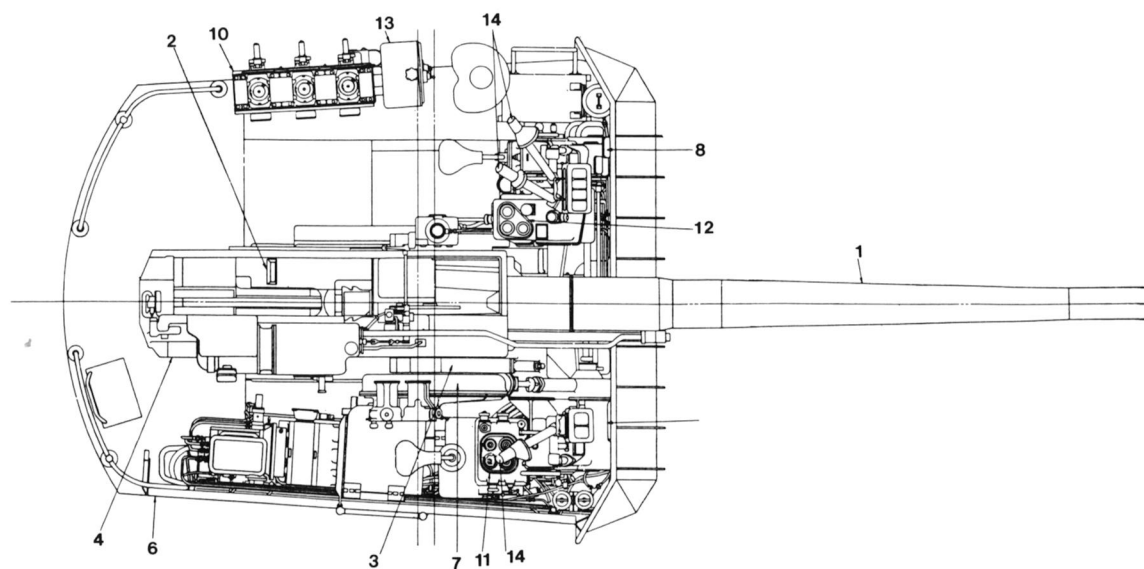
- 1 Barrel
- 2 Housing
- 3 Carriage
- 4 Slide
- 5 Stand
- 6 Platform
- 7 Sight
- 8 Elevating gear
- 9 Training gear
- 10 Fuse setting gear
- 11 Gun train indicator
- 12 Gun elevation indicator
- 13 Fuse setting indicator
- 14 Telescopes

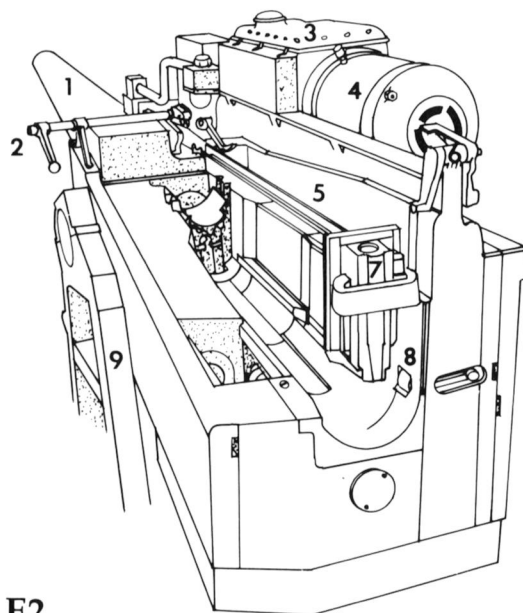
### E2 5in/38 MK12 RAMMER CONTROLS (no scale)

- 1 Barrel
- 2 Operating lever
- 3 Rammer gear housing
- 4 Rammer motor
- 5 Cam plate
- 6 Spade release lever
- 7 Space
- 8 Case stop
- 9 Carriage

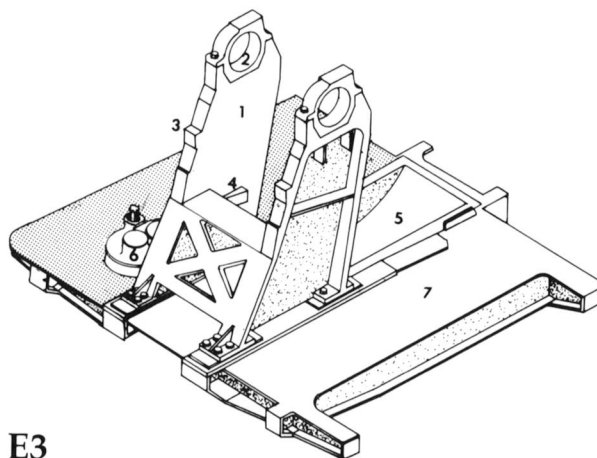
### E3 STAND AND CARRIAGE FOR 5in/38 (no scale)

- 1 Gun carriage
- 2 Trunnion bearing
- 3 Depression stop
- 4 Elevation stop
- 5 Centre plate
- 6 Training pinion gear housing
- 7 Platform

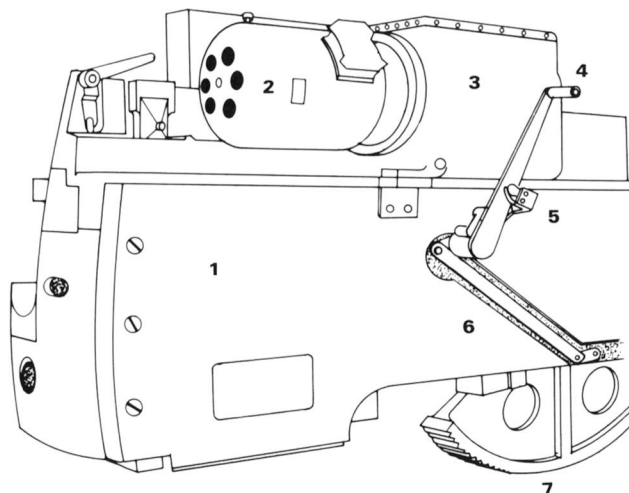
### E4 BREECH HAND OPERATING LEVER DETAILS, 5in/38 (no scale)

- 1 Slide
- 2 Rammer gear housing
- 3 Rammer gear housing
- 4 Hand operating lever
- 5 Lever catch
- 6 Connecting link
- 7 Elevating arc

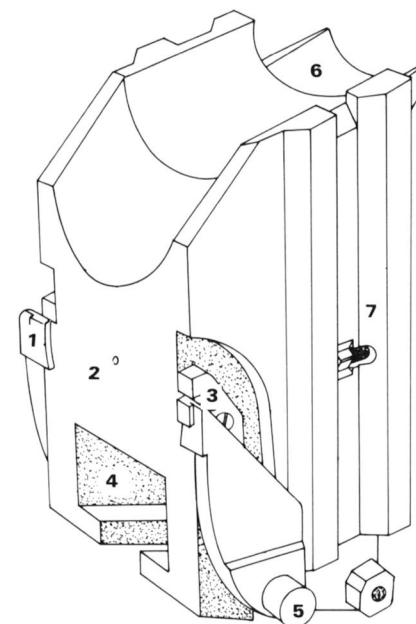
### E5 BREECH BLOCK AND EXTRACTORS, 5in/38 (no scale)

- 1 Lip
- 2 Firing pin
- 3 Pallet
- 4 Bearing block ways
- 5 Outer lug
- 6 Shelf
- 7 Seal

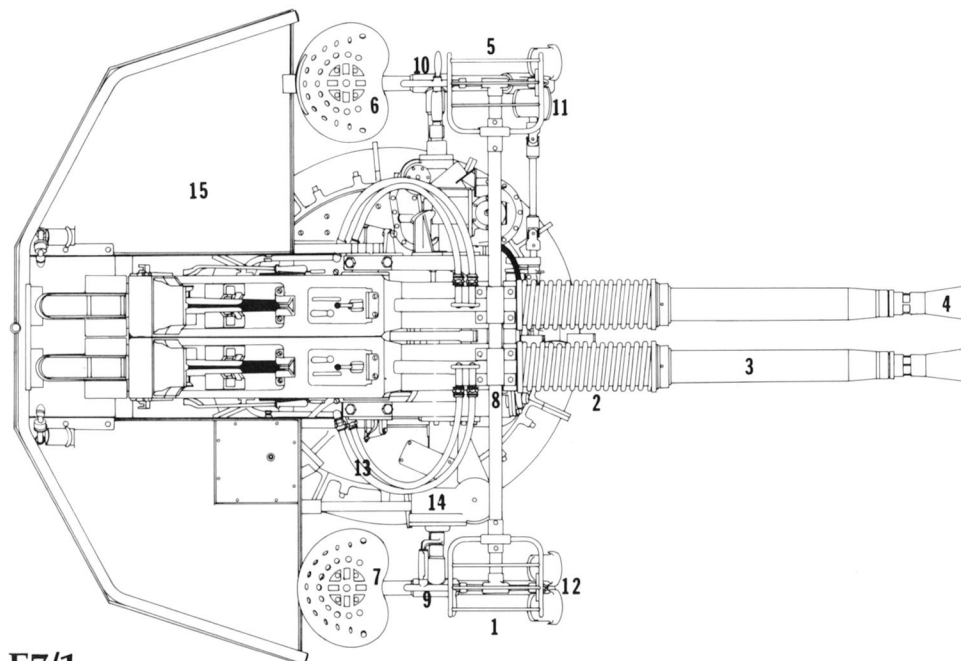
E7 TWIN 40MM MK1 MOUNT  
(1/32 scale)

E7/1 Top View

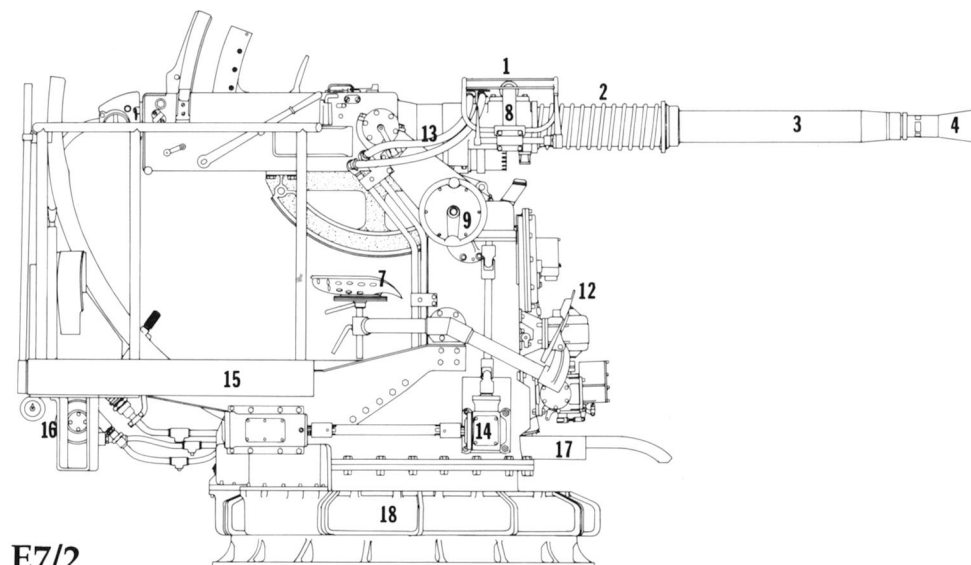
E7/2 Starboard elevation

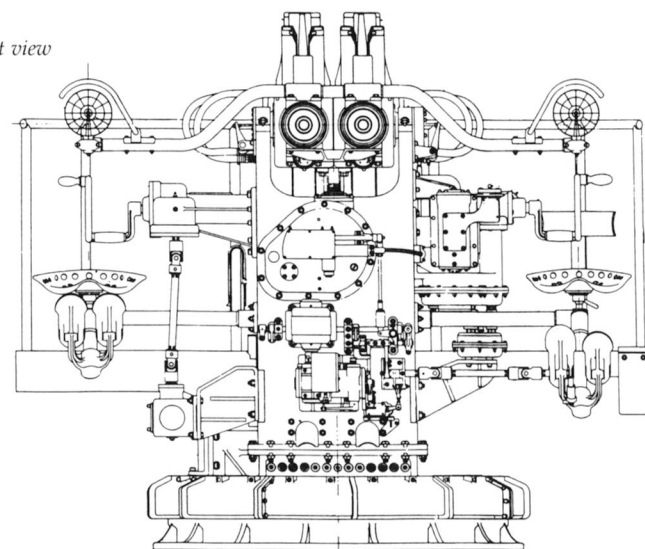
E7/3 Front view

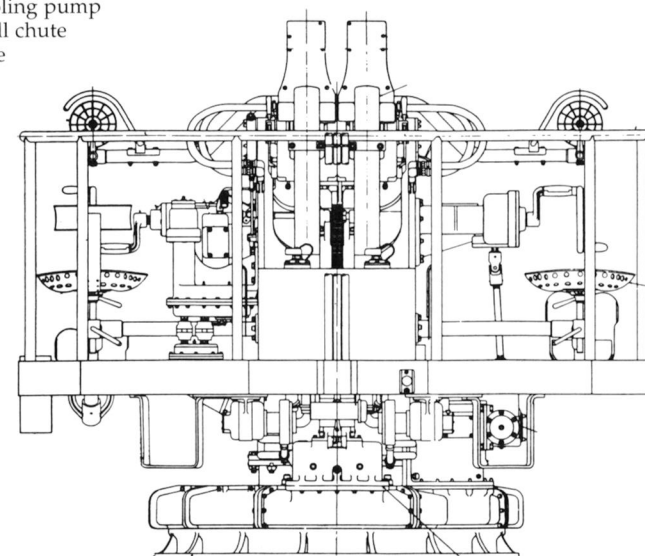
E7/4 Rear view

- 1 Open sight for trainer
- 2 Spring
- 3 Barrel
- 4 Flash guard
- 5 Open sight for pointer
- 6 Pointer's seat
- 7 Trainer's seat
- 8 Sight bar
- 9 Training handwheel
- 10 Pointing handwheel
- 11 Firing pedal
- 12 Footrests
- 13 Hydraulic lines
- 14 Training gear
- 15 Platform
- 16 Cooling pump
- 17 Shell chute
- 18 Base

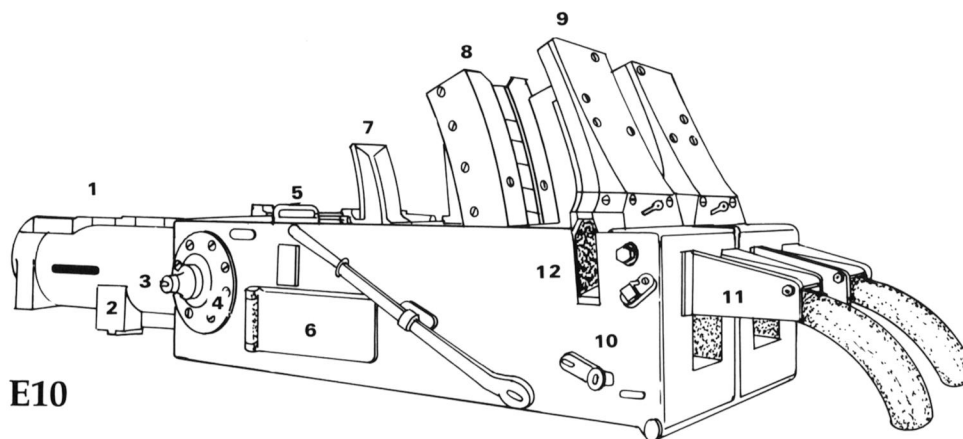
### E10 40MM SLIDE AND LOADER ARRANGEMENT (no scale)

- 1 Recoil cylinder
- 2 Recoil piston rod mount
- 3 Firing plunger
- 4 Trunnion
- 5 Top door
- 6 Side door
- 7 Front guide
- 8 Loader guide and pawls
- 9 Rear guide
- 10 Firing selector lever
- 11 Case deflector

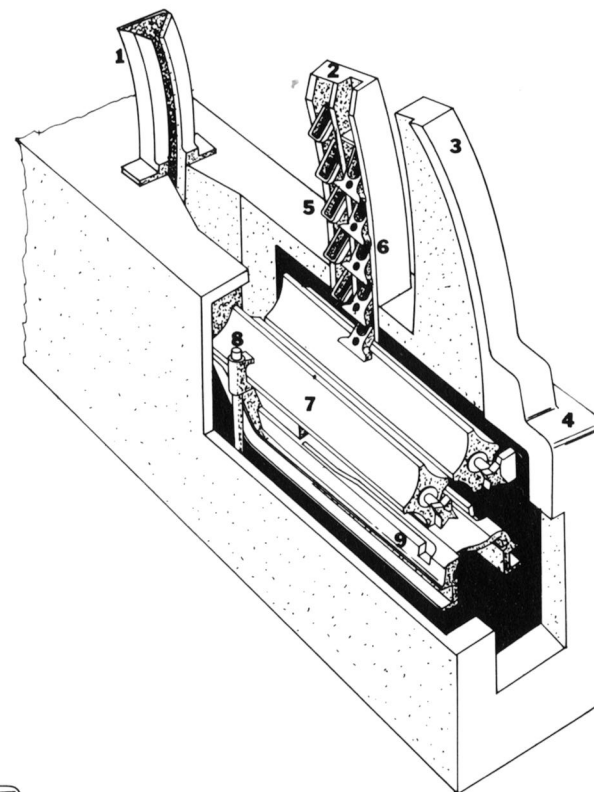
### E11 LOADER, 40MM (no scale)

- 1 Front guide
- 2 Right loader frame
- 3 Rear guide
- 4 Slide
- 5 Stop pawls
- 6 Feed pawls
- 7 Star wheel
- 8 Star wheel catch
- 9 Rammer tray

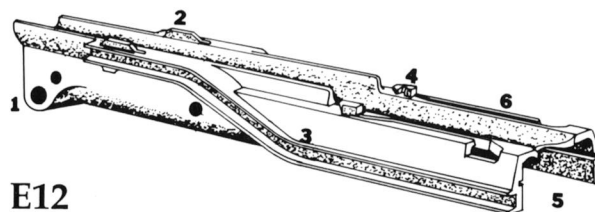
### E12 RAMMER TRAY, 40MM (no scale)

- 1 Securing bolt hole
- 2 Rammer tray pawl
- 3 Guide for feed pawl roller
- 4 Rammer lever
- 5 Rammer shoe guide
- 6 Rammer lever slot

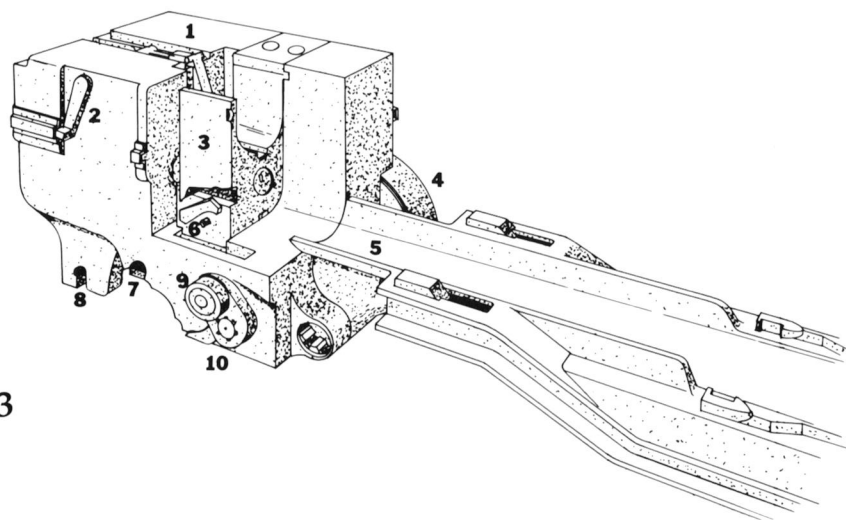
**E13**

**E13 BREECH MECHANISM, 40MM**  
(no scale)

- 1 Housing
- 2 Gun barrel catch control arm
- 3 Breech block
- 4 Operating spring case
- 5 Rammer tray
- 6 Outer cocking lever
- 7 Extractor shaft hole
- 8 Recoil piston rod bolt hole
- 9 Roller
- 10 Crankshaft

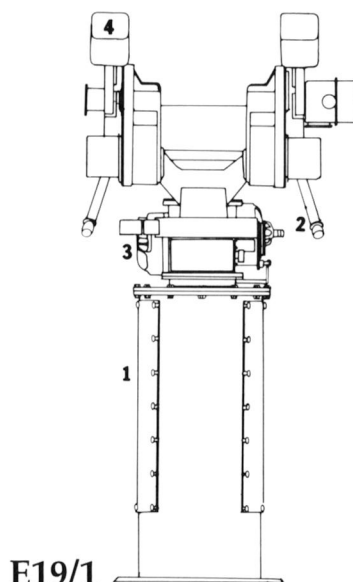
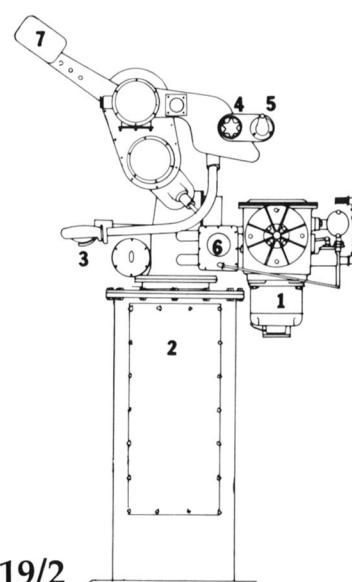
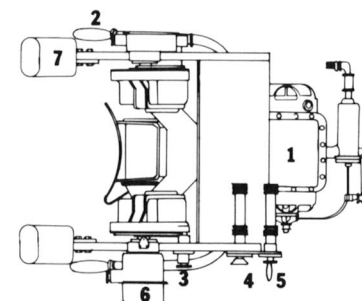
*E19/3 Plan view*

- 1 Air pump
- 2 Director handles
- 3 Elevation detent
- 4 Range rate setter
- 5 Range setter
- 6 Access to wind syncro
- 7 Counterbalance weight

*Gambier Bay* carried four MK51 directors to control the 40mm mounts at each end of the flight deck. The MK51 director was a simple lightweight director consisting of a pedestal, head, and, initially, a simple ring sight. Later, the ring sight was replaced with the MK14 computing gunsight. The pedestal was bolted to the deck and supported the head on ball bearings. The head supported a carriage which had a platform for mounting the gunsight. The handle bars attached to the carriage were used by the operator to move the carriage in elevation and the head in train. The right handle contained a firing key which controlled the guns when they were in a director-control mode. The sight power unit, which consisted of a motor-driven air pump, was mounted on the head.

The MK14 gunsight, developed by Dr Charles Draper of MIT, was mounted on both the MK51 directors and the 20mm guns. It incorporated two gyroscopically-operated mechanisms which automatically computed lead angle and super elevation. Lead angle computations were always correct for any value of trunnion tilt, and super elevation was computed and applied in the vertical plane. A luminous cross which established the sighting axis was the reflected image of an illuminated reticle. Sight movement during tracking caused the two gyroscopes to process, actuating the two mirrors which shifted the position of the cross. The offset of the cross was such that the sighting axis was displaced from the bore axis by the required lead angle corrected for super elevation.

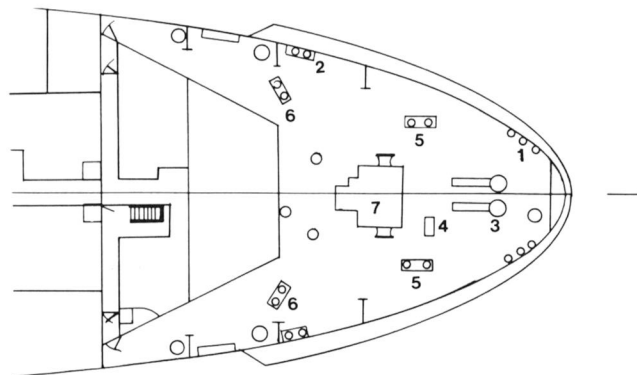
F1

- 1 Triple roller chocks
- 2 Double roller chocks
- 3 Hawse pipes
- 4 Hatch
- 5 14in bitt
- 6 12in bitt
- 7 Anchor winch

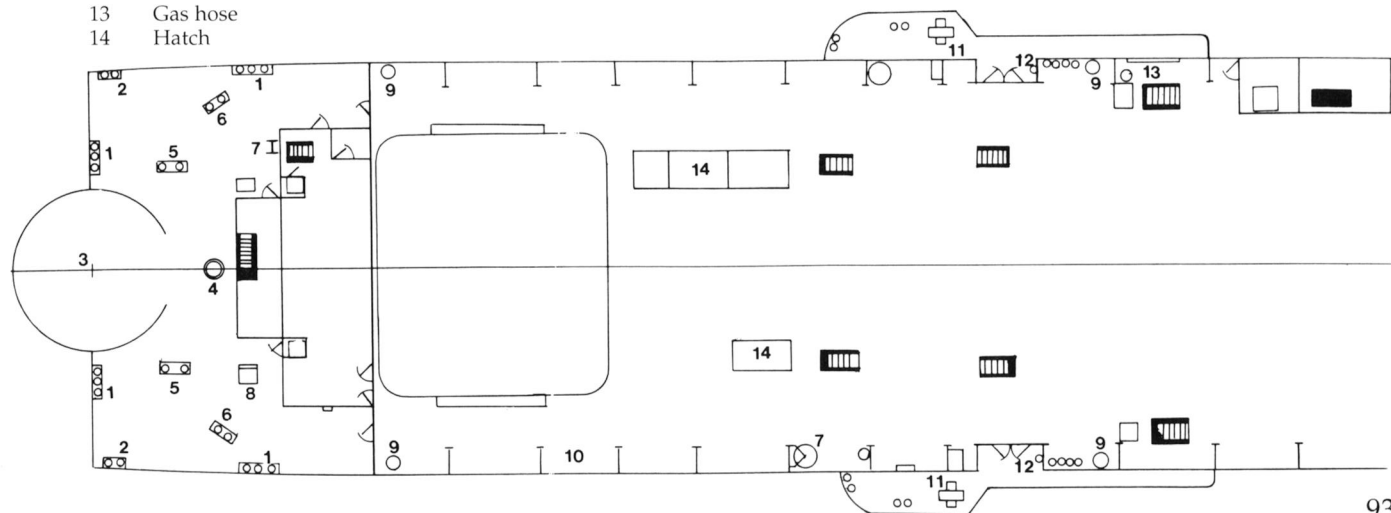
## F2 HANGAR DECK FITTINGS (1/384 scale)

- 1 Triple roller chocks
- 2 Double roller chocks
- 3 5in gun mount
- 4 Capstan
- 5 14in bitt
- 6 12in bitt
- 7 Hawser reel
- 8 Watertight escape hatch
- 9 Cane fenders
- 10 Aircraft propellers
- 11 Winch
- 12 Fuel oil fills
- 13 Gas hose
- 14 Hatch

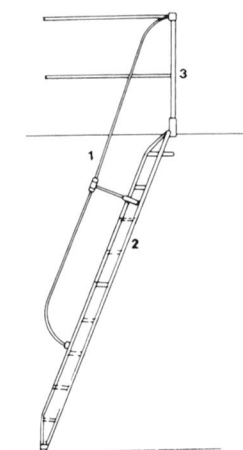
**F5/1**

F5/2 Front view

- 1 Railing
- 2 Ladder
- 3 Stanchion

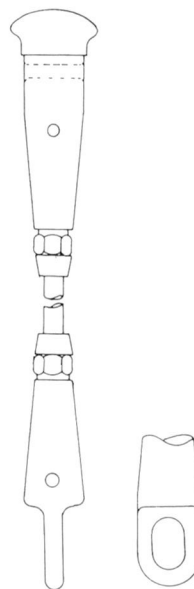
**F6**

F6 WIRE ROPE HANDRAIL  
FITTINGS (no scale)

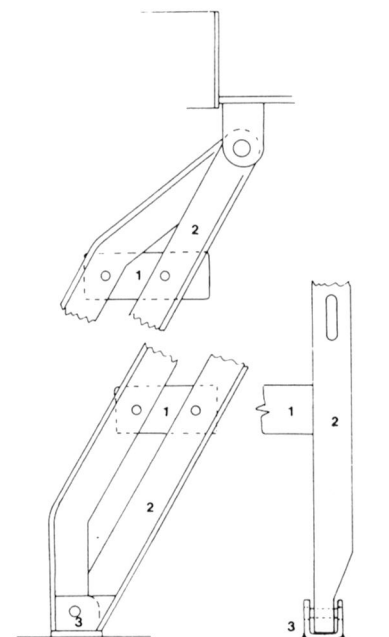
**F7**

F7 TYPICAL LADDER DETAILS  
(no scale)

- 1 Tread
- 2 Side frame
- 3 Clip

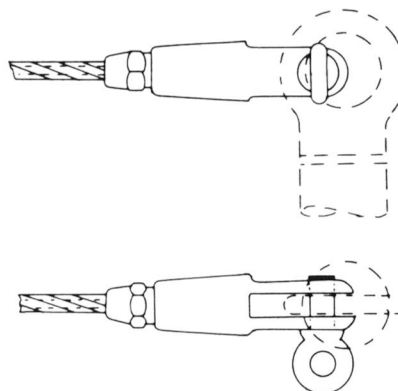
**F9**

F9 GUARD RAIL CLEVIS  
(no scale)

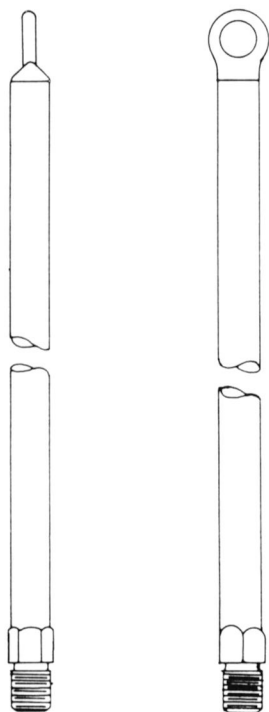
F10 TYPICAL STRAIGHT STANCHION (1/12 scale)

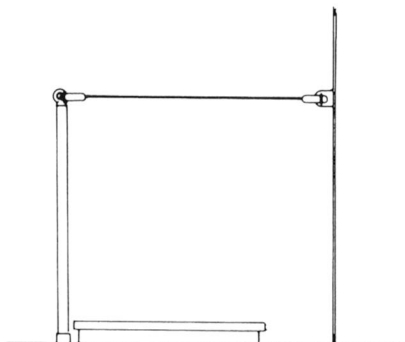
F11 TYPICAL WIRE ROPE AND STANCHION AROUND DECK HATCH (1/48 scale)

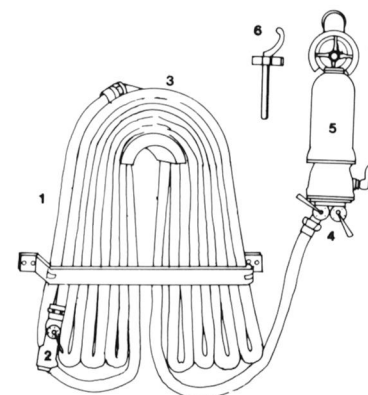
F12 FIRE PLUG (1/24 scale)

- 1 Bracket
- 2 Nozzle
- 3 Hose
- 4 Wyegate
- 5 Self-cleaning strainer
- 6 Adjustable spanner
- 7 Fire plug

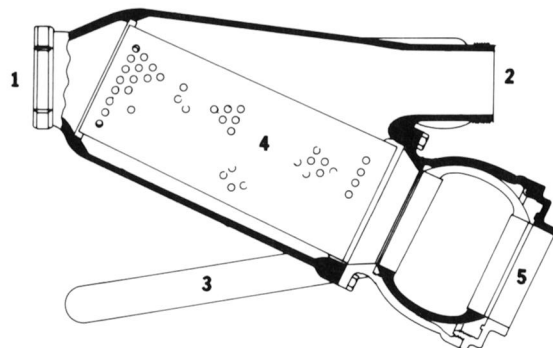
F13 SELF-CLEANING STRAINER FOR FIRE NOZZLE (no scale)

- 1 2½in inlet
- 2 2½in outlet
- 3 Operating handle
- 4 Strainer
- 5 Flushing outlet

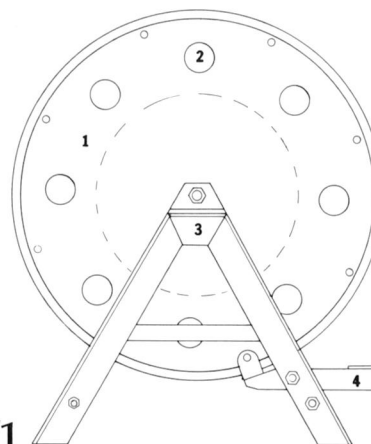
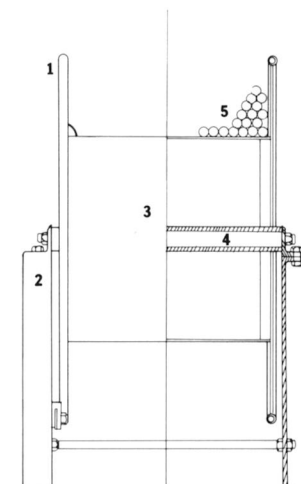
F14 TYPE A REEL (1/16 scale)

- 1 End plate
- 2 Lightening hole
- 3 Support bracket
- 4 Brake

F14/2 Front View

- 1 End plate
- 2 Support bracket
- 3 Reel drum
- 4 Axle
- 5 Wire rope

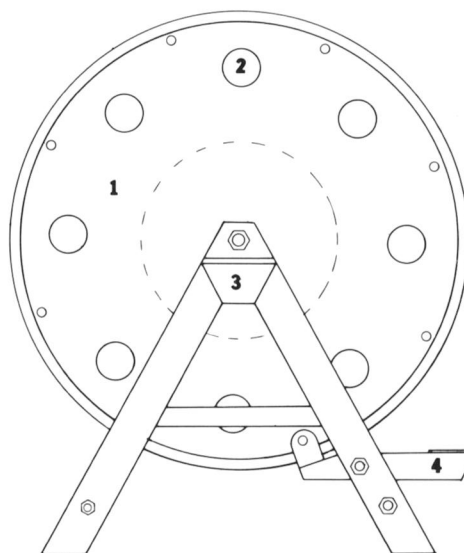
F15 TYPE B REEL (1/12 scale)

F15/1 Side view

- 1 End plate
- 2 Lightening hole
- 3 Support bracket
- 4 Brake

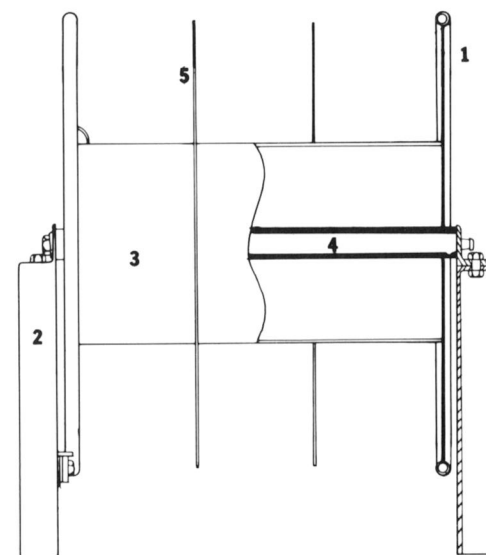
F15/2 Front View

- 1 End plate
- 2 Support bracket
- 3 Reel drum
- 4 Axle
- 5 Separators

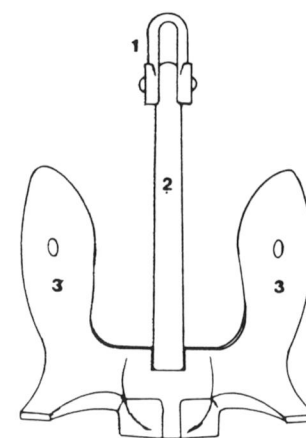
F17 STOCKLESS ANCHOR (1/40 scale)

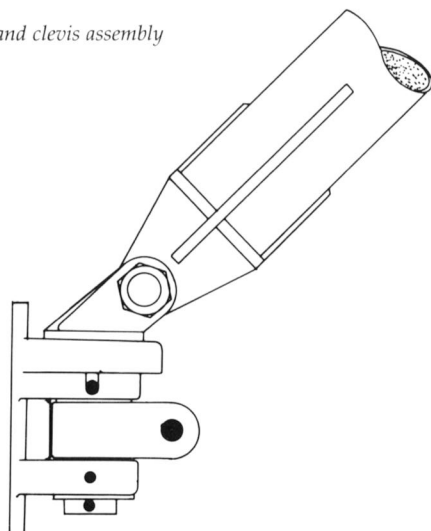
**F18/8**

F18/8 Boom and clevis assembly

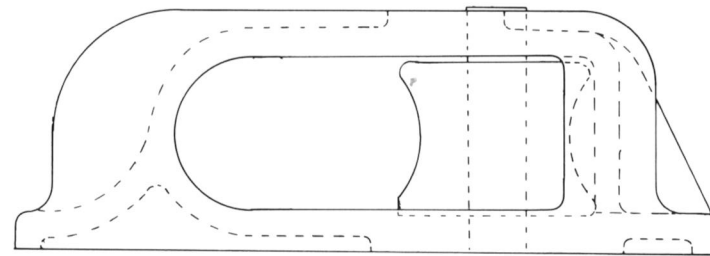
**F19/1**

F19 SINGLE ROLLER CHOCK  
(1/32 scale)

F19/1 Side view

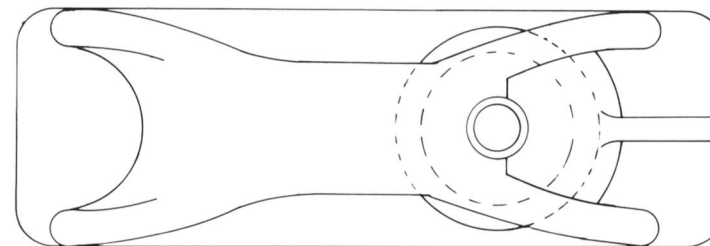
**F19/2**

F19/2 Top view

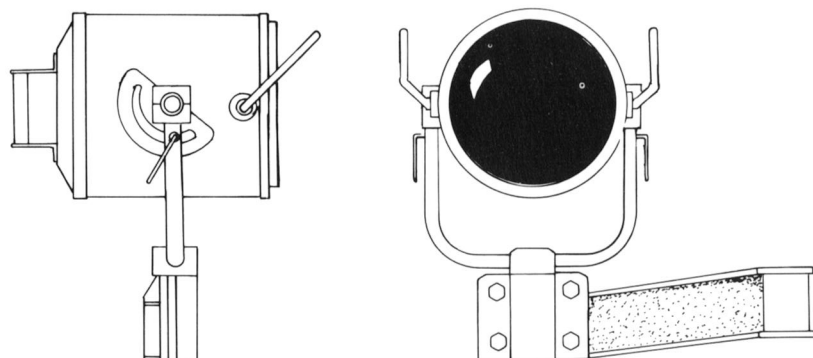
**F21**

F21 12in SIGNAL LAMP (1/12 scale)

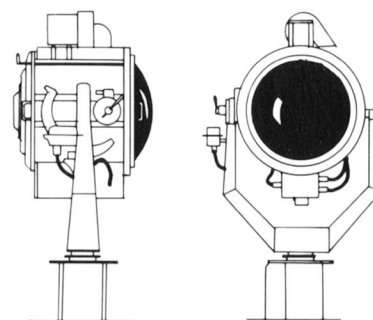
**F22**

F22 24in SEARCHLIGHT (1/48 scale)

The port side of *Gambier Bay's* superstructure. Sky lookouts have replaced the 2.5m optical rangefinder and the aft 24in searchlight has been removed from its platform. (National Archives 80-G-243853)

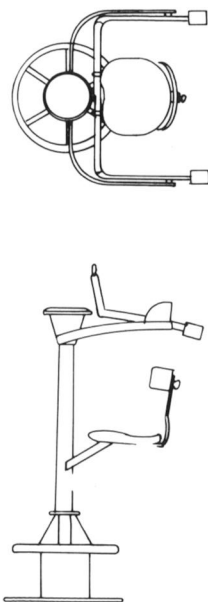
**F24**

F24 SKY LOOKOUT (1/40 scale)

As built, *Gambier Bay* carried a 2.5m rangefinder mounted on a platform just forward of the mast until at least February 1944. By July 1944, however, it was replaced by two sky lookouts.

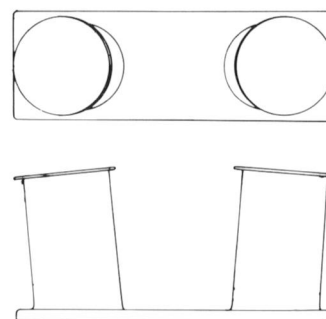
**F25**

F25 10in BITT (1/24 scale)

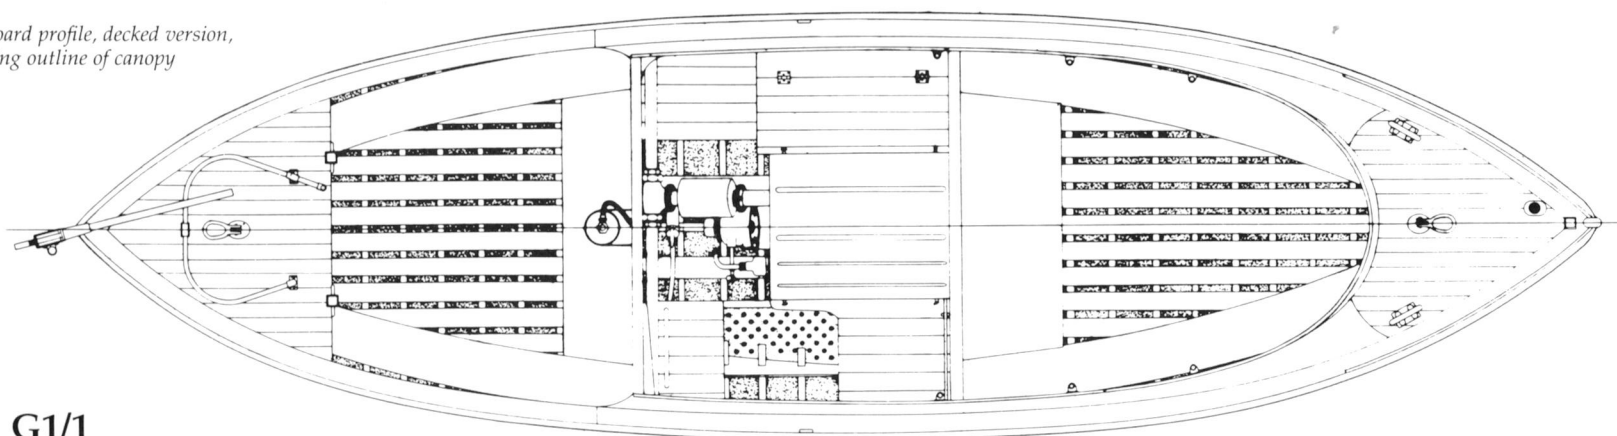
G1/1 *Plan view, decked version*

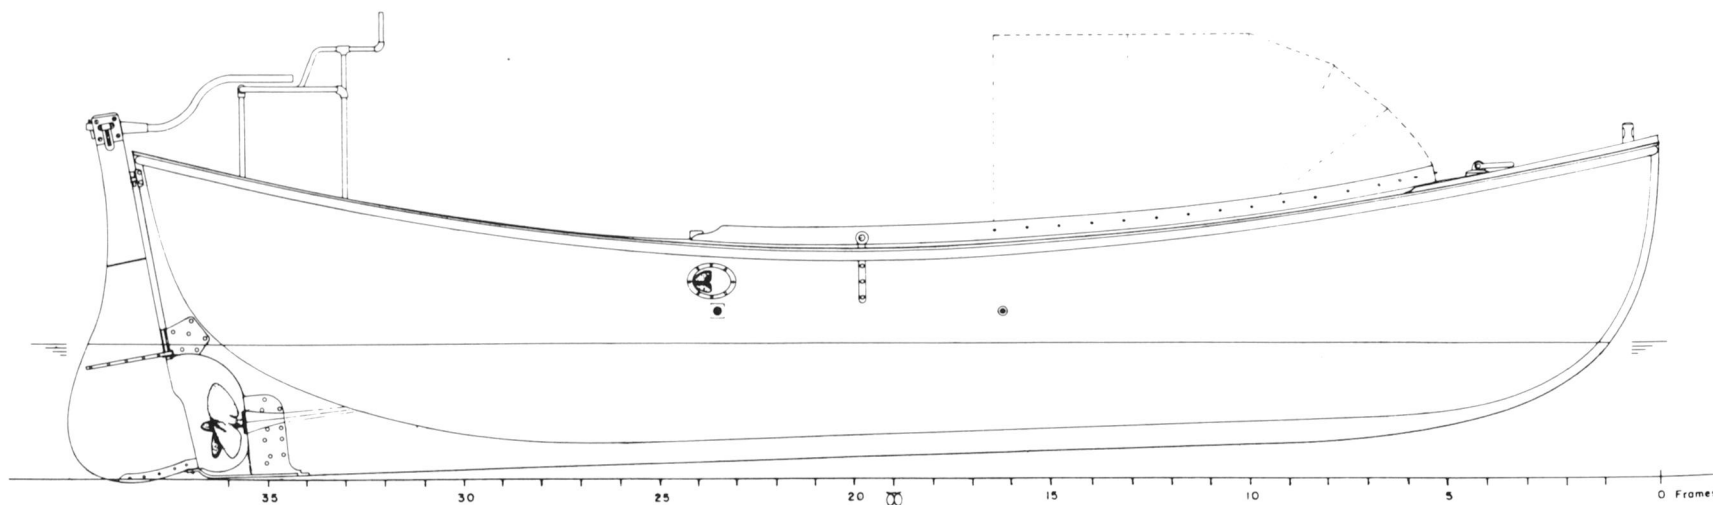
G1/2 *Outboard profile, decked version,  
showing outline of canopy*

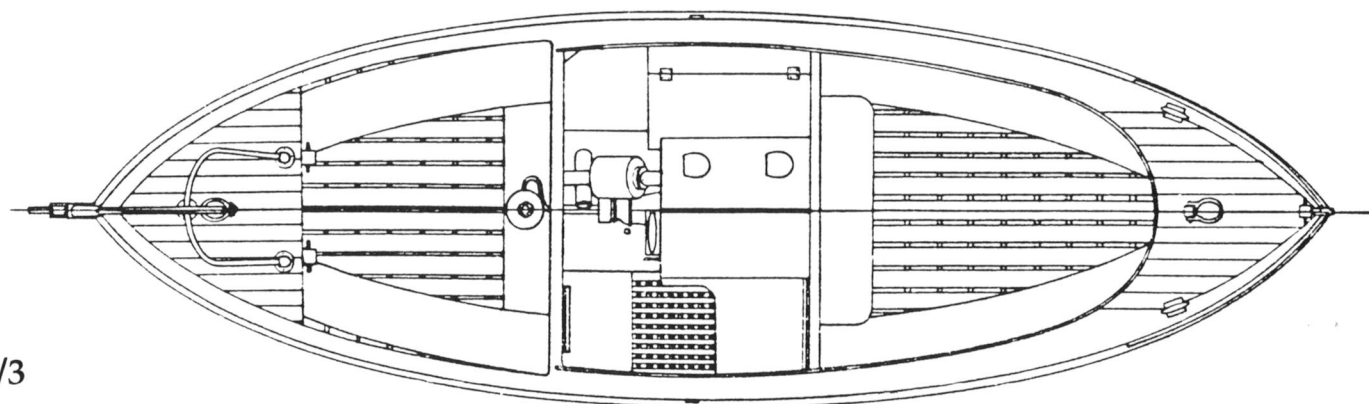
G1/3 Plan view, undecked version (1/48 scale)

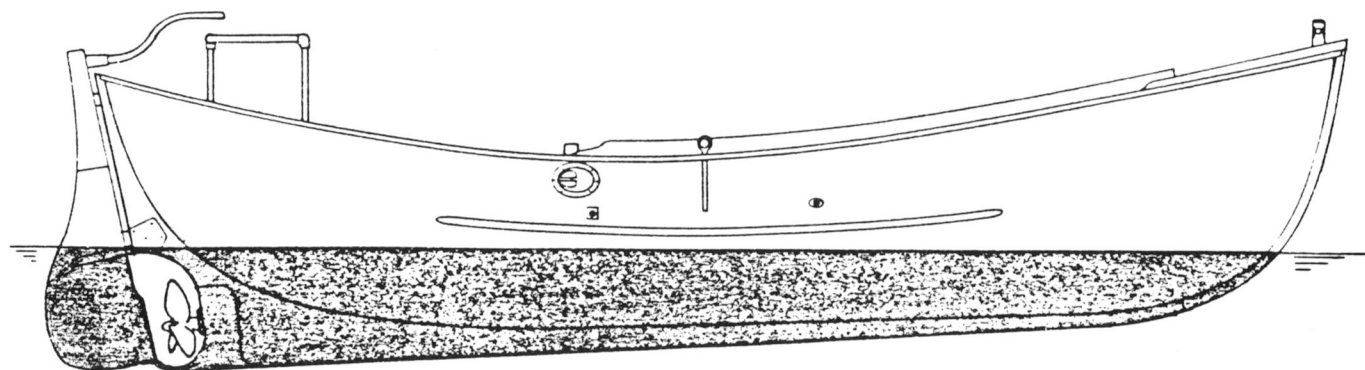
G1/4 Outboard profile, undecked version  
(1/48 scale)

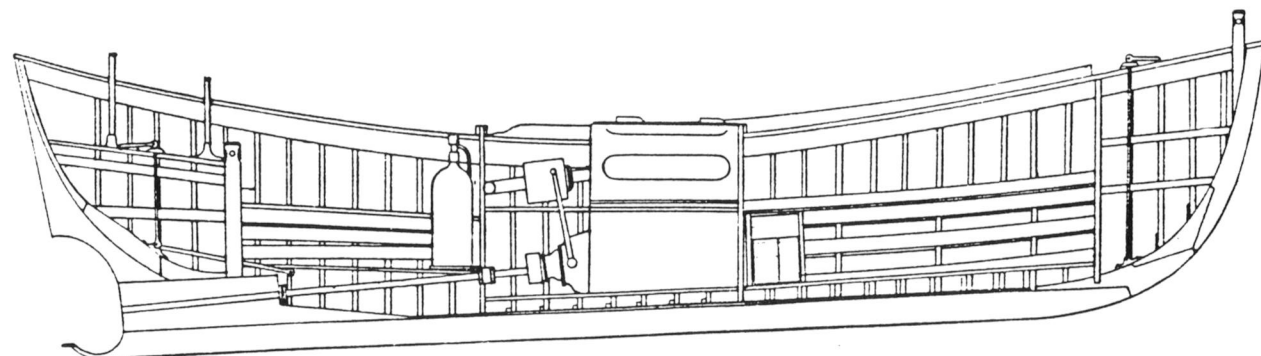
G1/5 Inboard profile, undecked version  
(1/48 scale)

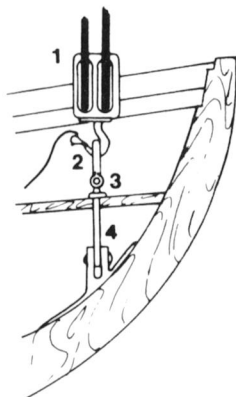
### G4 LIFTING ARRANGEMENT (1/48 scale)

- 1 Double block
- 2 Raymond releasing block
- 3 Lifting eye
- 4 Lifting eye support

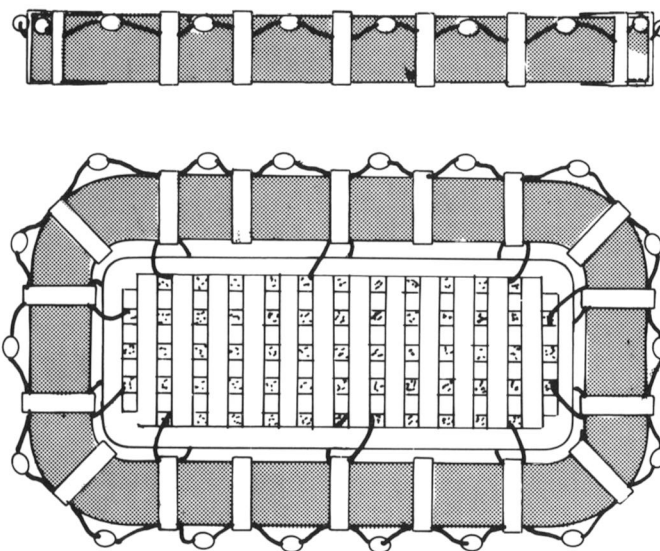
### G6 25-MAN LIFERAFT (1/32 scale)

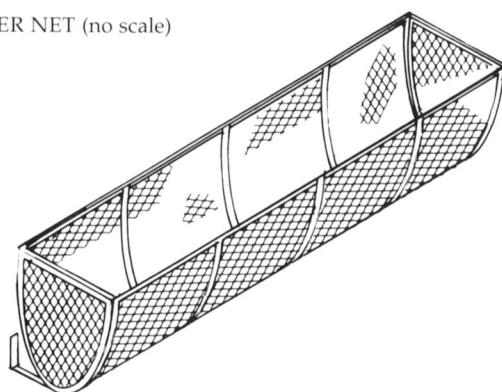
### G7 FLOATER NET (no scale)

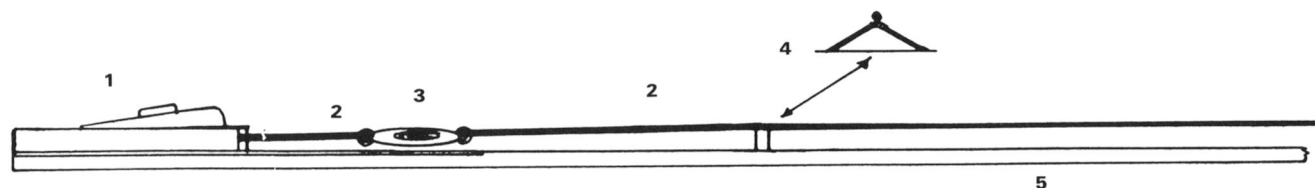
## H1 ARRESTING GEAR ARRANGEMENT (1/28 scale)

- 1 Sheave
- 2 Cable
- 3 Turnbuckle
- 4 Cable support
- 5 Flight deck

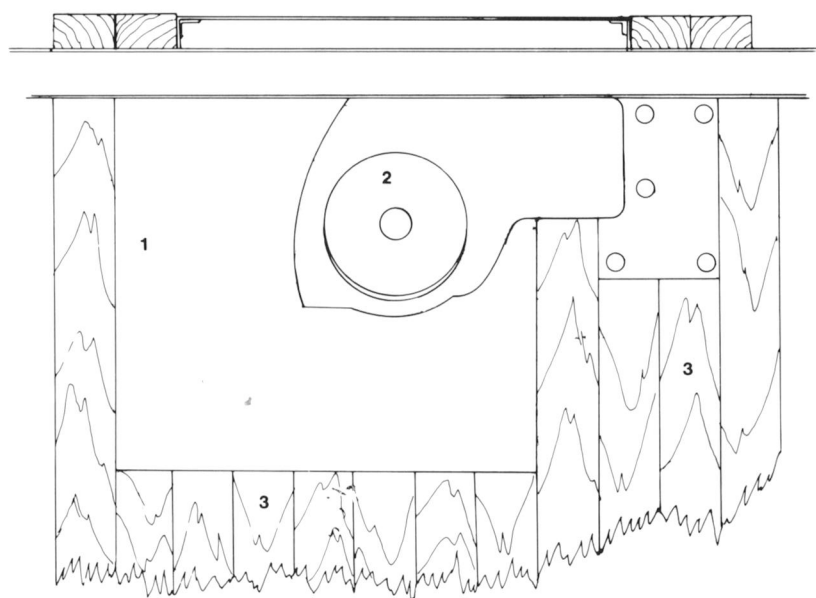
## H2 ARRESTOR WIRE SHEAVE AND PLATE (1/28 scale)

H2/1 Section through chafing plate

H2/2 Plan view

- 1 Chafing plate
- 2 Sheave
- 3 Planking

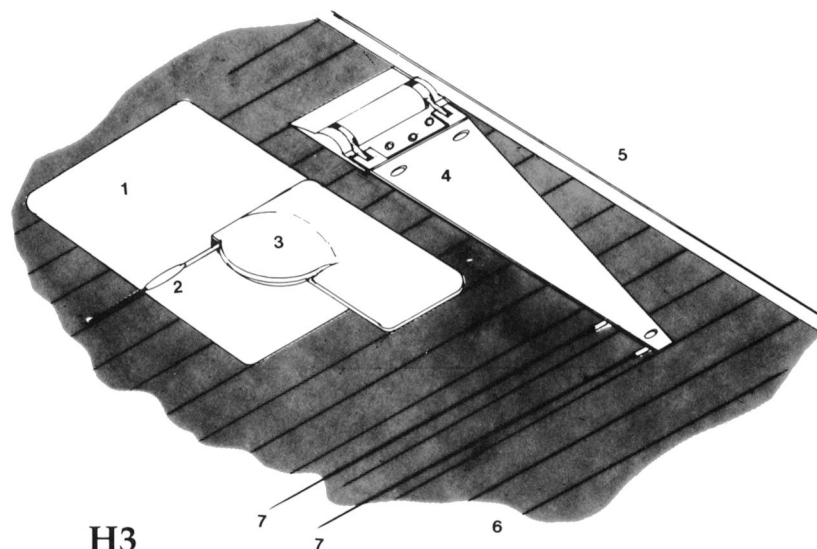
## H3 ARRESTOR WIRE SHEAVE AND BARRIER ARM (no scale)

- 1 Chafing plate
- 2 Turnbuckle
- 3 Sheave
- 4 Crash barrier arm
- 5 Flight deck lip
- 6 Flight deck planking
- 7 Barrier wires

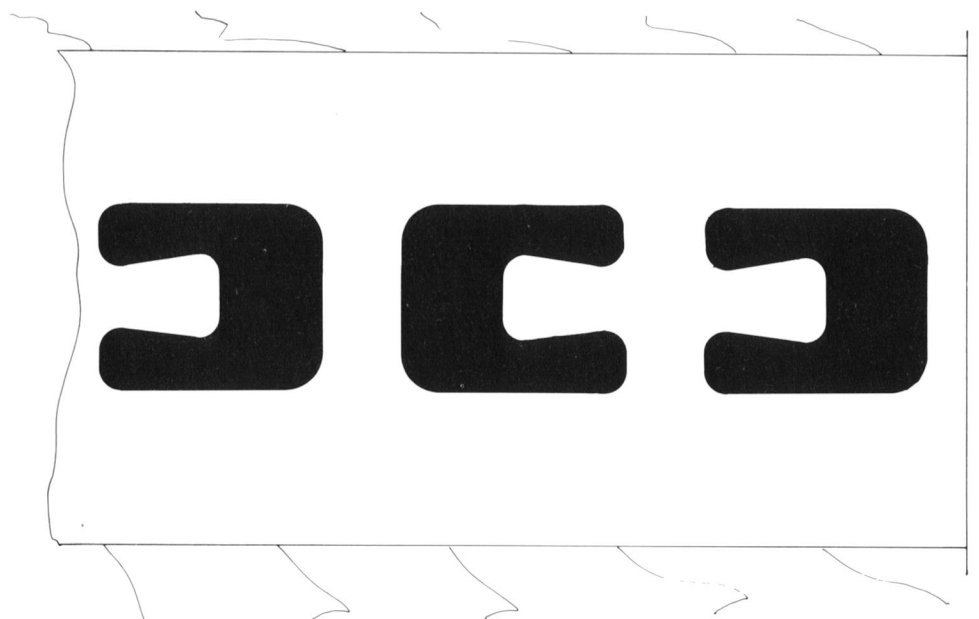
H4/2 *Tiedown strip (1/2 scale)*

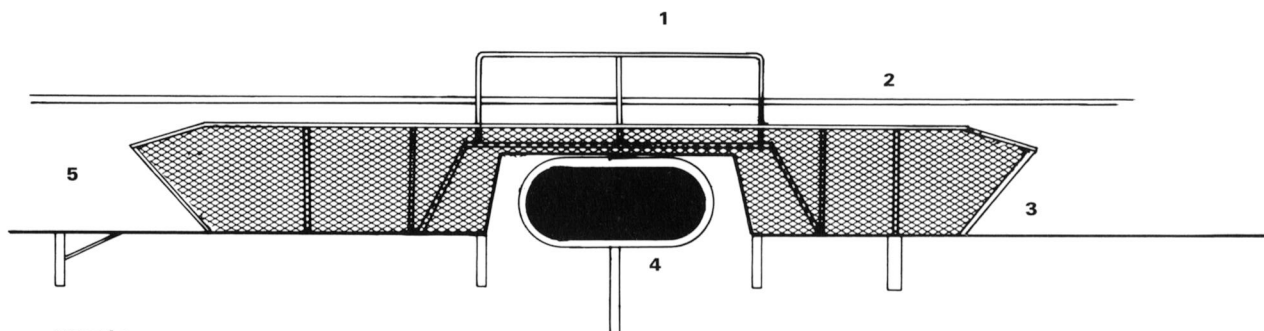
H5 SAFETY NET ARRANGEMENT  
AT STACK (1/64 scale)

H5/1 Side view

- 1 Folding rail
- 2 Flight deck lip
- 3 Safety net
- 4 Stack
- 5 Catwalk
- 6 Platform over stack

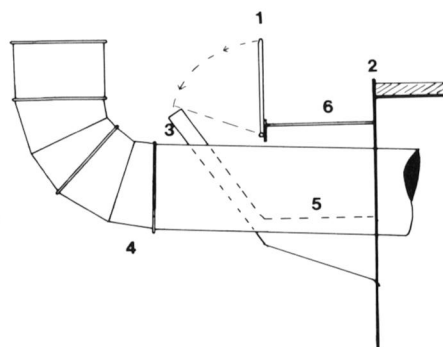
H5/2 Front view

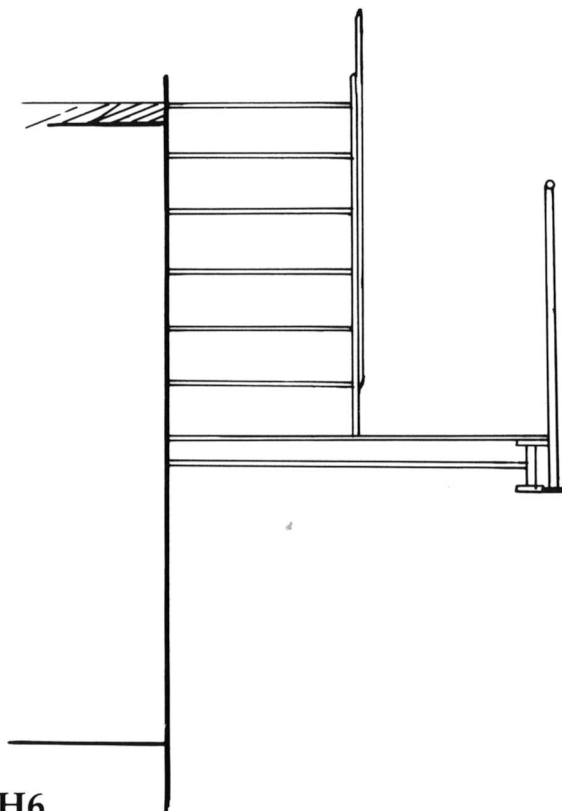
H6 LADDER FROM FLIGHT DECK  
TO GALLERY DECK (1/24 scale)
