# The Escort Carrier **GAMBIER BAY**

Al Ross

# The Drawings

## A General arrangement

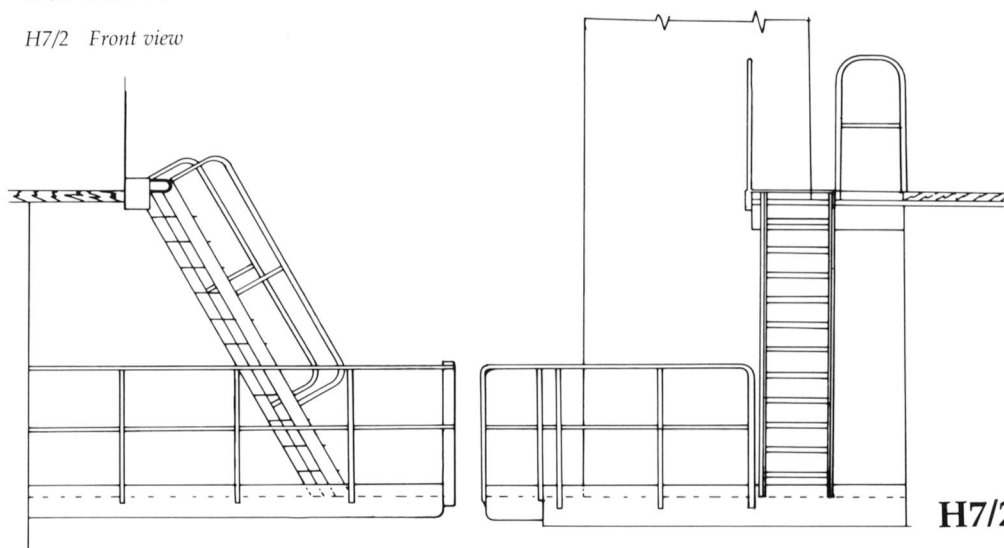
H7 LADDER FROM FLIGHT DECK  
TO GALLERY DECK AT ISLAND  
(1/64 scale)

H7/1 Side view

H7/2 Front view

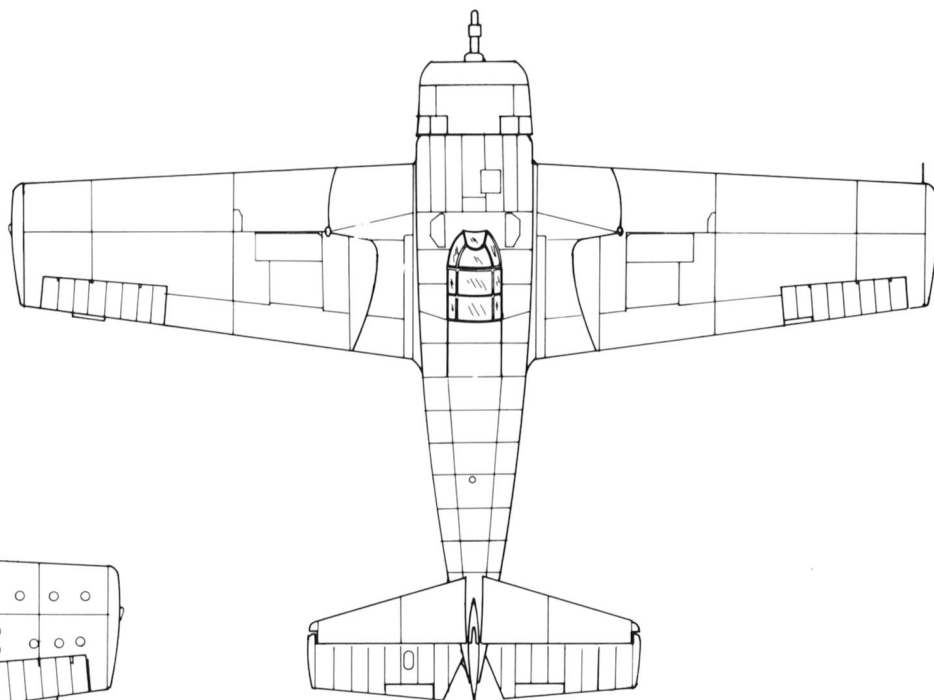
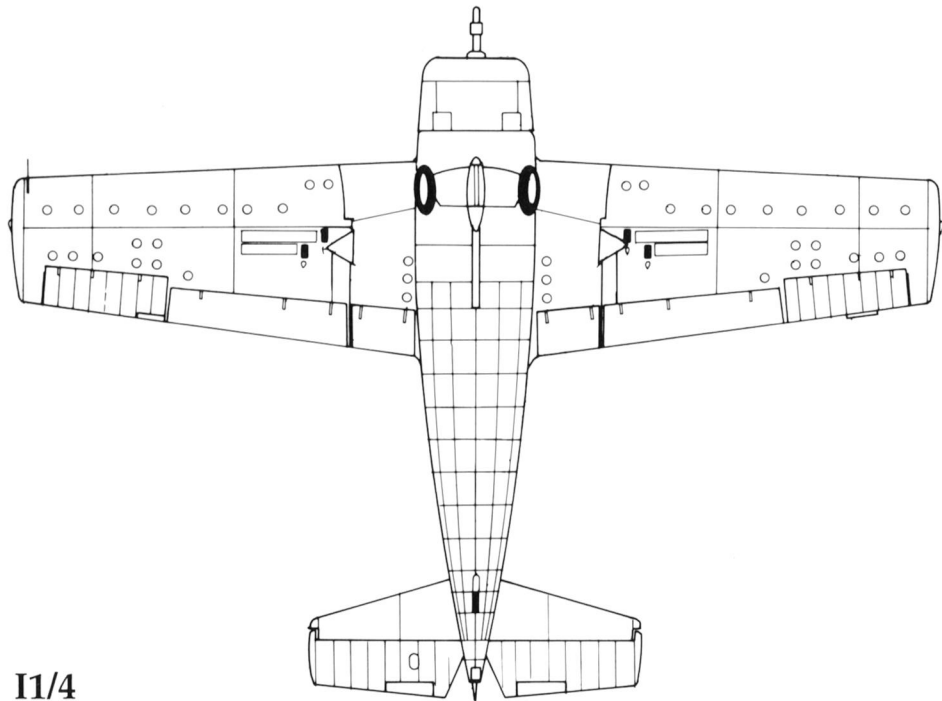
I1/4 Bottom view

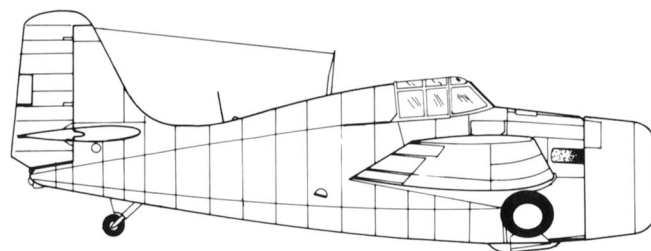
I1/3 Side view

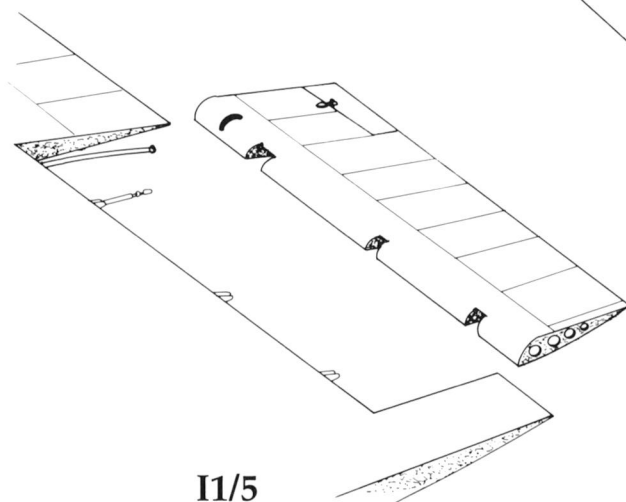
I1/5 Aileron arrangement (no scale)

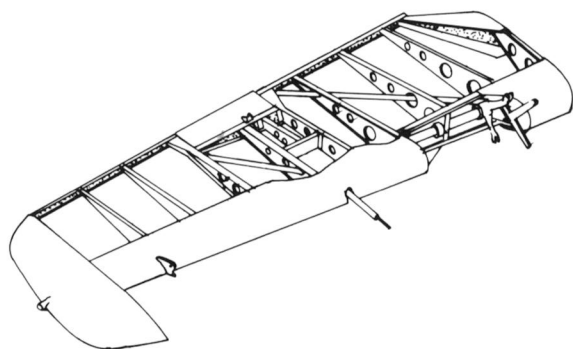
I1/9 Rudder framing (no scale)

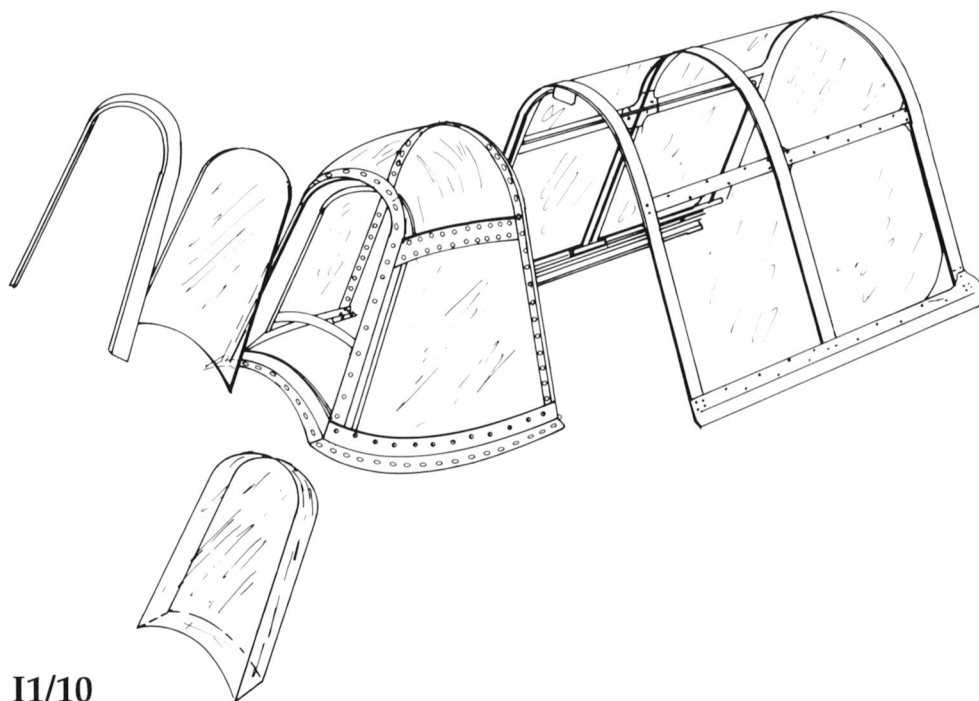
I1/10 Canopy components (no scale)

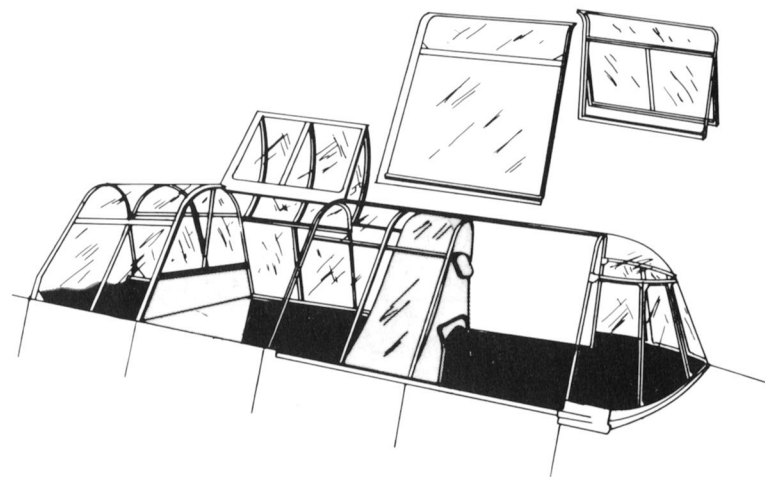
I2/6 Canopy components (no scale)

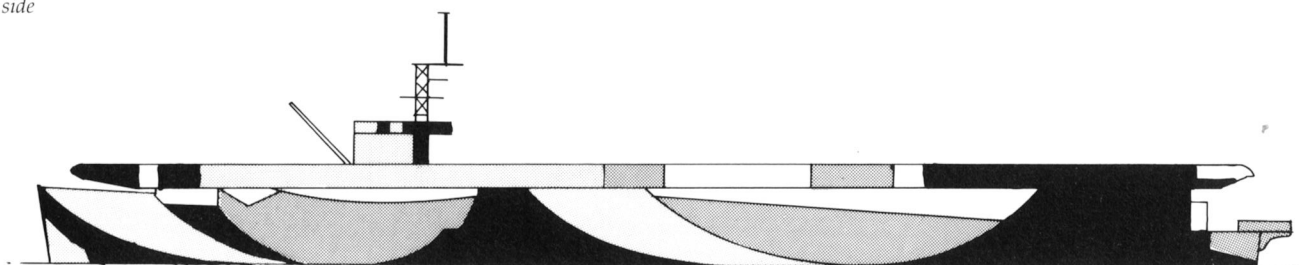
J1/2 Starboard side

*Gambier Bay* is known to have carried at least two schemes during her short life. Until February 1944 she was painted in Measure 14 – overall ocean grey (5-O). At the time of her loss, in October 1944, she was painted in Measure 32/15a – pale grey (5-P), light grey (5-L), ocean grey (5-O), and black. Exposed metal decks were painted deck blue (20-B), while the flight deck was either blue flight deck stain (No. 21) or a later, darker stain similar to deck blue. Flight deck stripes were originally white or light grey, but photos taken in mid-1944 show the stripes as either worn completely off or painted a shade similar to the flight deck. A large black '73' was carried on the forward end of the flight deck.

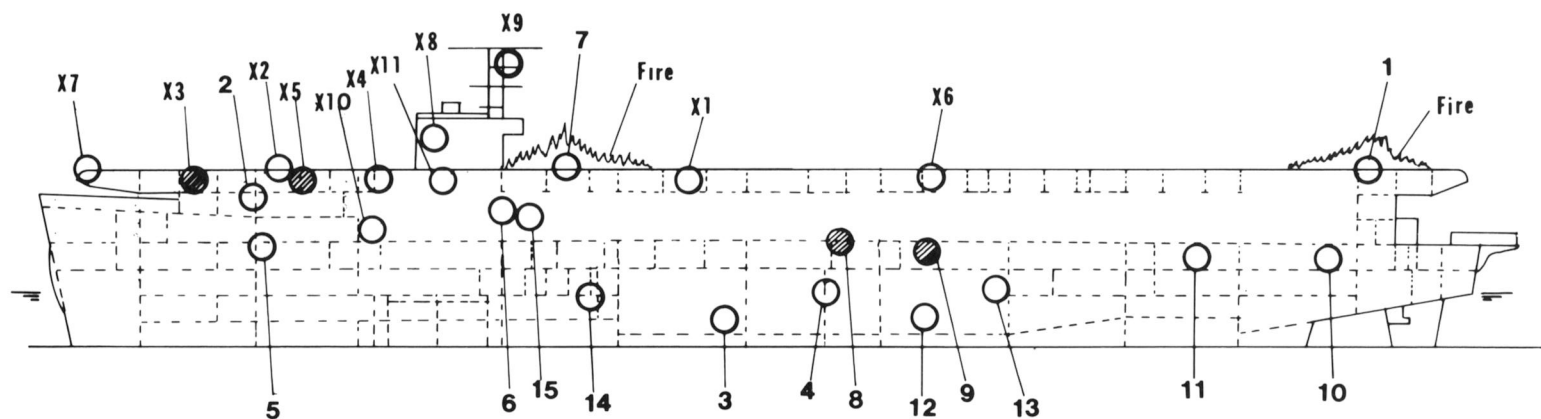
K BATTLE DAMAGE

Circles shown indicate known hits. Numbers correspond to those in the text.
